**Short report on the excavations carried out by the  
Department of Hungarian Medieval and Early Modern  
Archaeology in 2014 (Eötvös Loránd University, Budapest)  
Excavations at Castles Čabrad' and Drégely, and at the Pauline Friary  
at Sáska**

MAXIM MORDOVIN

**Excavations at the 16th century gate tower at Čabrad' Castle (Slovakia)**

## **Excavations of the artillery tower at Drégely Castle (County Nógrád)**

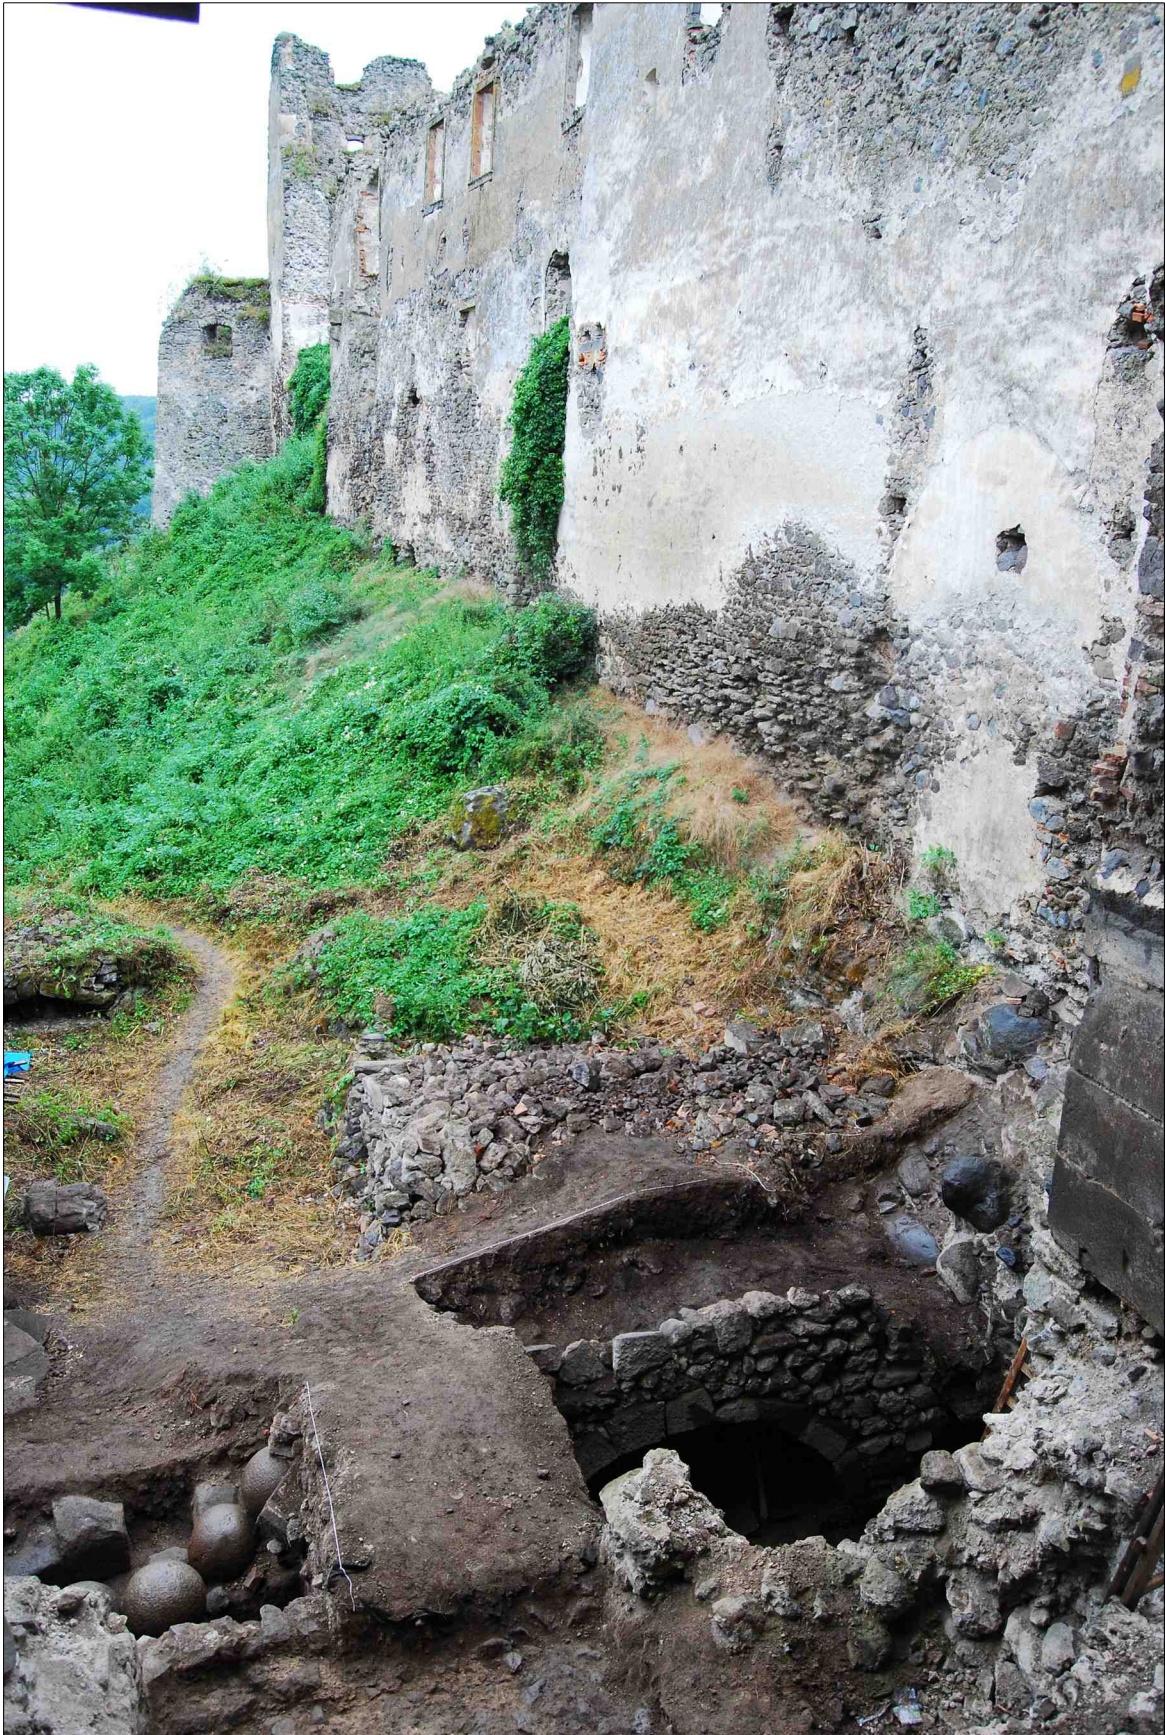
*Fig. 4. View from the southern gates on the drawbridge pit.*

In the first two trenches we continued the excavation of the drawbridge pit along the southern façade of the gate tower (Fig. 4). The pit appears as a ditch partially carved into the rock. This year seems to have been the most productive – maybe even among all archaeological sites in Slovakia – concerning the density of the finds per square meter. From the less than 20 m<sup>2</sup> of filling layers of the trench we obtained ca. 30,000 fragments, one third of which was pottery, another third were animal bones and the rest consisted of metal and glass finds (Fig. 5).

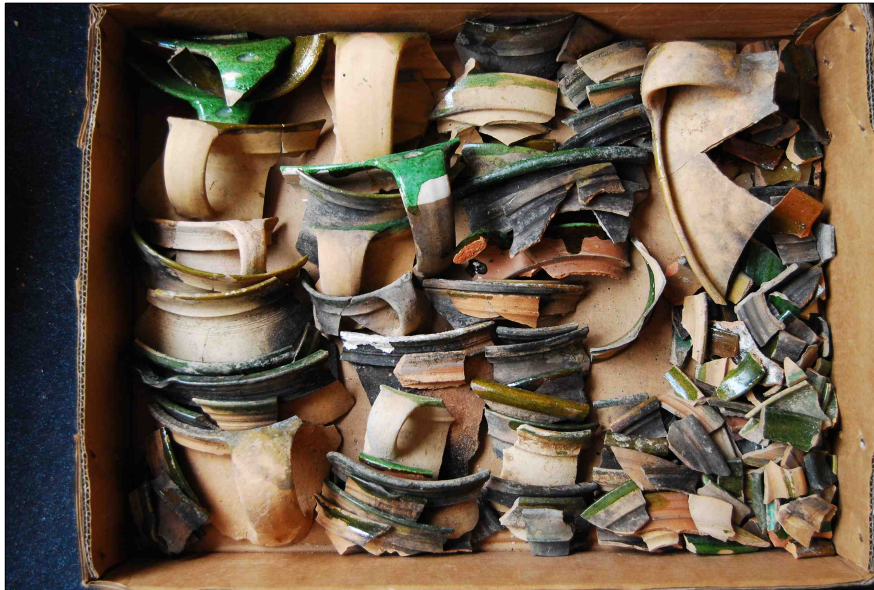
Fig. 5. Green-glazed pots from the drawbridge pit.

The assemblage included a high number of decorated table ware (plates, jugs), so-called *habán*-pottery (tin-glazed ware), and a large quantity of kitchenware (pots and specific pots with legs). Beside the 'classic' ceramic production a very high percentage of stove tiles were observed in the fillings of the pit. Most probably during the first half or mid-18th century some parts of the castle underwent a serious renovation (maybe even a reconstruction) which was accompanied by the replacement of most of the older, 17th century tile stoves. The tiles, at the same time, were 'deposited' (thrown away) into the already disused drawbridge pit. In trench 2/2014 the destruction layer of the tower contained five (!) stone cannonballs (Fig. 6). However, these were not used as ammunition but as simple decoration of the southern façade of the gate tower. Two more such balls still can be seen *in situ*.

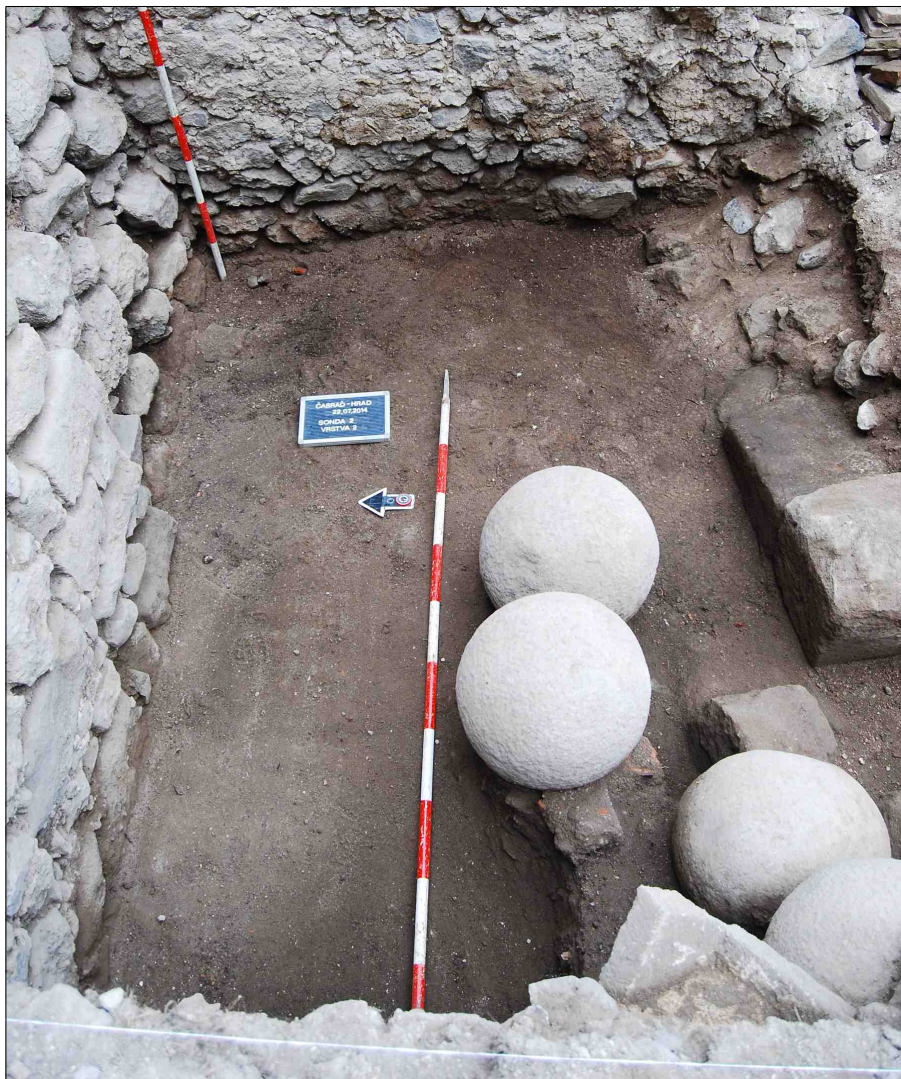
Fig. 6. Four cannonballs from trench 2/2014 (the fifth was removed earlier).

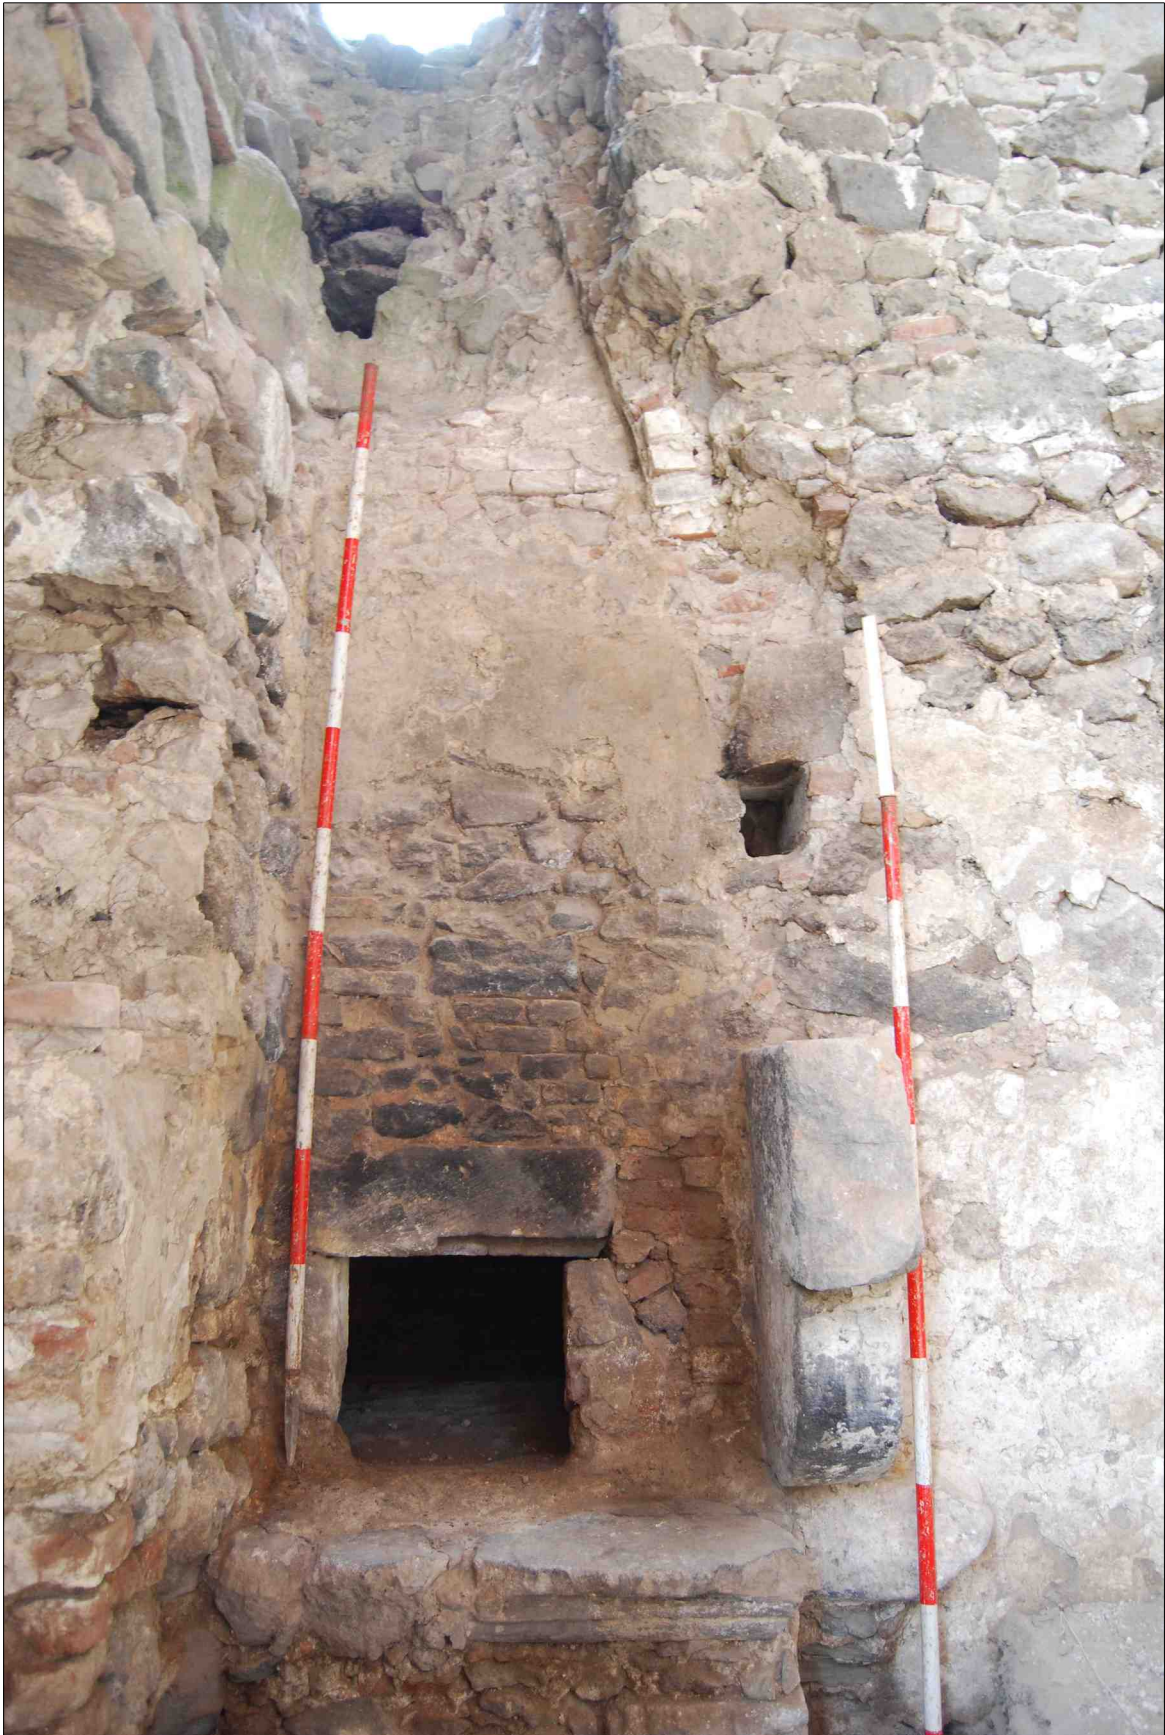
*Fig. 7.* The oven excavated in the southwestern corner of the gate tower.

Inside the gate tower the excavations focused on two localities. One was in the southwestern corner of the tower as a western expansion of trench 3/2013, while the other was situated just beside the western gate, which led from the tower to the great courtyard. In the southwestern corner, under the debris of the collapsed vaults of the two upper storeys we have excavated an oven, built in secondarily into the western wall of the tower. The oven survived in very good state. In front of it, in a smaller trench we reached the remains of the former floor with a 15 cm thick glass layer over it. There were some fragments of lead window frames among the glass shards. This all seems to have belonged to the windows of the tower smashed in order to get the lead after the castle was abandoned (Fig. 7–8).

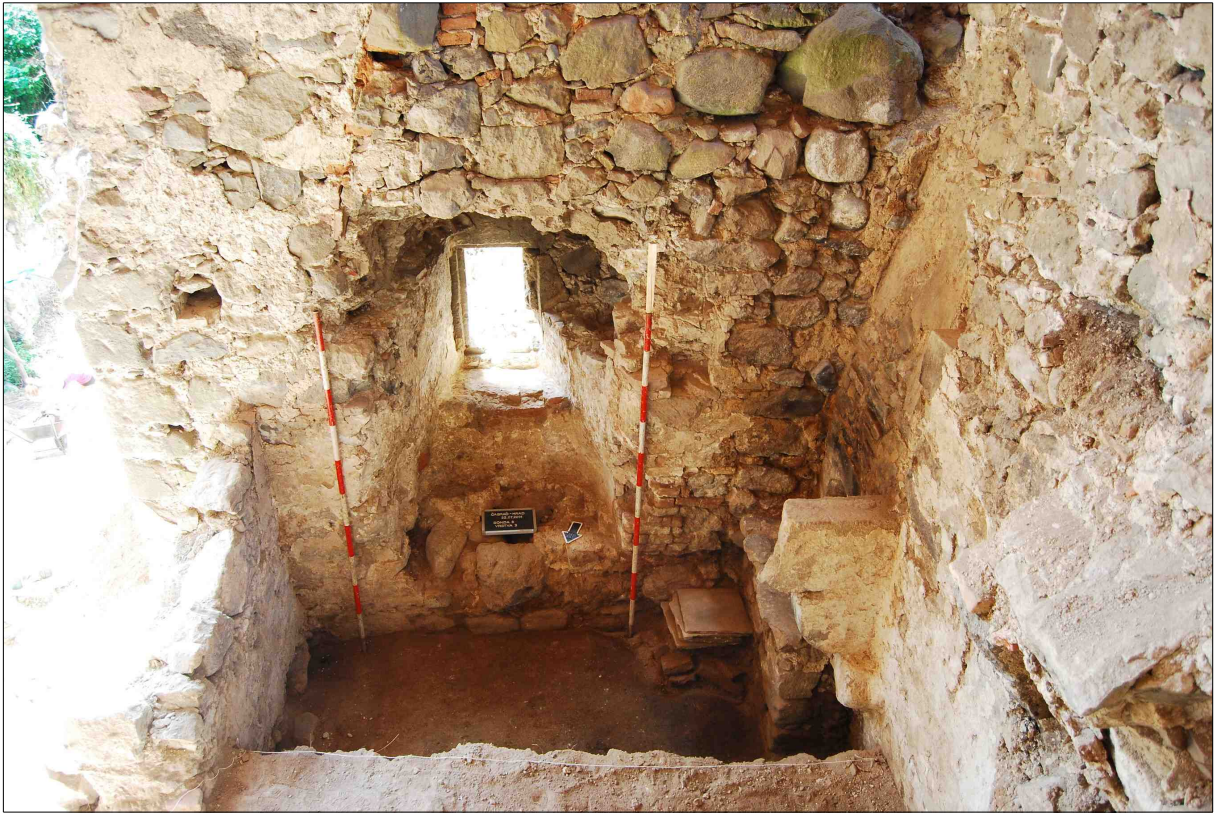
*Fig. 8.* Window in the southwestern corner of the tower.

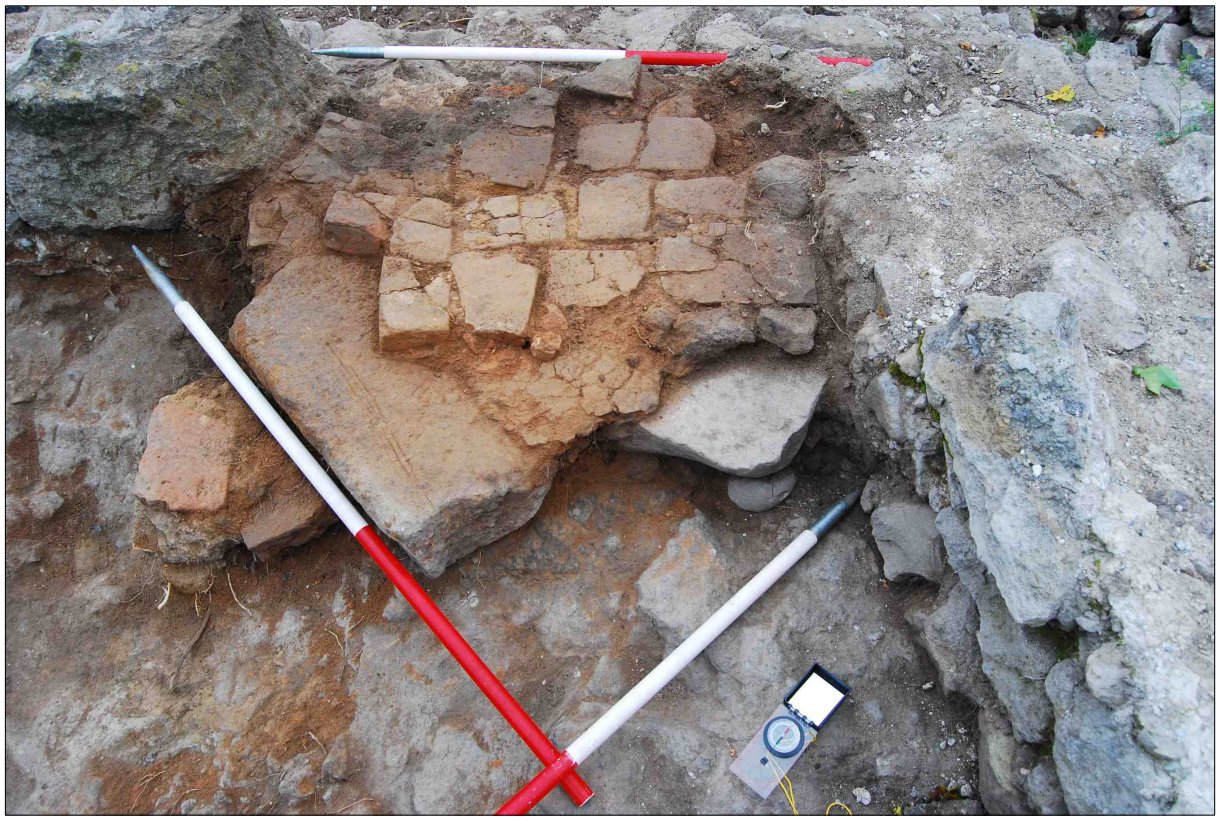
*Fig. 12.* Foundation of the tile stove (Drégely).

The interior of the tower consisted of a single room, no partition walls were found. The only heating structure was excavated in a special niche formed in the northwestern corner. It was a tile stove built of so-called 'onion shaped' ceramic vessels (*Fig. 12*). Because of the clearly military function of the building we expected only a relatively small amount of finds. Nevertheless, some of them appeared to be very interesting or important concerning the dating of the building. Thus, for example, several coins datable to the 16th–17th century were found on the inner surface of the tower. Traces of wooden shelves have been also identified within the burnt debris of the destruction layers. Fragments of at least two 17th century pots were found among the remains of these shelves. The whole interior was covered with broken sherds of the stove 'pots', which suggest its deliberate destruction. Then the tower was seemingly set on fire. Inside and around the building a number of other, non-ceramic artefacts were found, including a fragment of a candle stick, rings (among others seal rings), copper-alloy belt mounts and even pectoral crosses (*Fig. 13*).

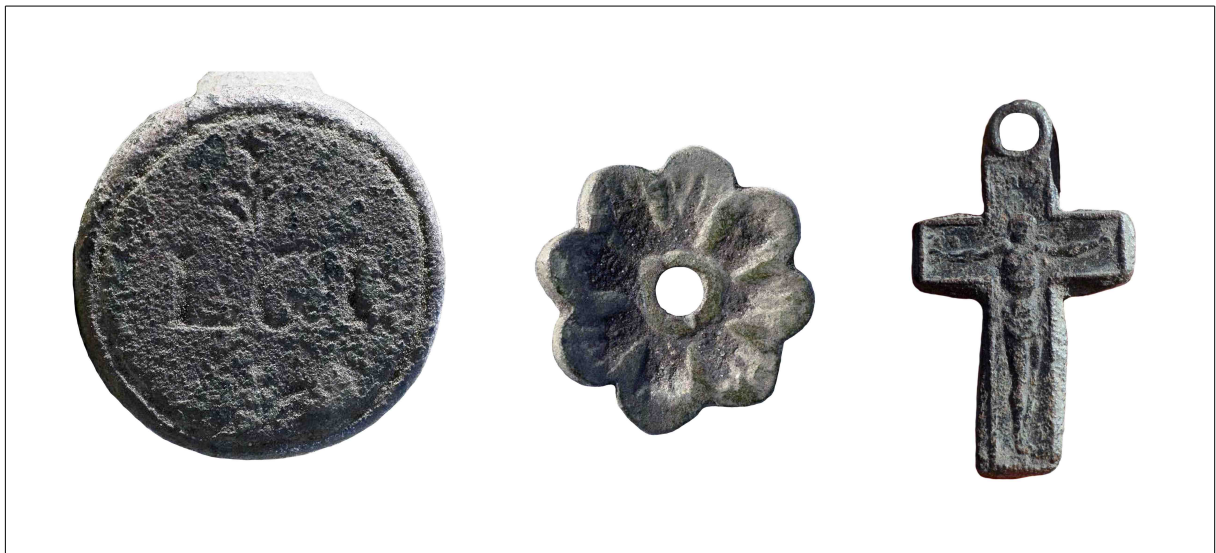
*Fig. 13.* Small metal finds from the tower (Drégely).

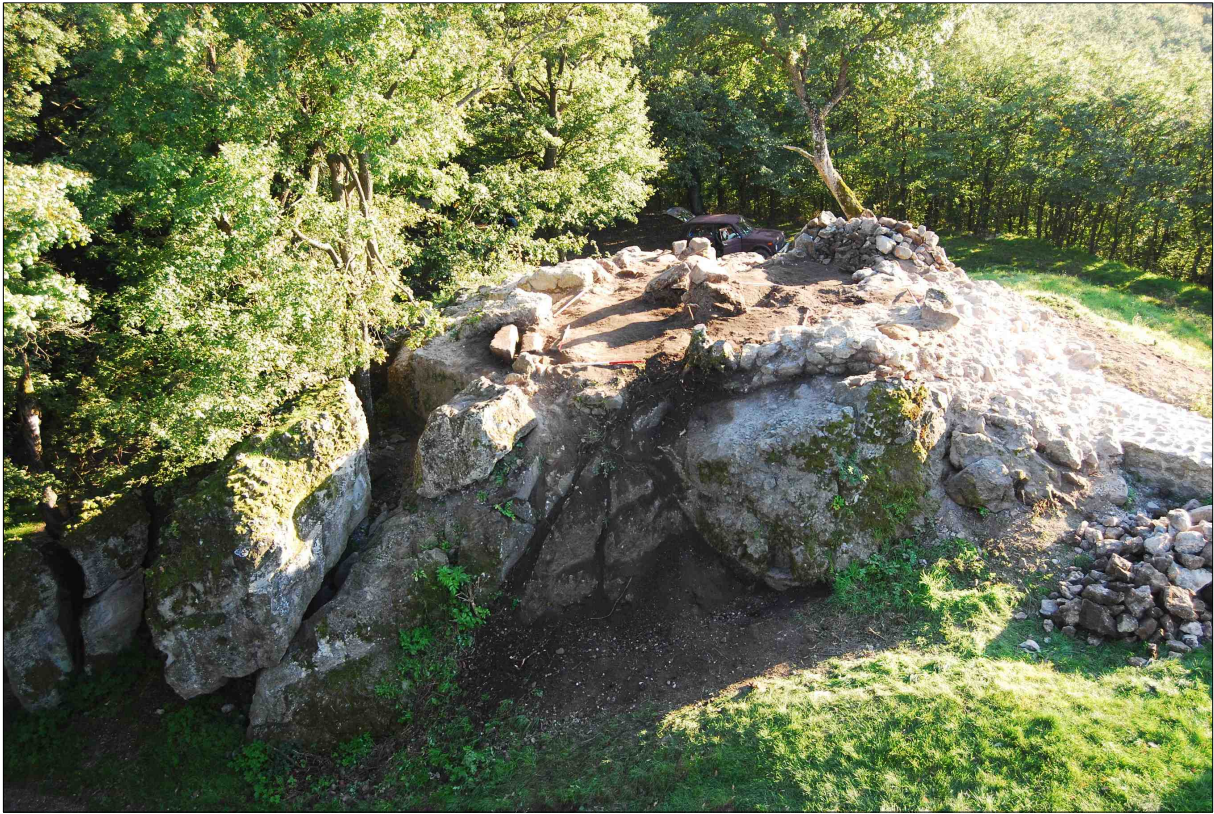
*Fig. 14.* Excavated artillery tower at the end of the research.

The excavation of the southern artillery tower of Drégely was completed in 2014 and in the same year a partial reconstruction took place at the site. There are no plans for possible further research of the castle (*Fig. 14–16*).

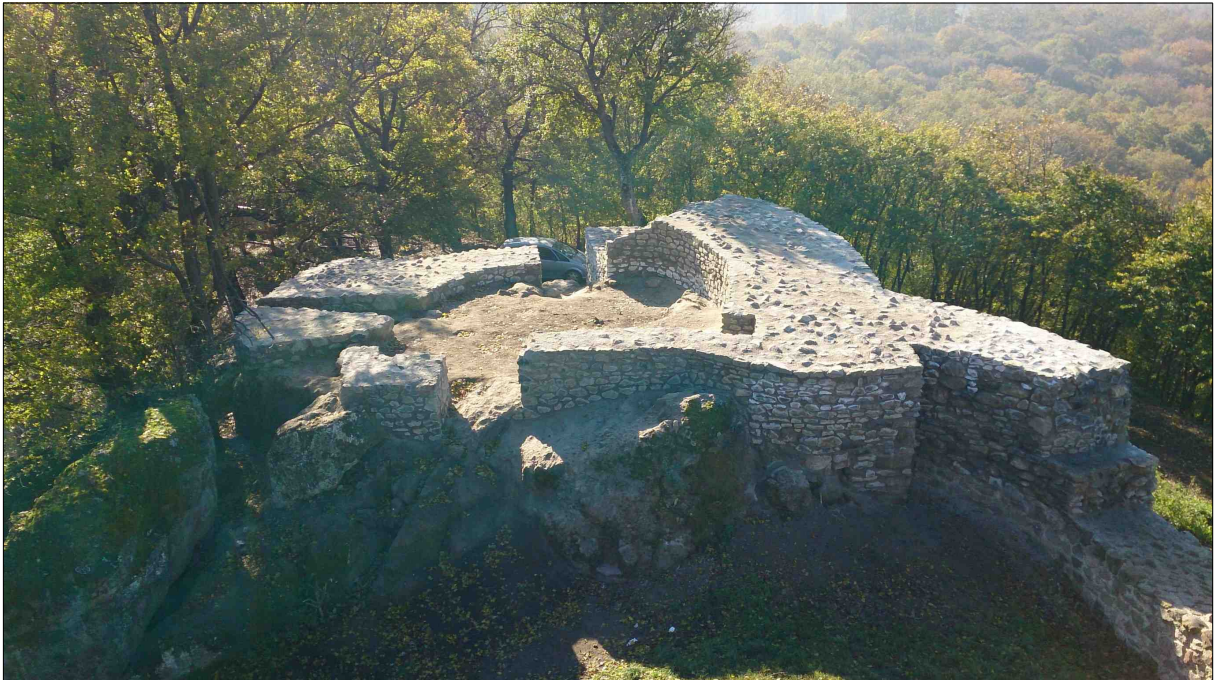
*Fig. 15.* Partially reconstructed tower in November 2014 (Photo: Péter István).

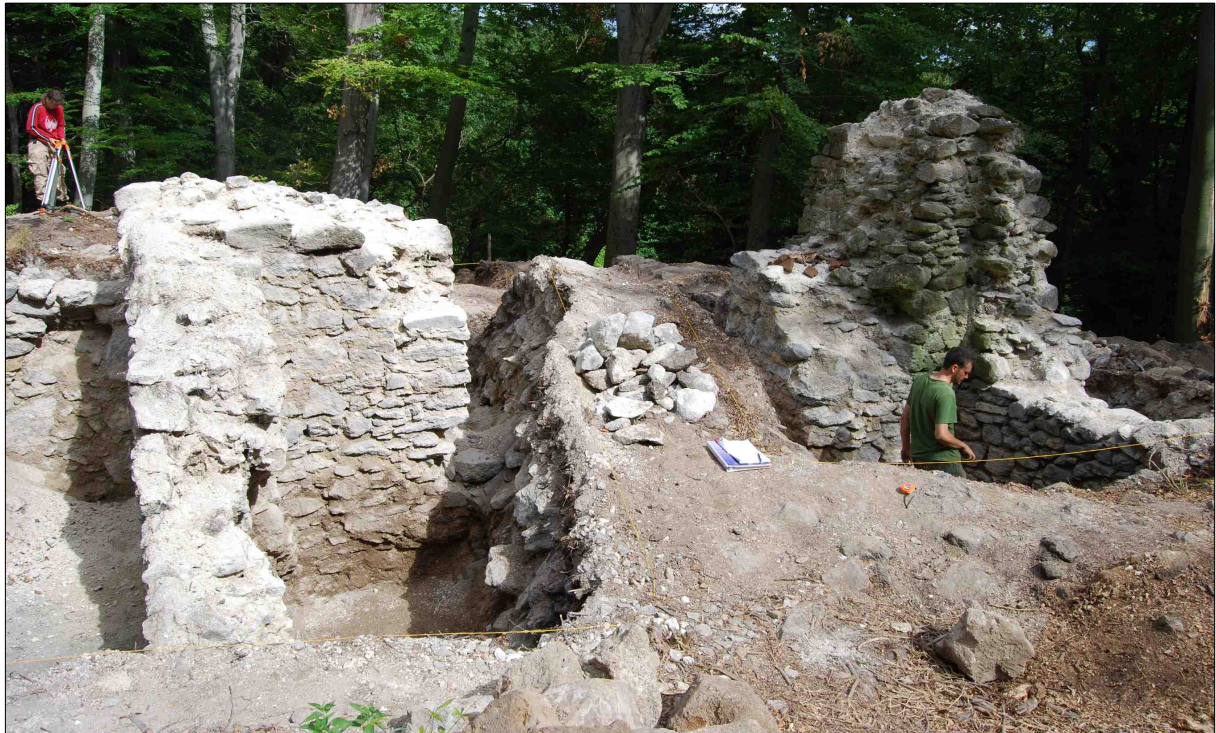
*Fig. 18.* Pillars of the triumphal arch (St. James' Friary, Sáska).

The excavated walls were in average 1,2–2 m high and 65–85 cm thick, built of large stones using relatively bad mortar. The easternmost end of the apse was completely destroyed by the treasure hunters. The best preserved part of the whole church was the triumphal arch, more precisely the two pillars, which might have supported the small tower known from Rómer's notes (*Fig. 18*).

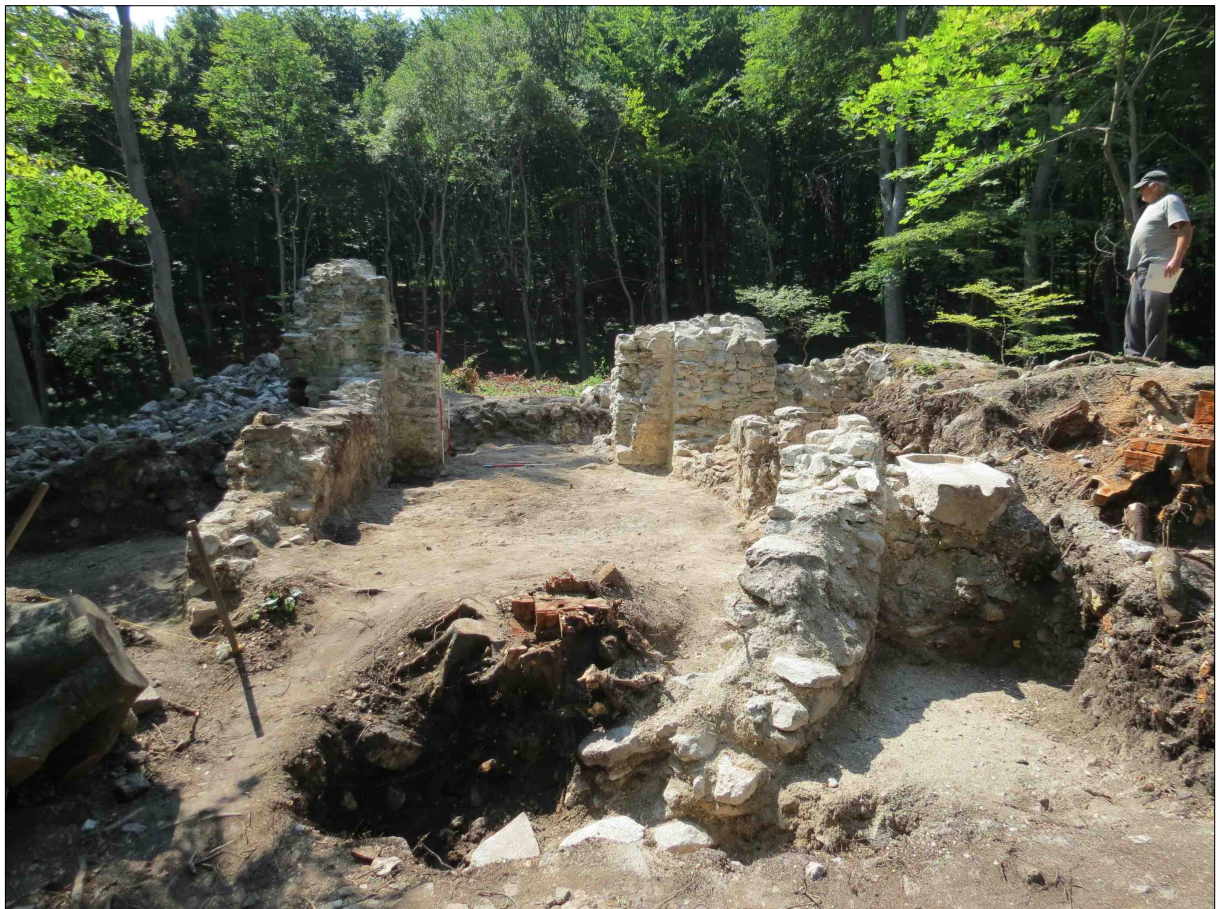
*Fig. 19.* View of the excavated chancel (St. James' Friary, Sáska).

According to the research of the remaining architectural details, at least two main phases of the structure could have been identified. The chancel and the pillars of the triumphal arch were built separately but in the same building phase. The sacristy and a small room west of it were attached later, most probably separately. A finely carved lavabo was found *in situ* in the eastern wall of the sacristy (*Fig 19*).
