# New results of the excavations at the Saint James' Pauline friary and at the Castle Čabrad'

MAXIM MORDOVIN

*In 2015 the Department of Hungarian Medieval and Early Modern Archaeology of Eötvös Loránd University participated in excavations at five different sites, including Pauline friary at Bakonyszentjakab, castles at Filakovo (Füleke), Zvolen (Zólyom) and Čabrad' (Csábrág) in Slovakia, Franciscan friary in Szécsény and a post medieval château at Sângeorgiu de Mureş (Marosszentgyörgy) in Romania. This report presents the two major from the aforementioned projects.*

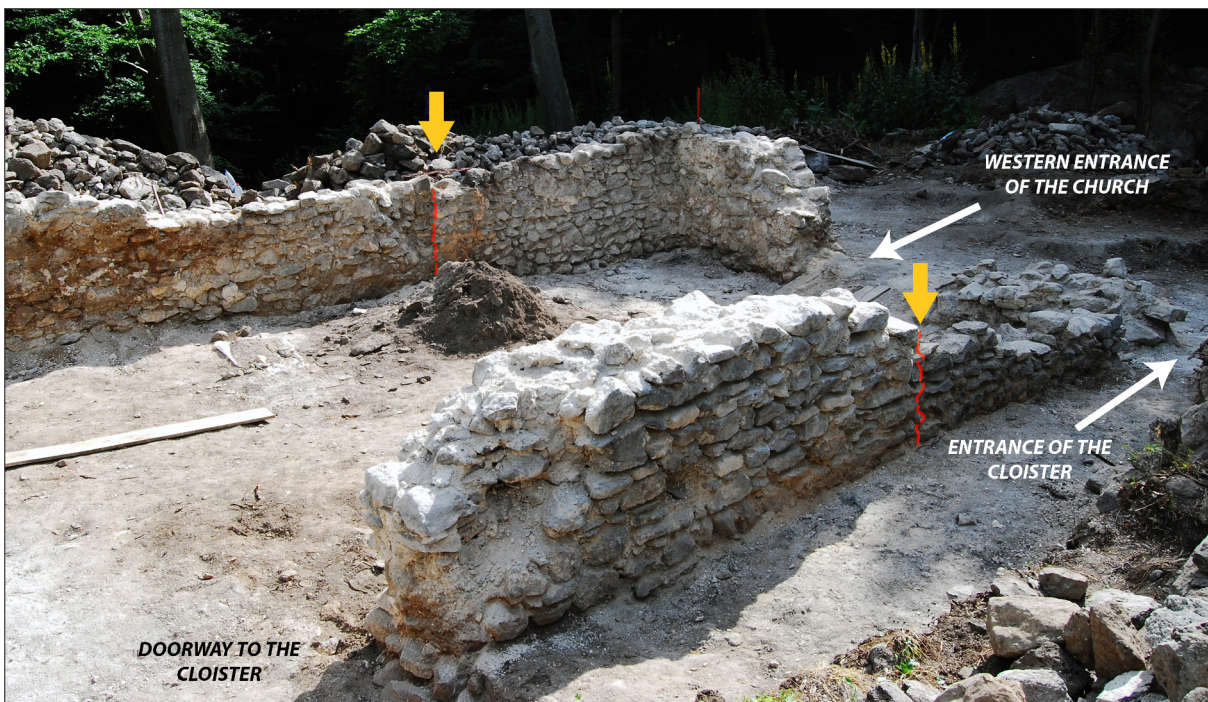
Fig. 2. Western part of the church showing the main entrances and the joints in the walls (Bakonyszentjakab).

quality lime mortar mixed with too large amount of gravel. The nave was completed in two stages but seemingly within the same building phase. On the both side walls, approximately 1.5 from the western façade there is a clearly visible vertical joint (*Fig. 2*). At the same time there is no sign of a possible western wall at this point. The nave had two entrances: one from the west and another from the north. The first one must have been the main entrance of the church with relatively simply carved door frame. The frame datable to the 14th–15th century was made of very poor quality sandstone. The northern door led to the yet unexplored cloister. No traces of any stone frames have been found here. Excavating the northern wall of the church we have partially uncovered the southernmost section of the cloister, more exactly the 1–1.5 m wide zone along the northern side of the church. This have enabled to reach the southwestern separate entrance of the cloister, which was located just beside the north-western corner of the church close to its main doorway.

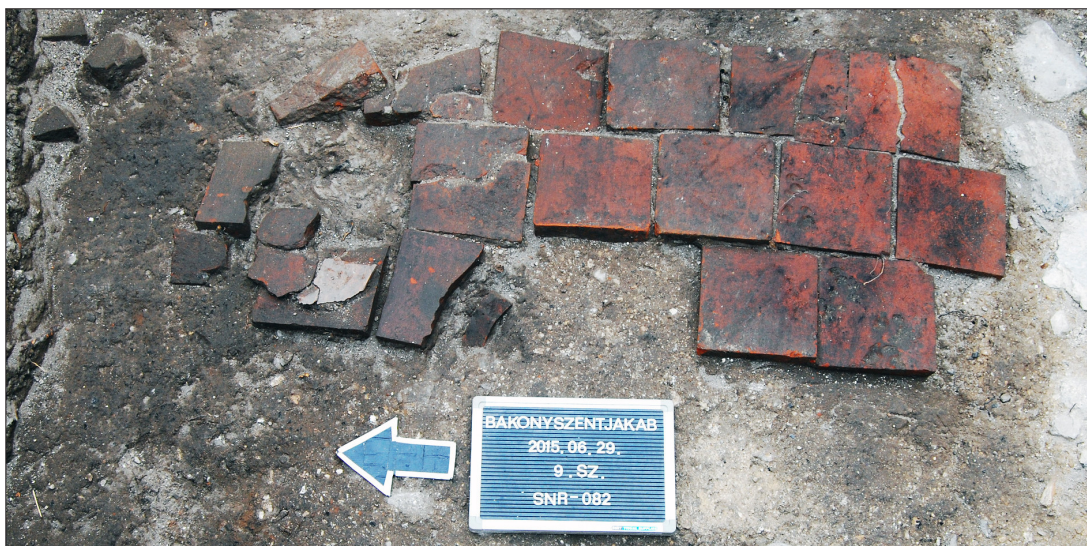
Fig. 3. The only *in situ* survived fragment of the floor inside the nave (Bakonyszentjakab).

The interior of the nave was almost completely dug up after the destruction of the friary. The latest, 16th-century surface survived only beside the southern wall of the church. It was made of very simple square (19 × 19 cm) floor tiles (*Fig. 3*). The deserted complex was used as a quarry for several centuries by the inhabitants of neighbouring villages, which process led to loss of most of the fine architectural details. Fortunately enough, in those places where the walls collapsed soon enough before being pulled down intentionally, the stone rubble had buried some carved fragments (*Fig. 4*). These finds give essential help in reconstruction of the building history of the church. It seems that the main outline formed as late as in the 13th century were left with no significant changes until the very end of its existence. The above mentioned joints infer to that the construction process was interrupted at least once with no known or visible reasons. At the same time the available carved stones indicate two later refurbishment of the complex. The earlier reconstruction might have happened during the first half of the 15th century (*Fig. 5*) while the second, larger alteration was carried out already in the early 16th century, but not earlier than ca. 1500. It seems that during the latter most of the carved details were changed to “modern” late gothic frames. Such stone frames were excavated *in situ* collapsed next to the southern façade of the chancel and inside the nave. These relatively large fragments can be regarded quite unusual representing not a common lancet-arched form of windows but rather a twinned type united by three-centred hood mould arch with very simple geometrical tracery (*Fig. 6*). This solution can be described both as a very decayed form of gothic or as relatively early appearance of renaissance style.

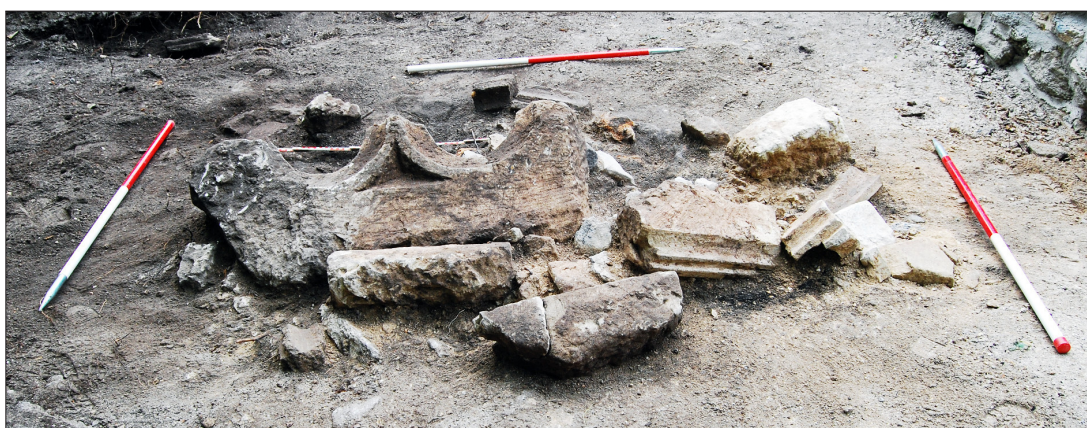
Fig. 4. Collapsed window frame left *in situ* south of the chancel (Bakonyszentjakab).

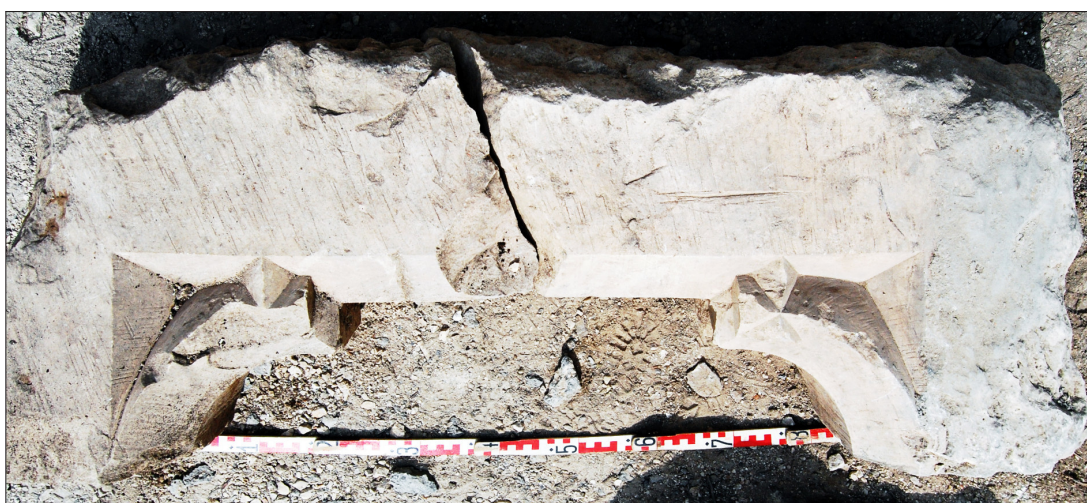
Fig. 5. Excavated fragments of a door frame from sacristy of the earlier gothic phase (Bakonyszentjakab).

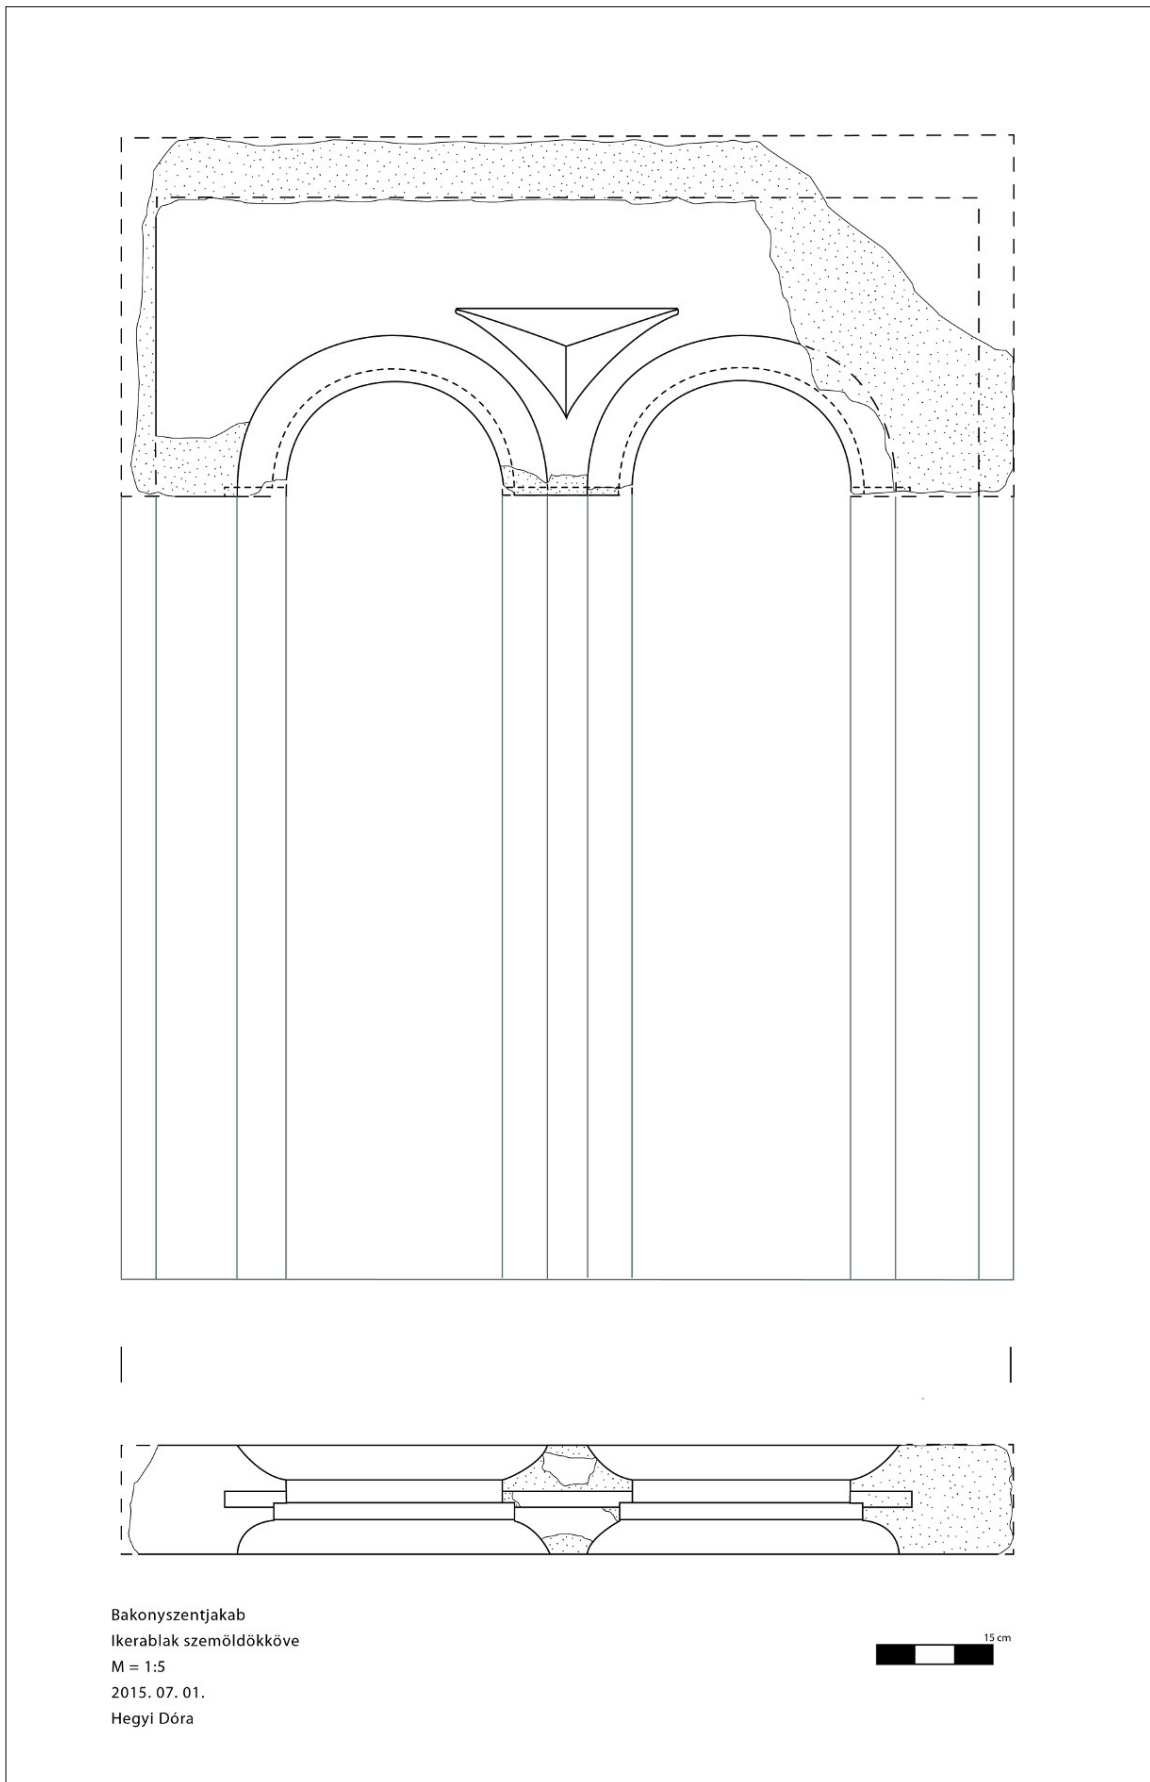
Fig. 6. Graphic reconstruction of a later gothic window from the church made by Dóra Hegyi (Bakonyszentjakab).

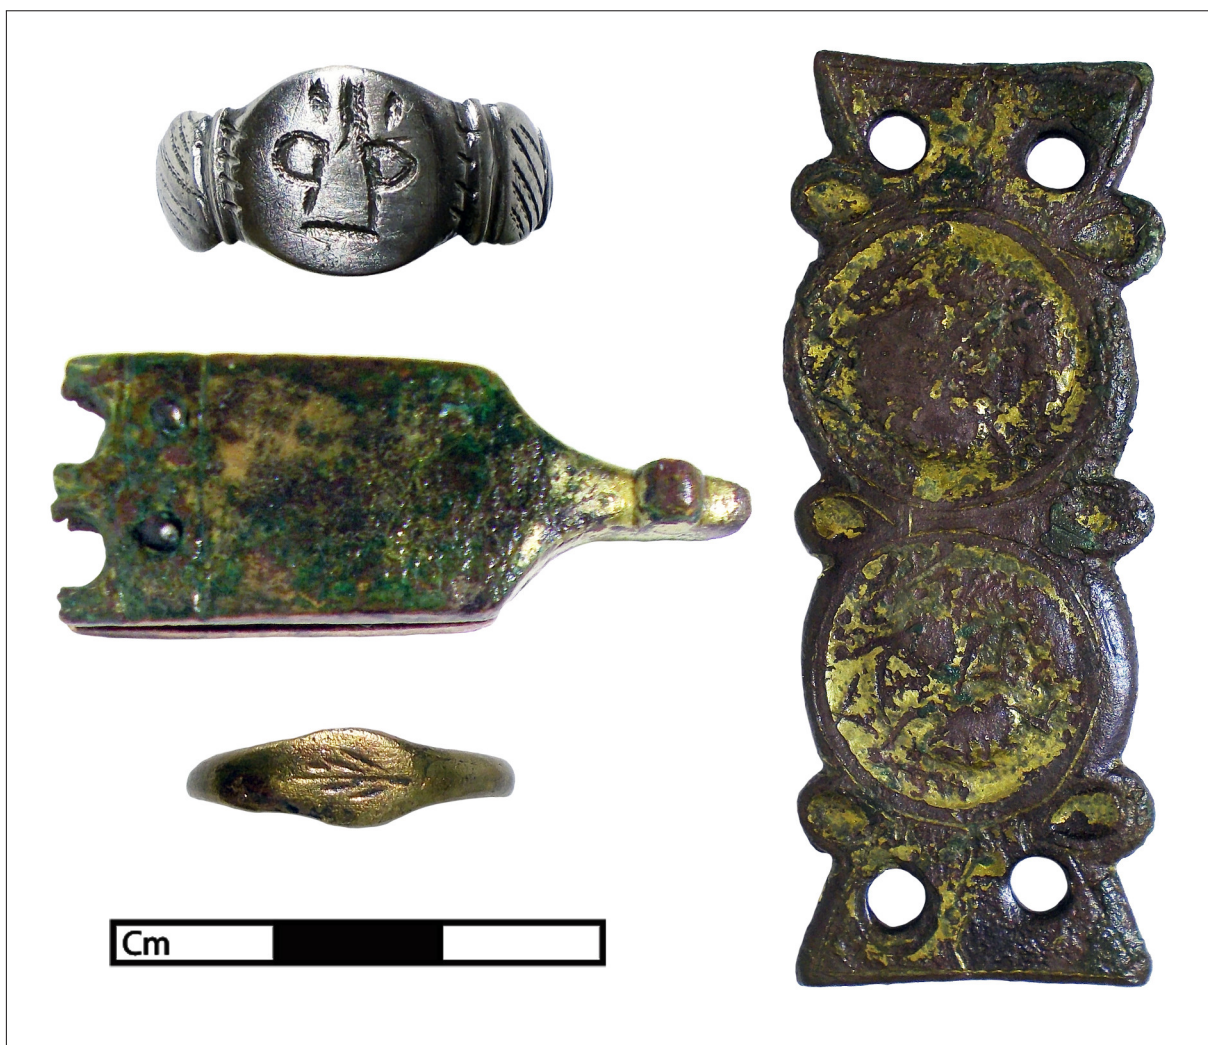
Fig. 7. Medieval small metal finds from the church and its surrounding (Bakonyszentjakab).

The friary emptied before the expansion Ottoman Empire in this region in 1560s was probably robbed and definitely set on fire not to be used as a fortifiable place for the enemy. The traces of the fire could have been observed in all areas not affected by treasure hunting. These events explain why there are almost no small metal finds from the site. However, some notable objects lost during the lifetime of the friary have been collected.<sup>3</sup> Apart from the predominantly 16th-century coins some late medieval rings, buckles and book bindings are worth to be mentioned (*Fig. 7*).

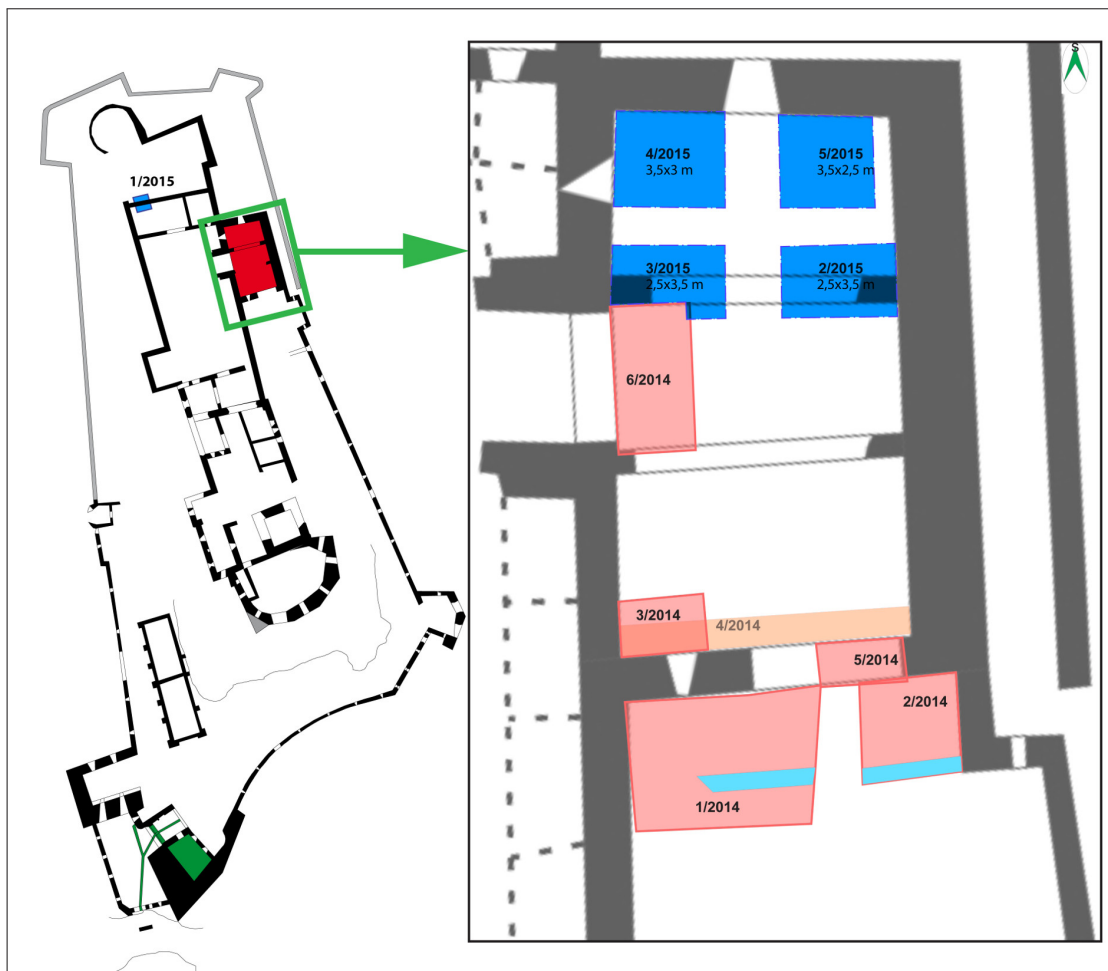
Fig. 9. Ground plan of the castle showing the investigated locations (Čabrad).

Altogether five new trenches have been set including the one outside the tower (*Fig. 9*). With four of them situated within the walls of the 16th-century gate tower our team had two goals. On the one hand to clarify the building history of the site and in particular to examine the character of the foundations of the northern partition wall inside the tower; on the other to partially remove the debris of the collapsed upper vaultings of the building and thus to decrease the pressure on the surviving lowest vaults. Four significant layer groups could have been identified in these trenches. The uppermost one consisted of soil accumulated during the last several decades containing traces of tourism and most of all modern rubbish. This layer directly covered the destruction debris of the building. This second stratum composed most of all of larger stones, mortar and plaster debris, and contained almost no finds. Very interesting situation could have been observed in the southwestern part of the tower. Partially mixed with the wall rubble and at the same time under it an earth filling was found, which contained a relatively large amount of finds. These were predominantly 15th–16th-century ceramic objects (pottery and stove tiles), iron nails and fittings and fragments of lead window frames. The dating of the layer can be done according to some 16th-century coins and fragments of early 17th-century glazed pottery. Correspondingly, the layer, which obviously was used to fill the uppermost vaults of the tower can be used to date a later building phase of the gate tower. The third layer observed during the excavations was a thick terrazzo-floor, most likely of the second storey of the tower. The whole floor slipped down as the lower vaults collapsed. However, some architectural features survived relatively well. One of such is a baroque pilaster foundation in the southwestern corner, beside the western wall (*Fig. 10*). It is quite clear that this pilaster was added later to the already existing interior. There are no traces of any joints between this architectural detail and the floor nor the walls. Some carved stone fragments found in the rubble support the above mentioned dating and thus the identification of a new building phase. Previously it was supposed that the tower was vaulted yet by the end of the 16th century.

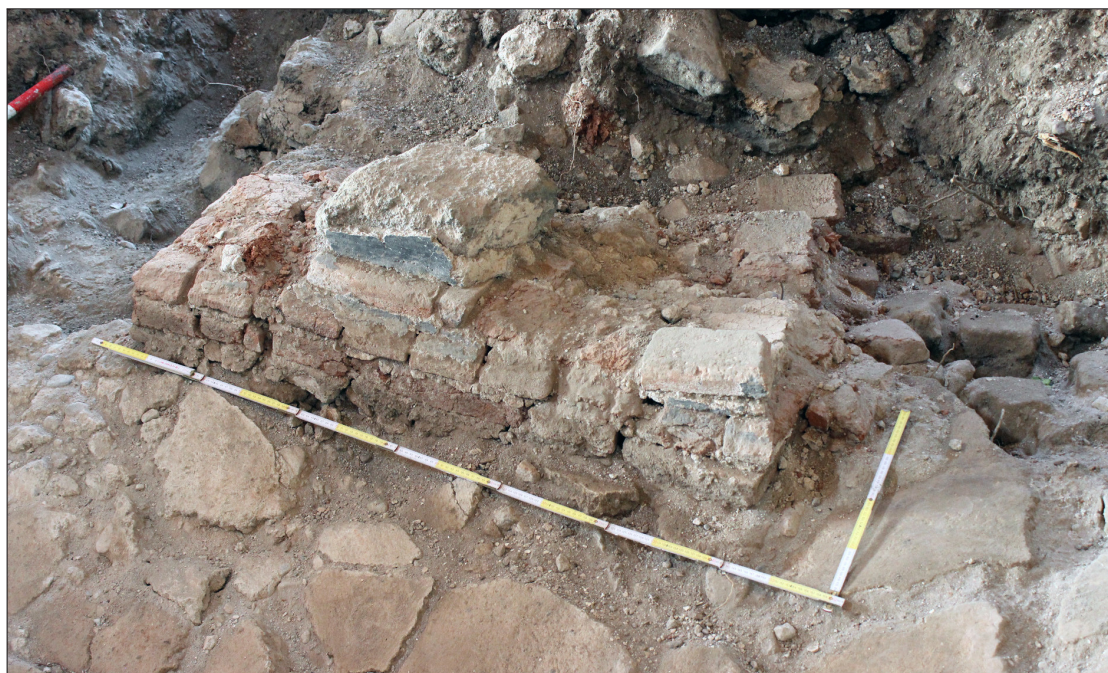
Fig. 10. Remains of the baroque pilaster (Čabrad).

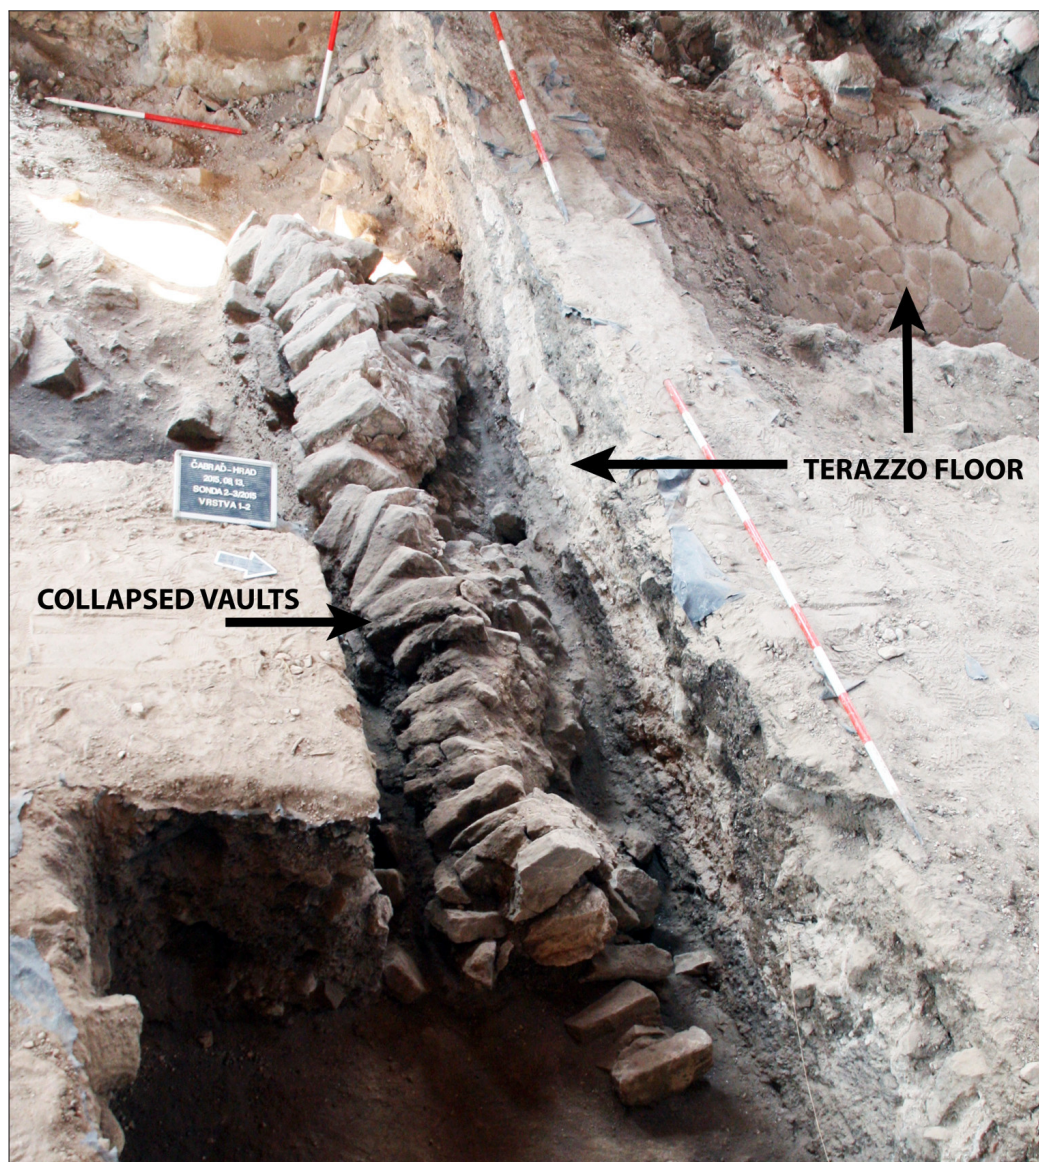
Fig. 11. Collapsed vaultings in the trenches 2–3/2015, with indication of the floor layer (Čabrad).

The terrazzo floor – seemingly being part of a later (baroque) reconstruction of the building – was laid on another group of layers loaded onto the lower vaultings of the ground floor (*Fig. 11*). This vaulting was constructed also secondarily according to the well visible putlog holes in western and eastern walls of the tower. At the same time the traces of the putlogs refer to the character of the earlier ceiling. The filling layers of the lower vaults can also help in dating

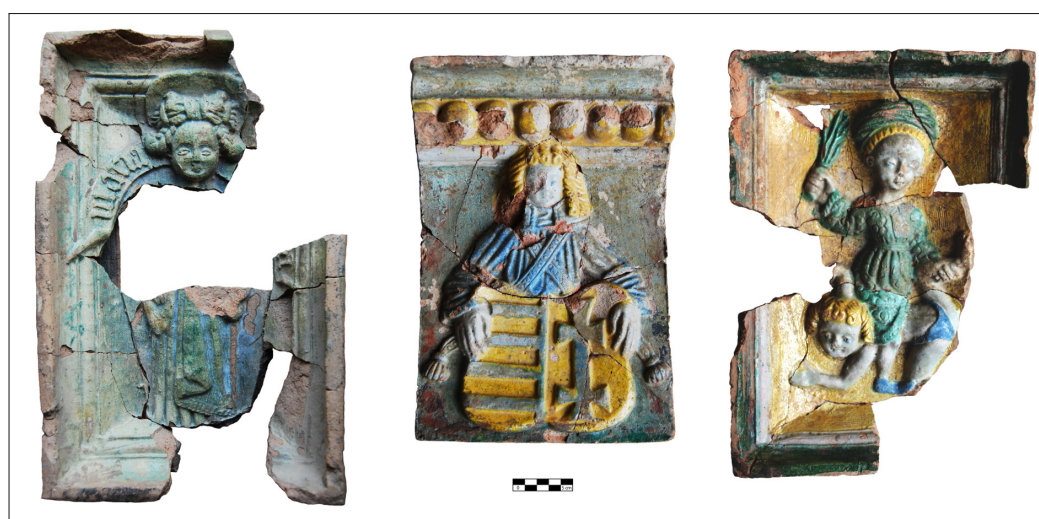
Fig. 12. Early 16th-century stove tiles (Čabrad)

Three groups of finds discovered in 2015 are worth to be mentioned particularly. The first is the huge collection of the high quality renaissance stove tiles. This assemblage can be divided in at least three groups: tiles with floral, ecclesiastical and secular motives (*Fig. 12*). According to the glazes there are simple green glazed (monochrome) and polychrome finds, while some types appear both in mono- and polychrome version. All the three groups represent a very widespread type of renaissance stove tiles, which was very popular in Northern Hungary. Similar finds have been found so far in Szécsény,<sup>6</sup> Salgó,<sup>7</sup> Šintava,<sup>8</sup> Rimavské Jánovce,<sup>9</sup> Beckov, Širkovce,<sup>10</sup> Banská Štiavnica<sup>11</sup> and Banská Bystrica.<sup>12</sup> The last is the main find location of this type and actually the whole group was named after it. It is very likely now that Banská Bystrica is the “birthplace” of the whole type but at least the largest number of similar tiles has been collected in this city. However, the finds from Čabrad have closest analogies in Banská Štiavnica – Kammerhof. Even the smallest details of the stove files from these sites are identical. Thus it is very likely that the renaissance stove tiles found in the late 16th-century layers at Čabrad were produced in Banská Štiavnica.

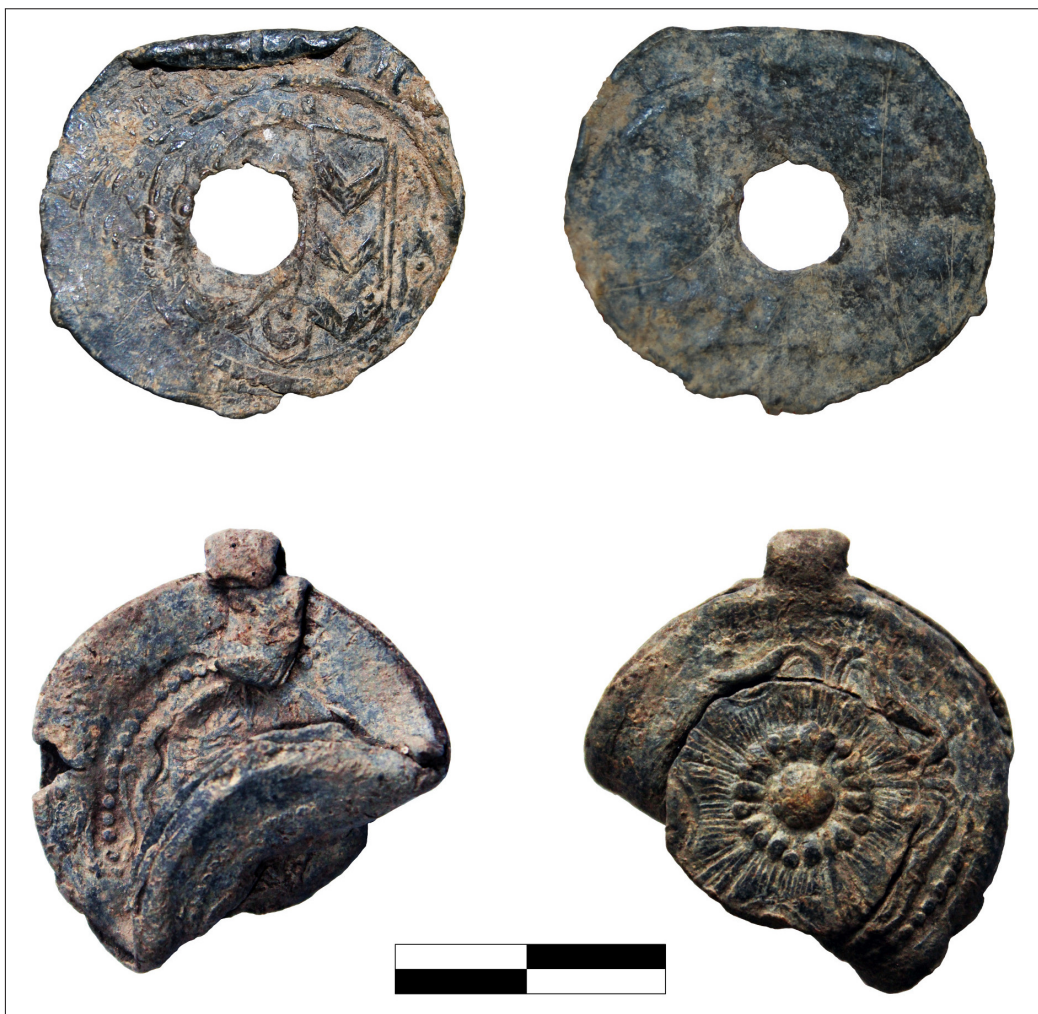
Fig. 13. 16th-century cloth seals: Opava and England (Čabrad).

Among other finds datable to the 16th century two cloth seals should be mentioned (*Fig. 13*). The first one survived only fragmentarily was discovered yet in 2014. It depicts a quite specific coat of arms and thus its provenance can be identified with Opava (Troppau), a relatively significant city in Silesia (today Czech Republic). The second one is very well preserved and can be really regarded as unique since no other similar such seal is known so far from the available publications.<sup>13</sup> The obverse of the seal shows an unambiguously identifiable Tudor rose, while the reverse depicts English coat of arms. According to the shape of the object and the details of the arms, the cloth seal can be dated to the first half of the 16th century, most probably to the reign of King Henry VIII. While the seal from Opava refers to cloth of medium or even low quality, the English one surely belonged to fine woollen cloth, which was extremely popular but relatively expensive in contemporary Europe.<sup>14</sup>

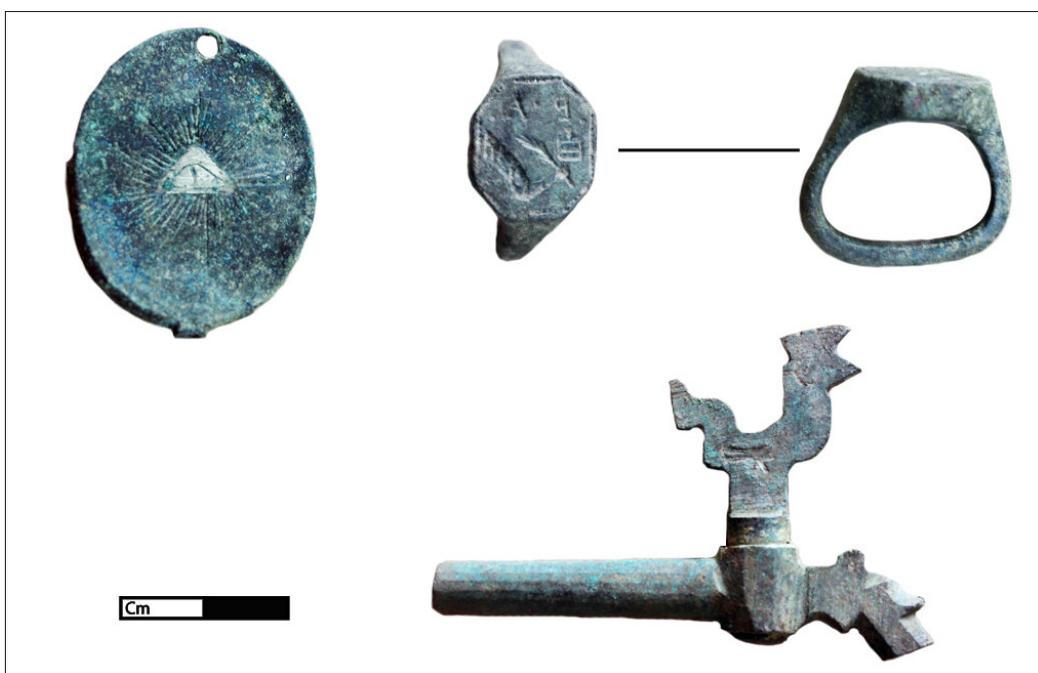
Fig. 14. 16th-18th-century metal finds from the castle: pendant, seal ring and tap (Čabrad).

There are some other interesting objects found in the late 16th – early 17th century layers. The most notable among them is a barrel tap with privy marks on the handle survived in remarkable condition (*Fig. 14*).

Prior to the intended but once again postponed reconstruction of the southern façade of the tower some levelling was required on the site of the former trenches 1–2/2013–2014 (Fig. 15–16). During the removing of the balk within the shaft of the drawing bridge a huge amount of 18th-century finds have been collected, including coins, jewellery, architectural fragments and 17th–18th-century stove tiles. One medallion is of particular interest since it might be interpreted as a freemason pendant. Another extraordinary find is a ring seal with P.E. monograms depicting a hand holding a feather. This one most likely was owned by a notary (Fig. 14).

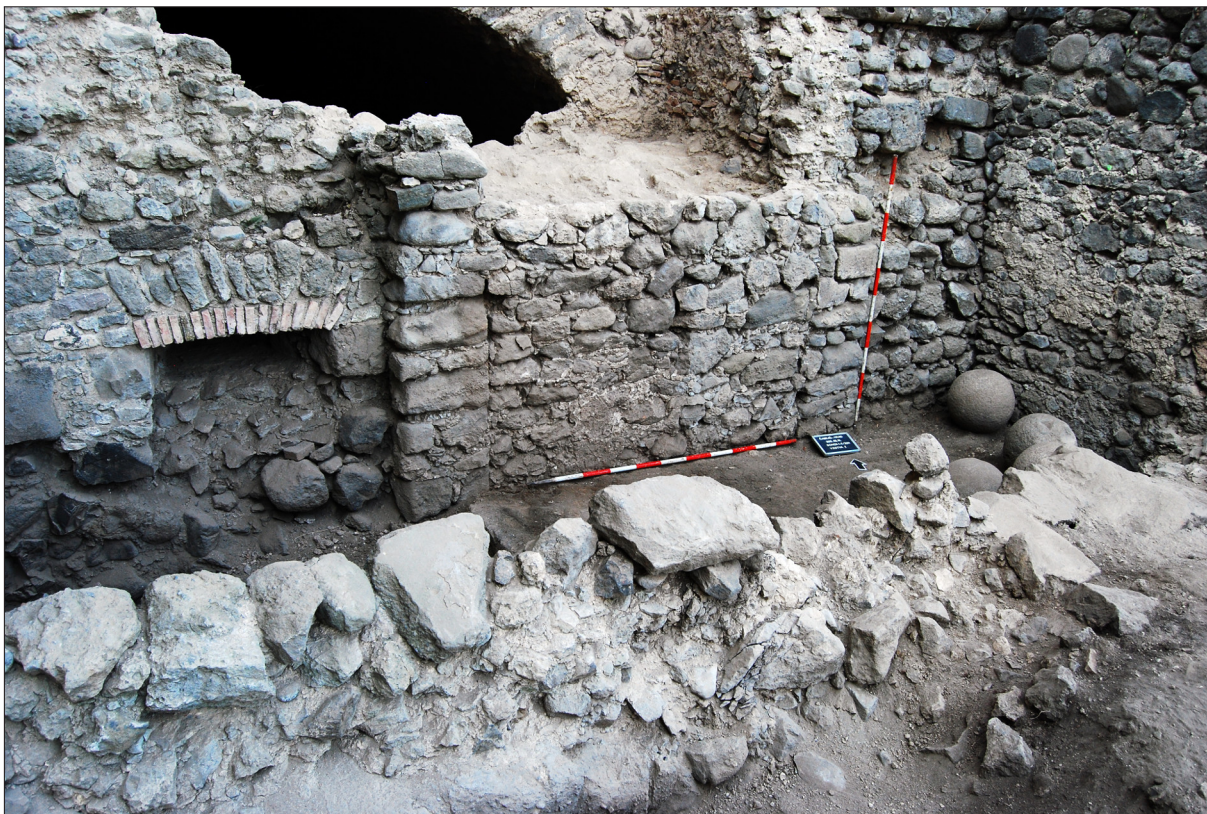
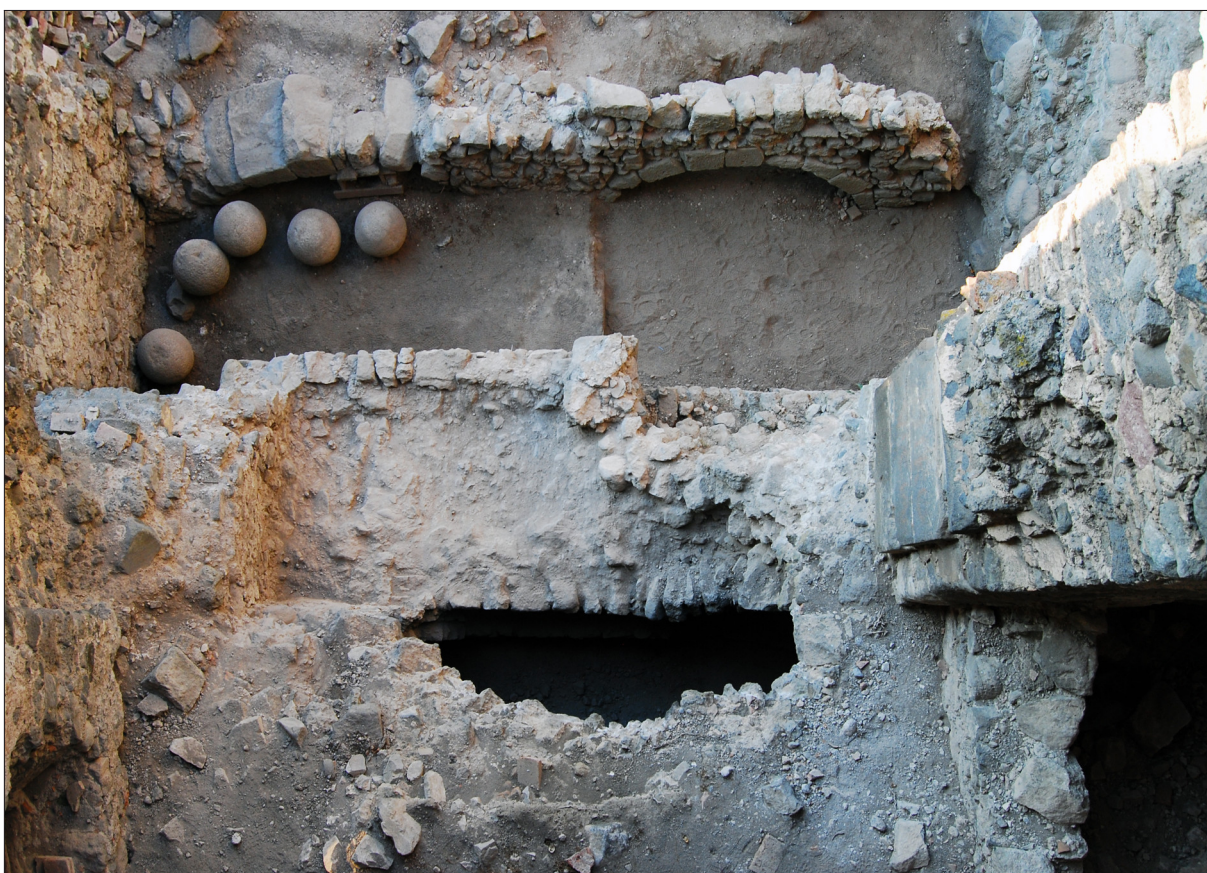
*Fig. 15.* Excavated drawbridge shaft, view from the south (Čabrad).

*Fig. 16.* Excavated drawbridge shaft, view from above (Čabrad).

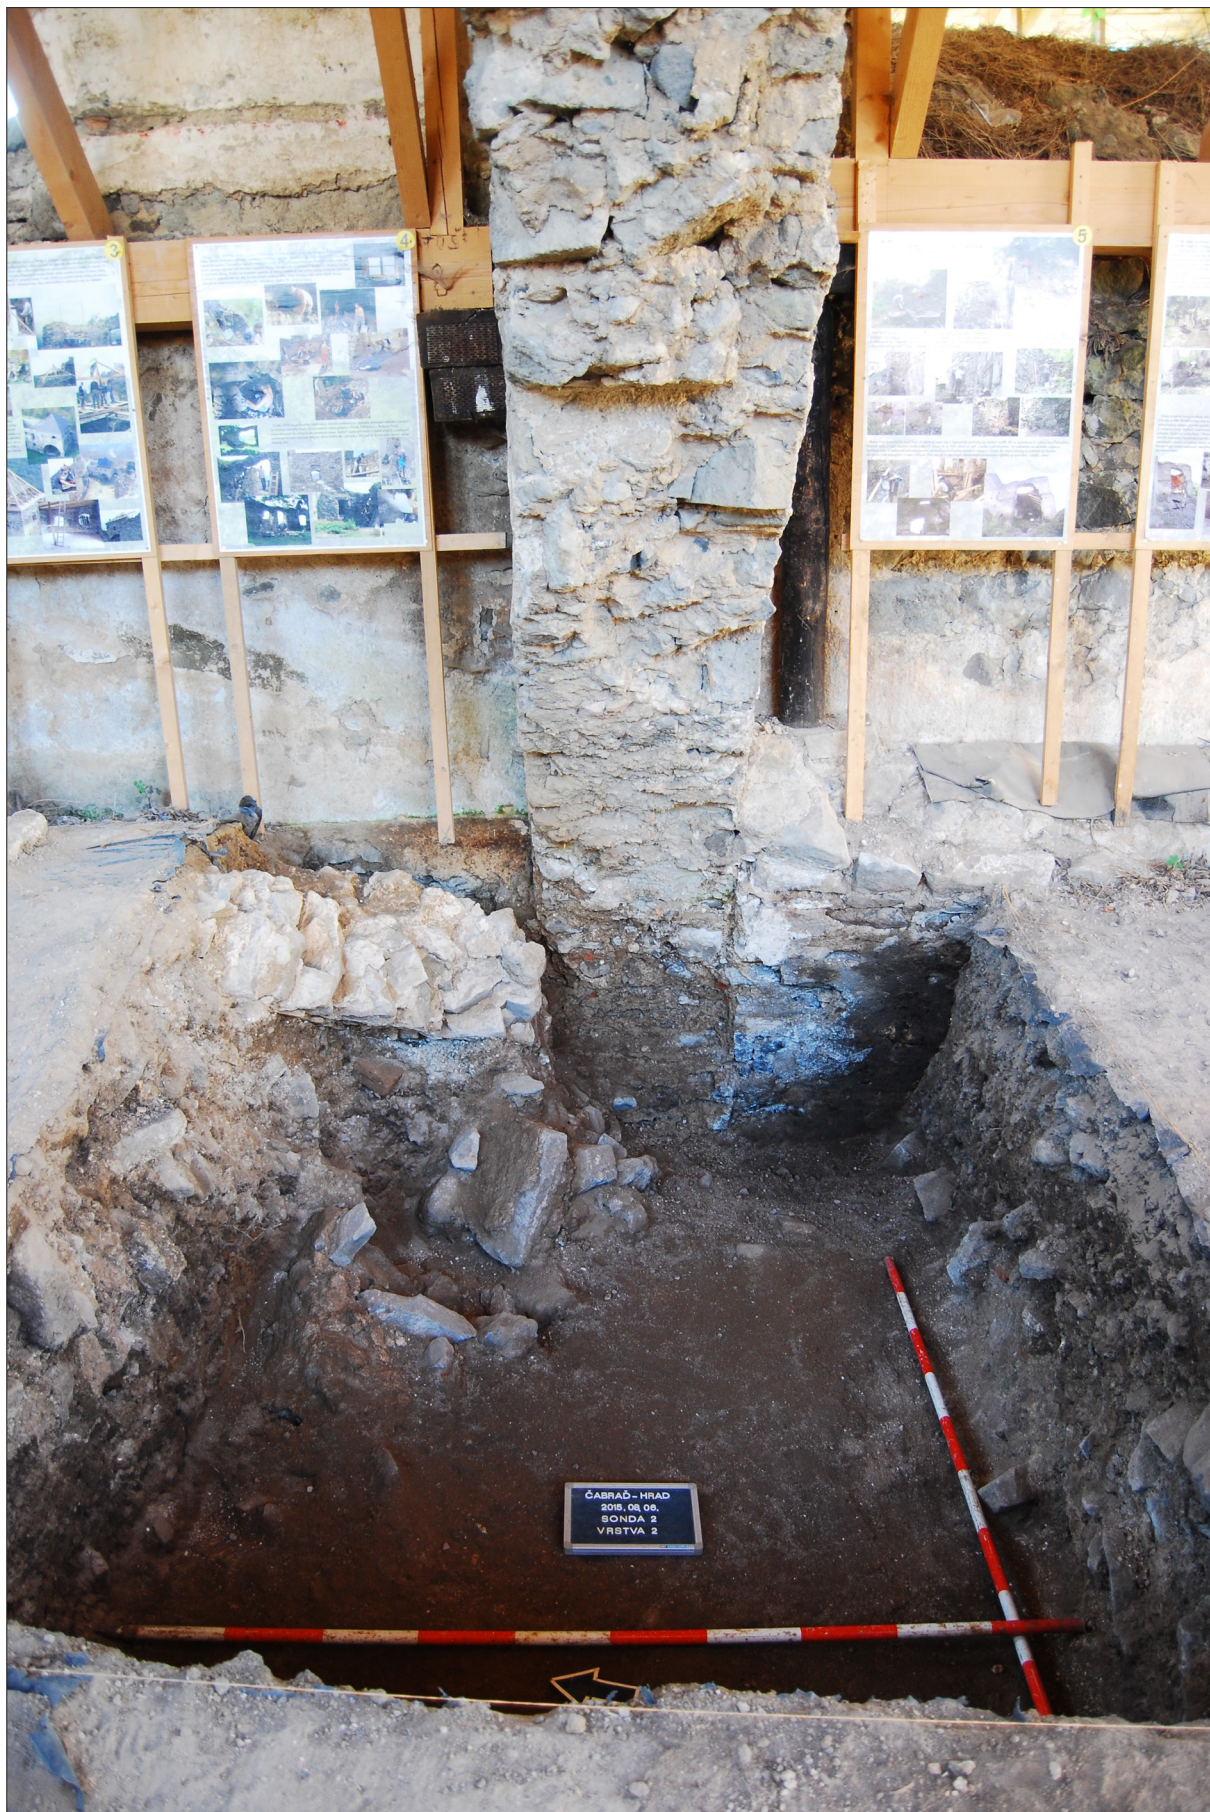
Fig. 17. The northern partition wall in the tower with no traces of the foundations (Čabrad).

The excavations inside the tower have not been finished. Removing the debris in some places to 1–1.5 m depth we could not find the foundations of the northern partition wall (Fig. 17). Its lack in this depth can only mean that it was already missing when the vaults collapsed. In this case some explanation should be found for this situation but some further research is needed before.
