DISSERTATIONES ARCHAEOLOGICAE

Ser. 3. No. 4. | 2016

Short report on the excavations in the Castle of Sátoraljaújhely in 2016

Abstract

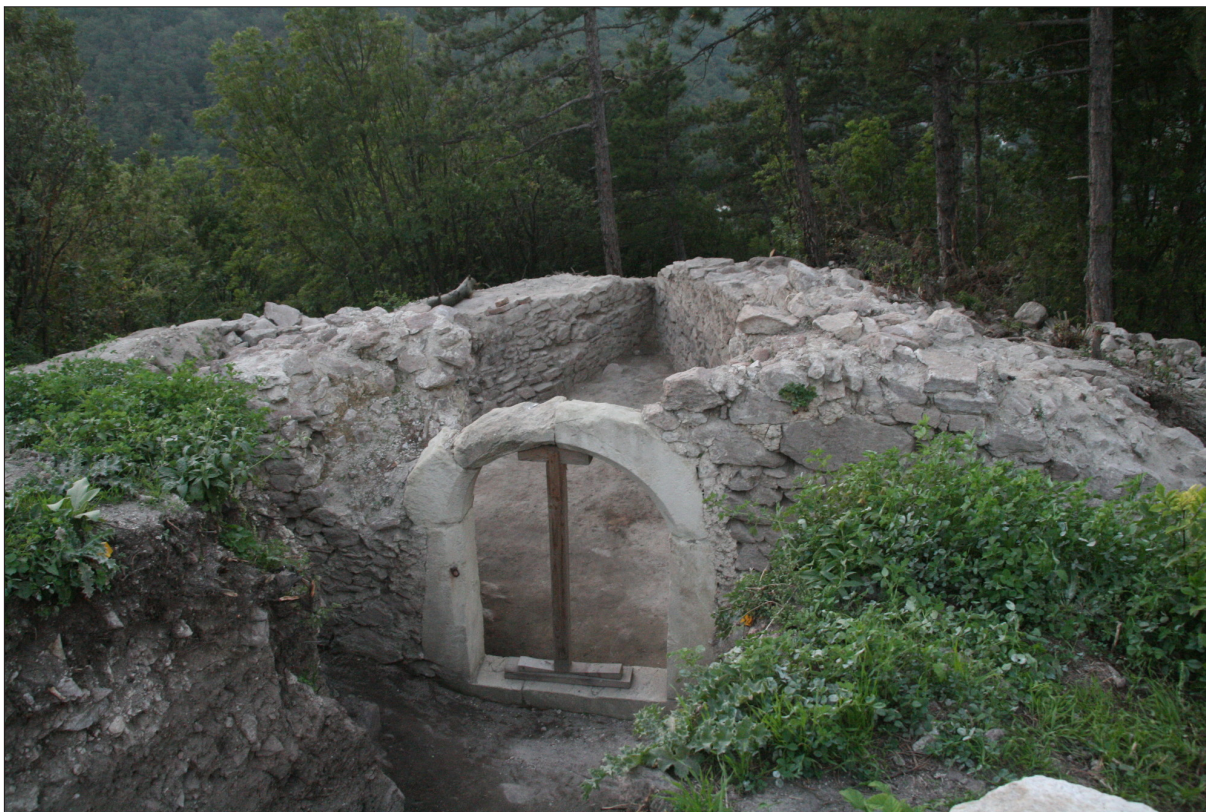
Fig. 2. The triangle-shaped, northern tower (Photo: Dóra Hegyi).

During the season of 2015 the tower's south wall with intact carved stone doorframe, and a small part of eastern wall, joining to the south in an acute-angle, were discovered. This year we could verify the ground plan of the tower: under the thick layers of ruins we found the hard-packed clay floor, surrounded by walls of 2 metres thick. As we suspected, the walls were closed in triangle-shape, which we could confirm, moreover it shows an isosceles triangle-shape

with the size of 5.6×7.1×7.1 meters. The triangle's tip points exactly to north direction, and its east and south walls were preserved in good condition, standing high under the ruins and soil, however, almost all of the western wall was badly eroded, slithered down on the hill's slip. We could determine the exact location of this wall, because the clay floor, which could be tracked all over the inner surface of the building, disappeared only in the line between the north and southwest tips of the triangle. It was harder to define the outer line of this wall, because we investigated it only in a short section, due to its bad condition. The surroundings and the inside of the tower were covered with big sized rocks, shreds of bricks, mortar and charcoal. Only over the floor level could we recognise another layer, which was very similar to the one on the top, but contained more clay and whole bricks. Also in this layer were the remains of burnt wooden structures: we could survey timbers and decks with spikes in good state, which could have belonged to the tower's contemporaneous upper slab. The thick layer of ruins in the tower, especially the lower part, consisted of rich material: several coins; one remarkable bronze ring, decorated with increased lily on it, dated from the 15th–16th century; but mostly pottery fragments from the 16th century. This period coincides the time of the castle's destruction known from written sources (*Fig. 2–5*).

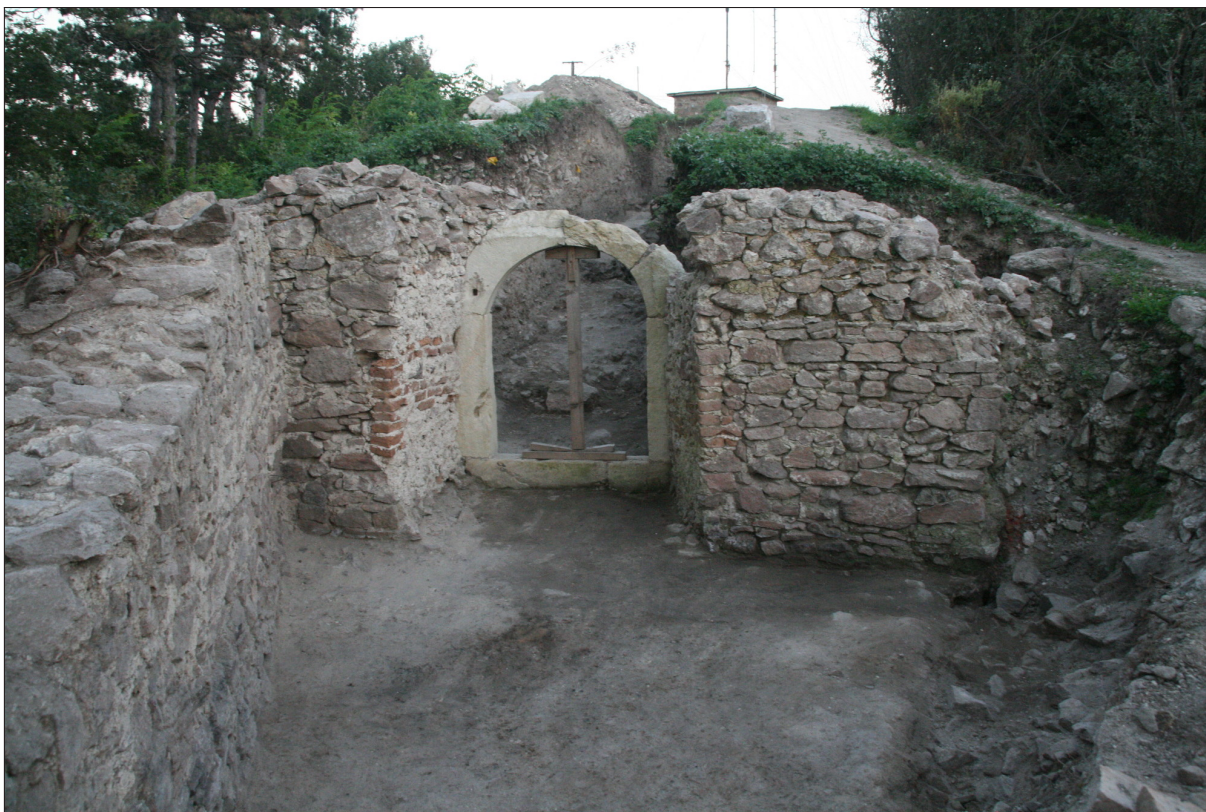
Fig. 3. The southern wall and the entrance of the tower (Photo: Dóra Hegyi).

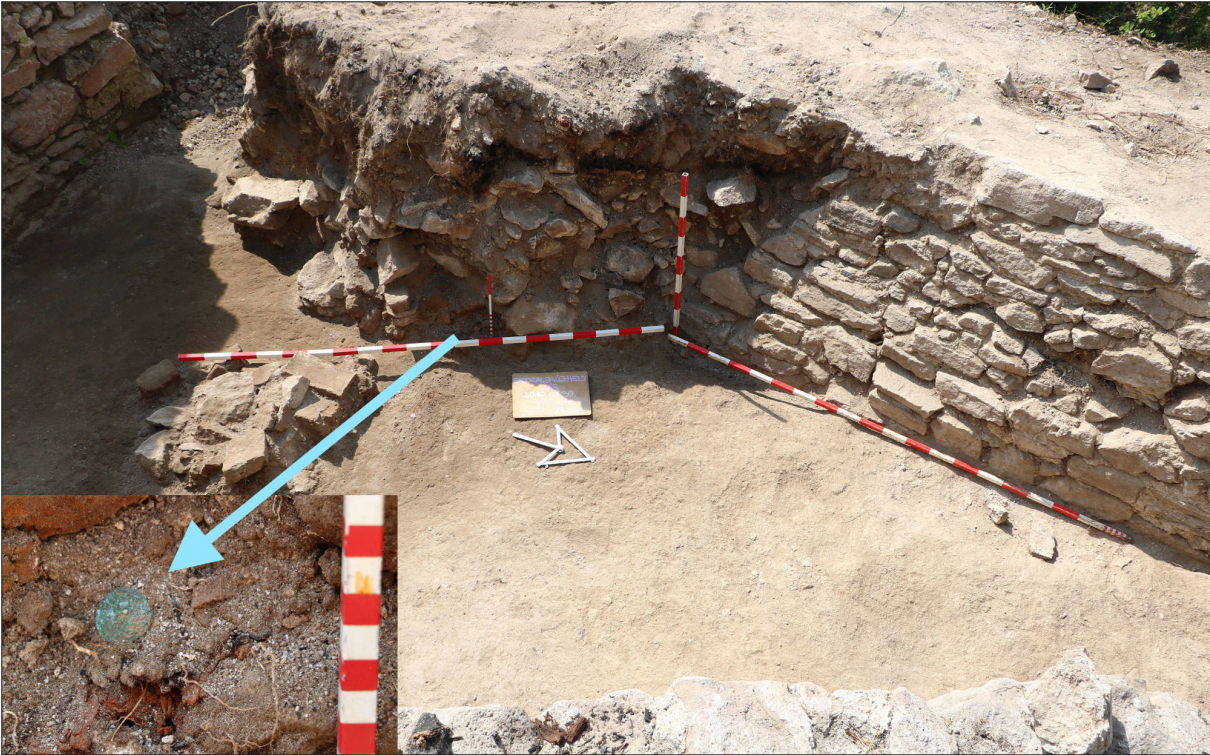
Fig. 4. The cleaning of the tower and the demolished western wall of it.

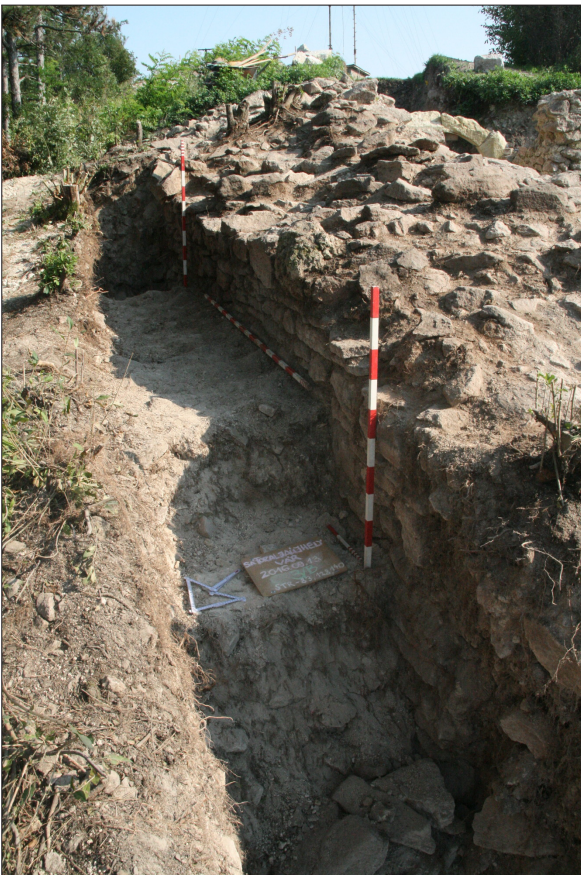
Fig. 5. The exterior side of the eastern wall of the tower (Photo: Dóra Hegyi).

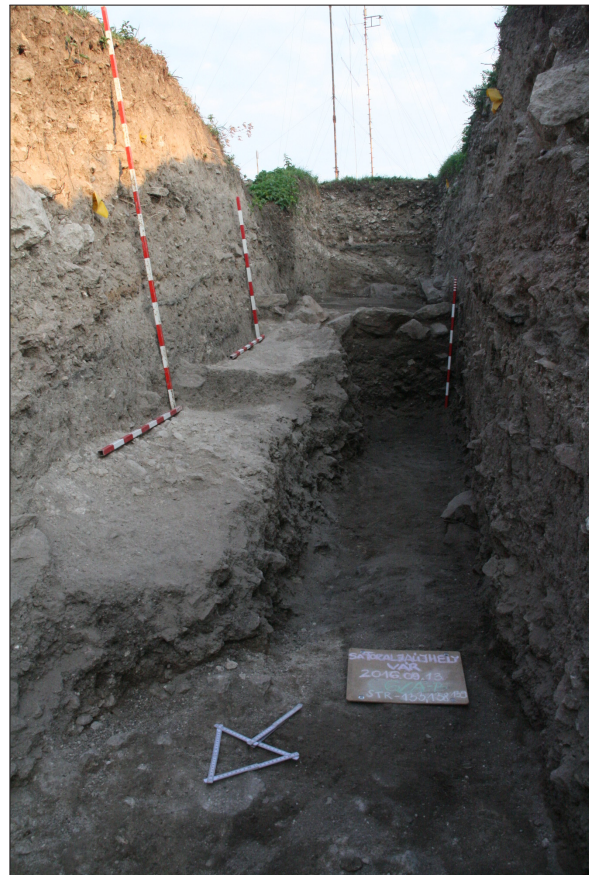
Fig. 6. Trench 6, opened on the northern courtyard of the castle, from the north (Photo: Dóra Hegyi).

Many of the season's important observation was taken in the trench we had opened in the axis of the previously discussed north tower. The sixth trench stretches in north-south direction across the northern courtyard. It was 1.5 meters wide and 27 meters long divided into two parts. Our aim was to define the context of the tower, its connection with other structures and the mortar covered rock surface of the courtyard.

As a result of the excavation of this surface we know the different periods, when the courtyards sloping floor was filled up on purpose or when the nearby buildings' destroyed parts covered the area. These layers had a different structure, contained much more mould comparing to the ones inside the tower, of which main component were the tower's own building materials. Just before the tower's entry, under the topsoil we found a thick layer of rocks and mortar consisting of huge carved stones. Under this, in a depth of 1.3 metres, we had found a dark grey, burned, firm layer. Maybe it was a floor, though it had been marked only in one part of the trench, and hadn't got any relation to the tower's entrance (*Fig. 6–7*).

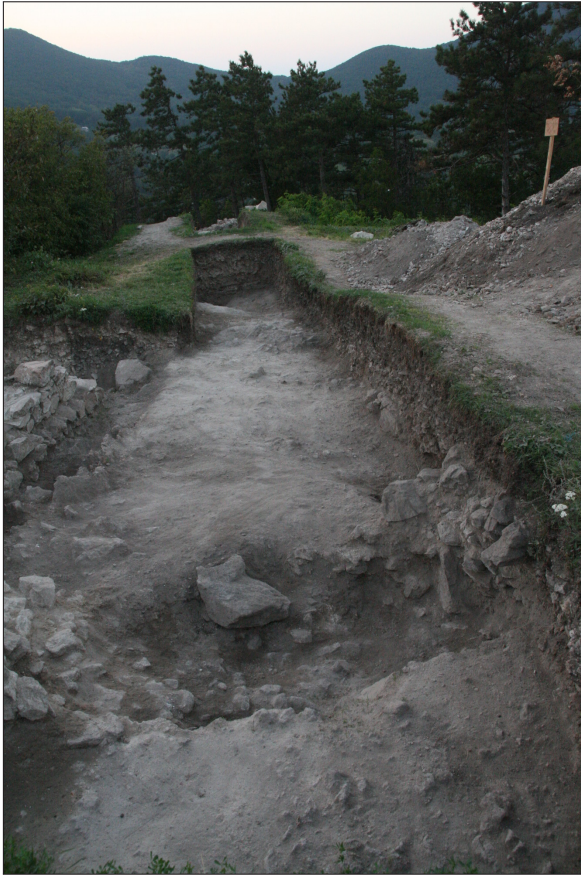
Fig. 7. Trench 6 from the south
(Photo: Dóra Hegyi).

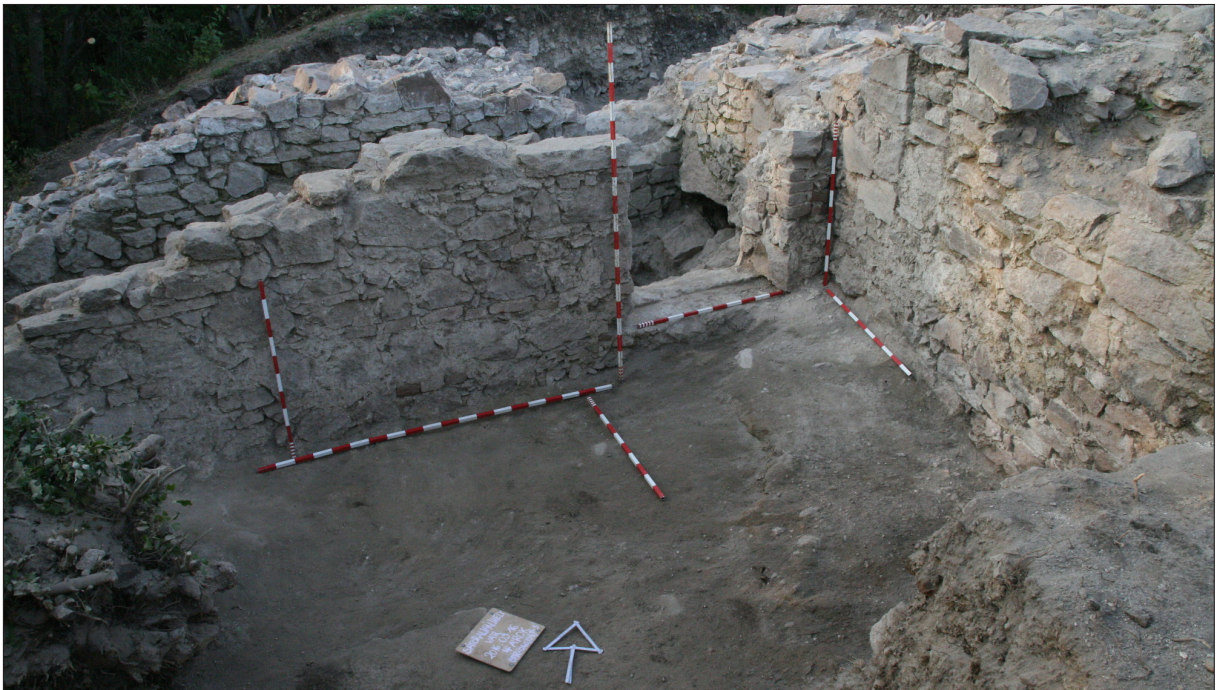
Fig. 9. The southern room of the building connected to the western wall of the castle (Photo: Dóra Hegyi).

was to clean the inside of the building with unknown function and find the southern wall of it. During the excavation of the building we found a relatively narrow, 50 cm thick, east-west lined partition wall which divides the lowest storey of the building to a smaller northern and a bigger southern room. On the eastern end of the wall opens a doorway, which was preserved in excellent condition. Based on the imprints and the narrow reveal a timber frame used to stand in the doorway. On both sides of the doorstone places of timber boards were observed (*Fig. 9–10*). Because there were no doorway or any traces of it on the outer walls of the building we assumed that the excavated lower storey was reached from upstairs. The excavation of the bigger, southern room proved that it was a multi-storied building because in the upper part of the layer of ruins were the smaller and larger pieces of the crashed room's floor upstairs. We also found here a large amount of mortared vaulting bricks and carved stone elements made of rhyolite: a large arched door frame element, a small bench and two stone elements matching in L shape. We interpreted them as a corner of a stove. Our definition was verified by the marks of burn and the imprints of brick on the surfaces of the stones and the large amount of simple, bowl-shaped stove tiles with a lot of matching pieces and fragments of other stove elements, which were found there too. These were definitely the ruins of a stove that stood in the upstairs room (*Fig. 11–12*).

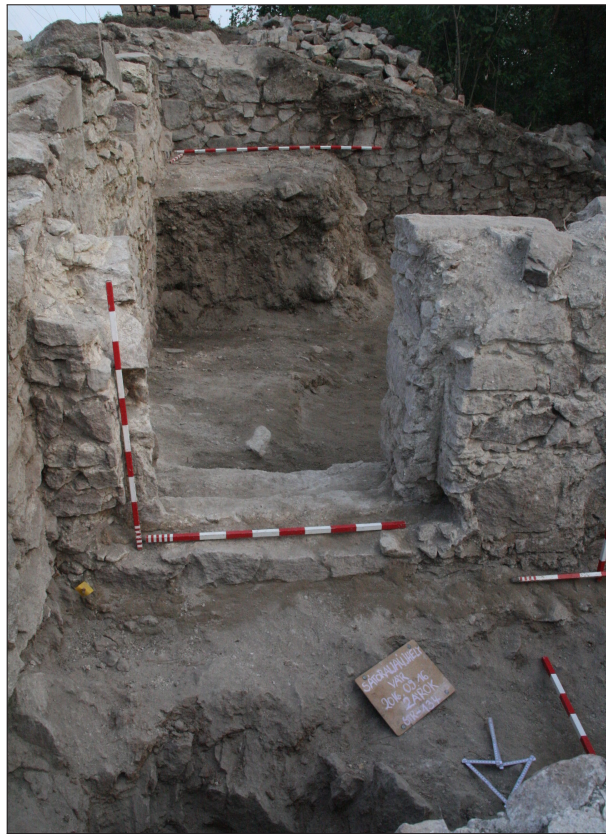
Fig. 10. The doorway in the partition wall (Photo: Dóra Hegyi).

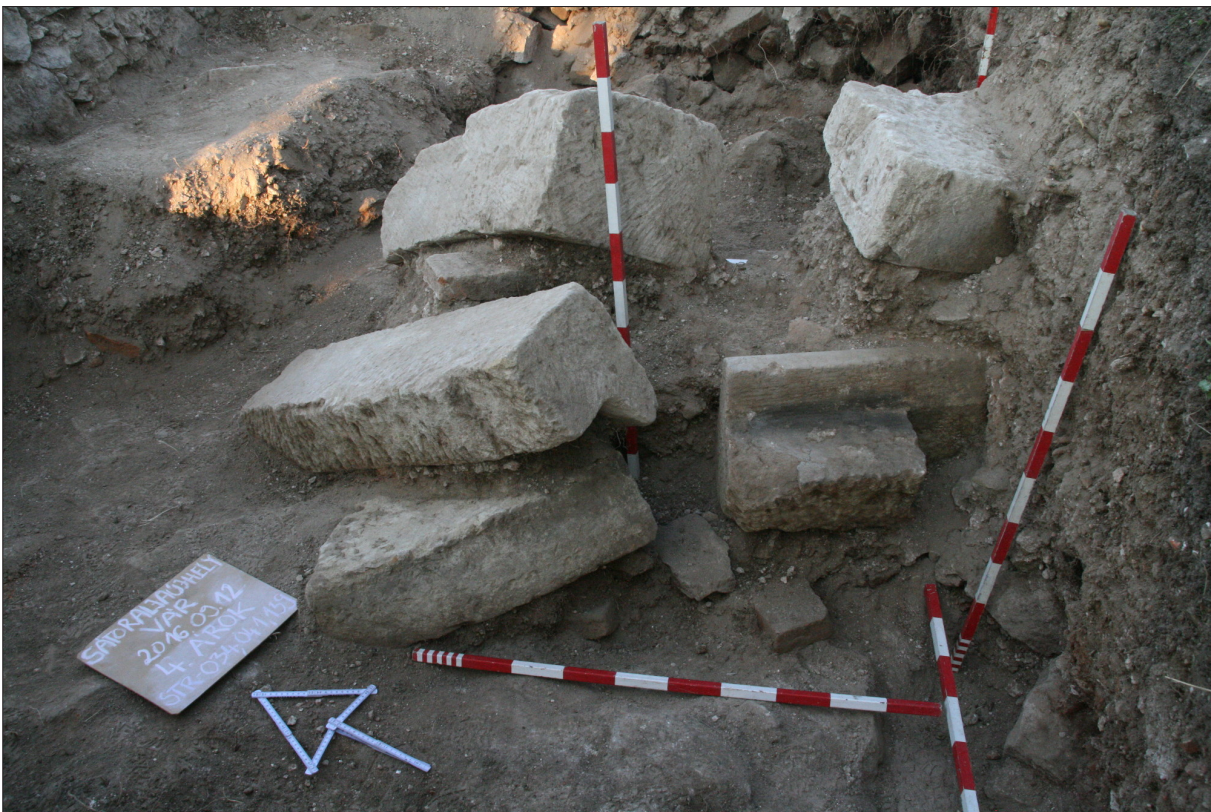
Fig. 11. The stone elements which were found during the excavation of the building (Photo: Dóra Hegyi).

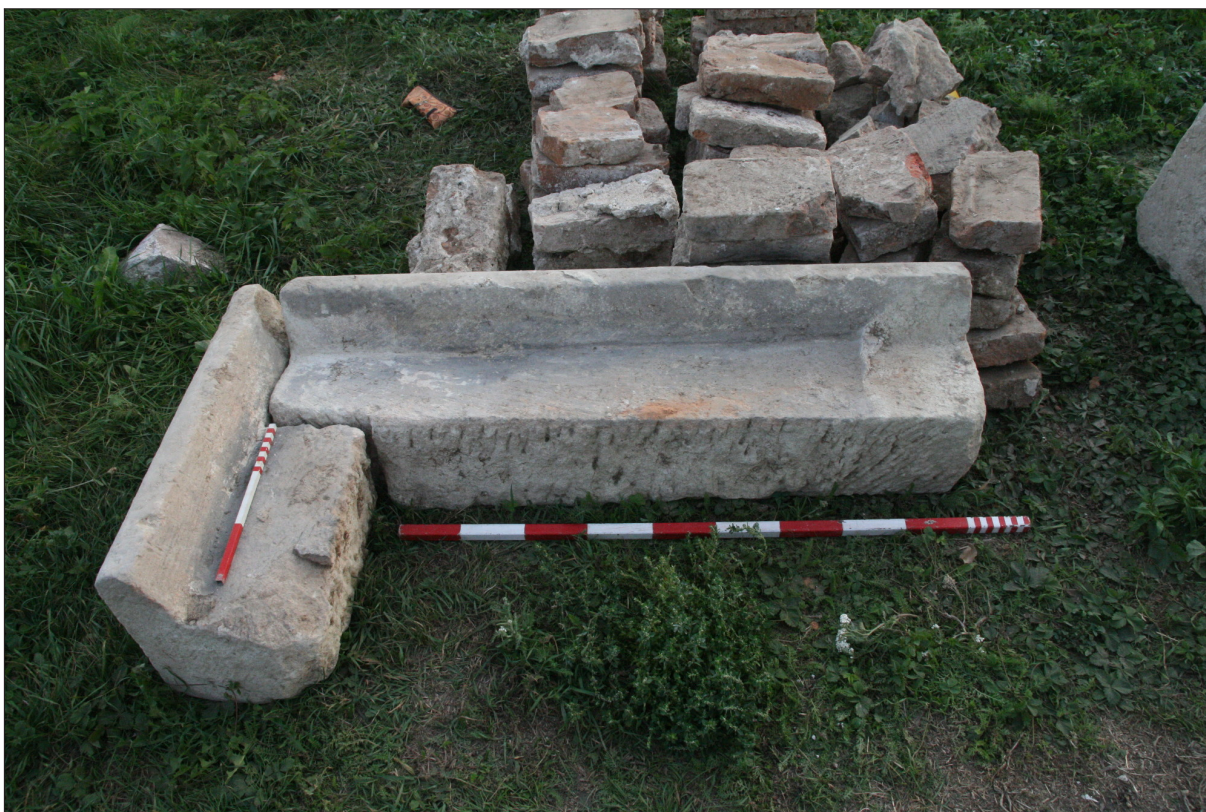
Fig. 12. Two stone elements matching in L shape and interpreted as the corner of a stove (Photo: Dóra Hegyi).

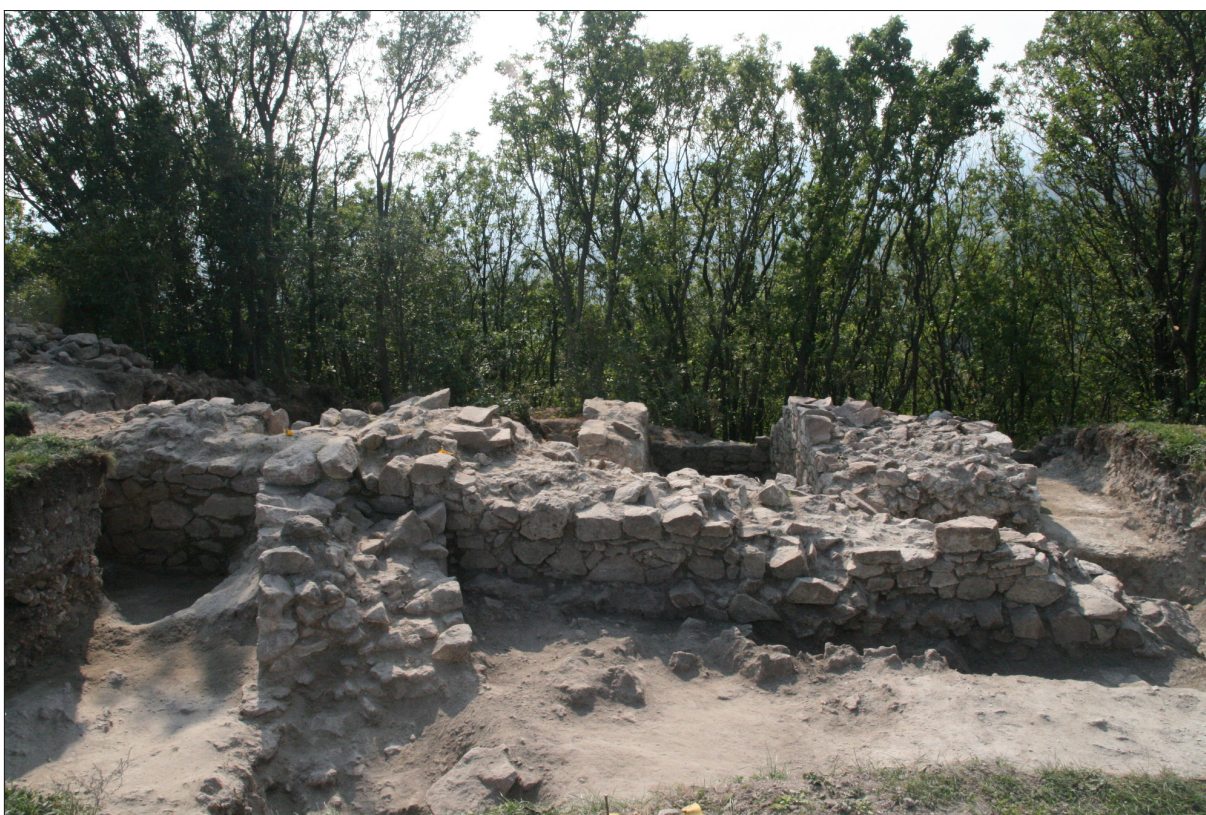
Fig. 13. The eastern wall of the building connected to the western wall of the castle (Photo: Dóra Hegyi).

Based on the observations we found a multi-storied, tower-like building with more than two meters thick walls, of which perhaps the first and second floor covered with brick vaults. On upstairs the floor were covered with so-called terrazzo and a stove that stood in the corner of the room. The lower storey was separated definitely and these two rooms due to their small size could have functioned as a storage. They were reached from the second floor, probably on an interior stairs. To the eastern wall of the above-described building on the courtyard joined a splayed, slightly curved wall. One part of this wall was teared down before to the bottom of the foundation trench. It is possible that a doorway stood here, of which stone frame had taken away (*Fig. 13–14*).

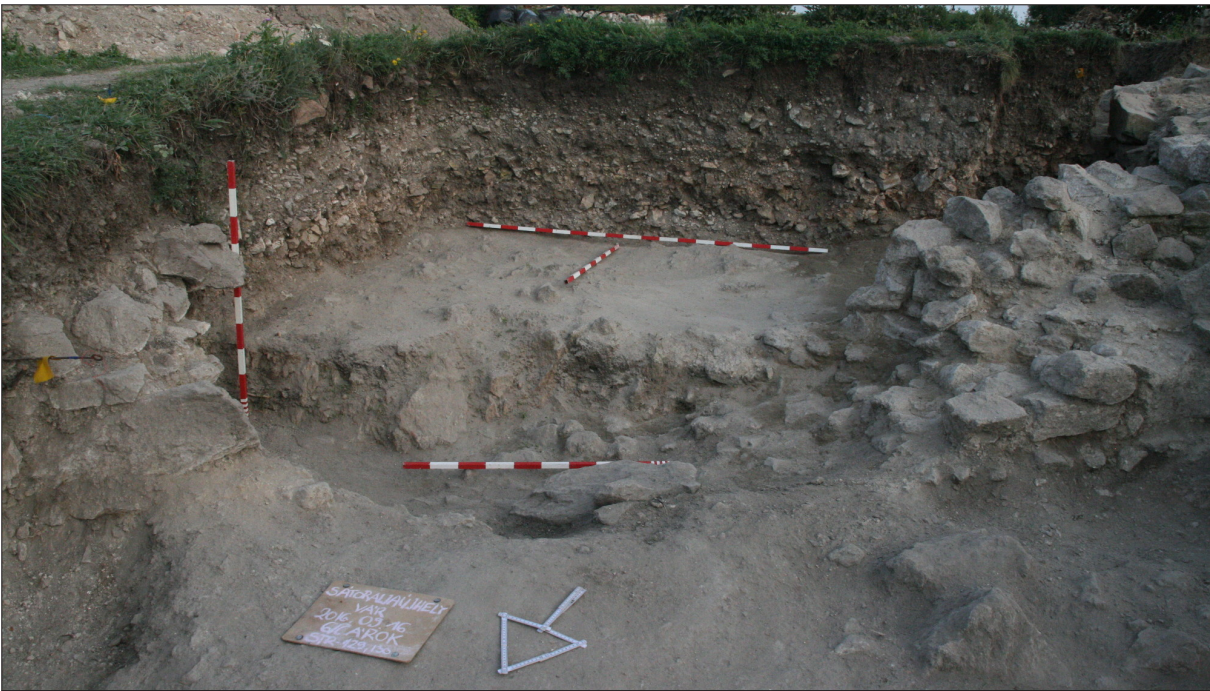
Fig. 14. The slightly curved wall joined the eastern wall of the building on the courtyard (Photo: Dóra Hegyi).
