# Short report on the excavations in the Castle of Sátoraljaújhely in 2017

## **Abstract**

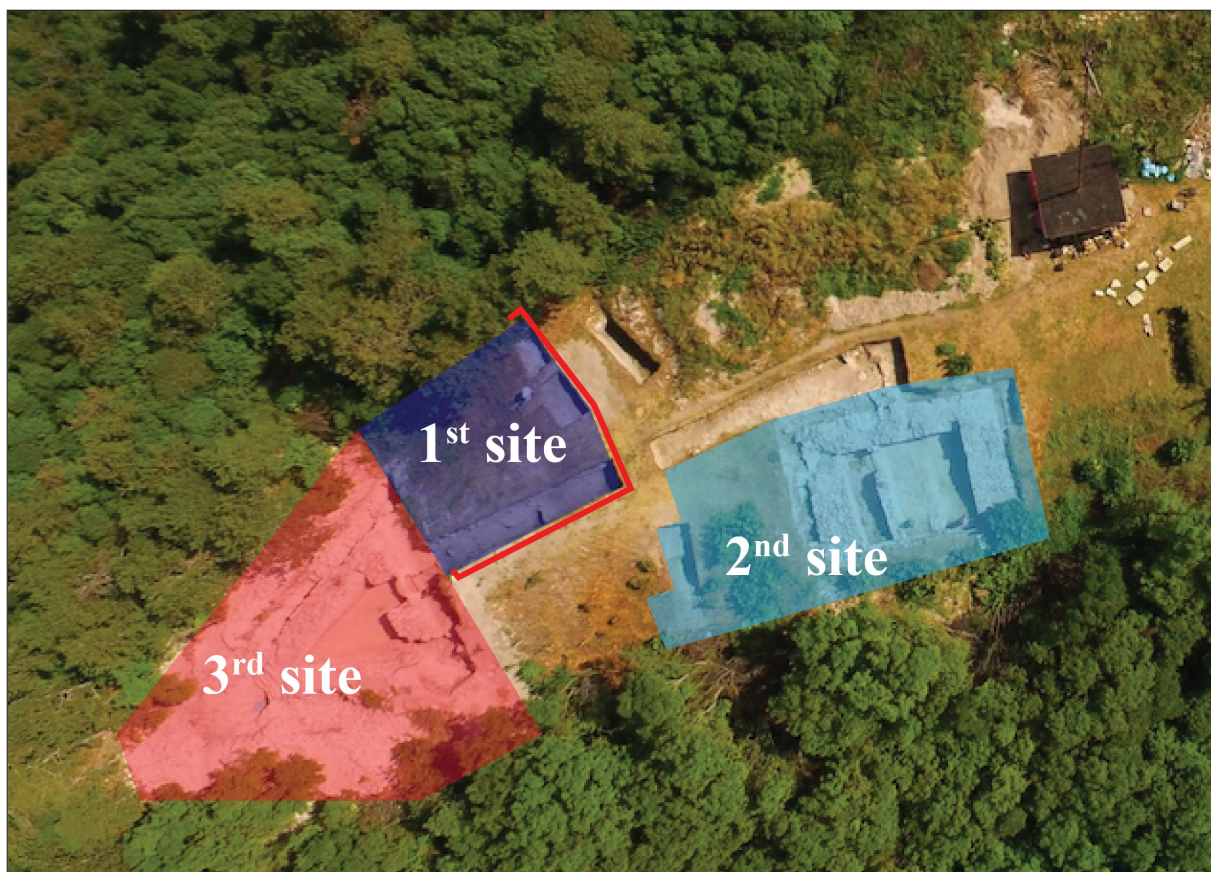
*Fig. 1.* The main sites of the excavation (The red lines show the cross-section of the 10<sup>th</sup> illustration).

Similarly to the previous seasons, the main research area was in the northern part of Castle Hill.<sup>3</sup> The work was carried out in three sites at the same time: firstly, in and around the triangle-shaped tower at the tip of the northern plateau; secondly, from the tower to the south on the outer and inner sides of the former eastern castle wall; and finally, in and around the area of the building adjoining the western castle wall. Our main goal was to clear as large part of the inner courtyard as possible in order to examine the stratigraphy above the ground level (*Fig. 1–2*).

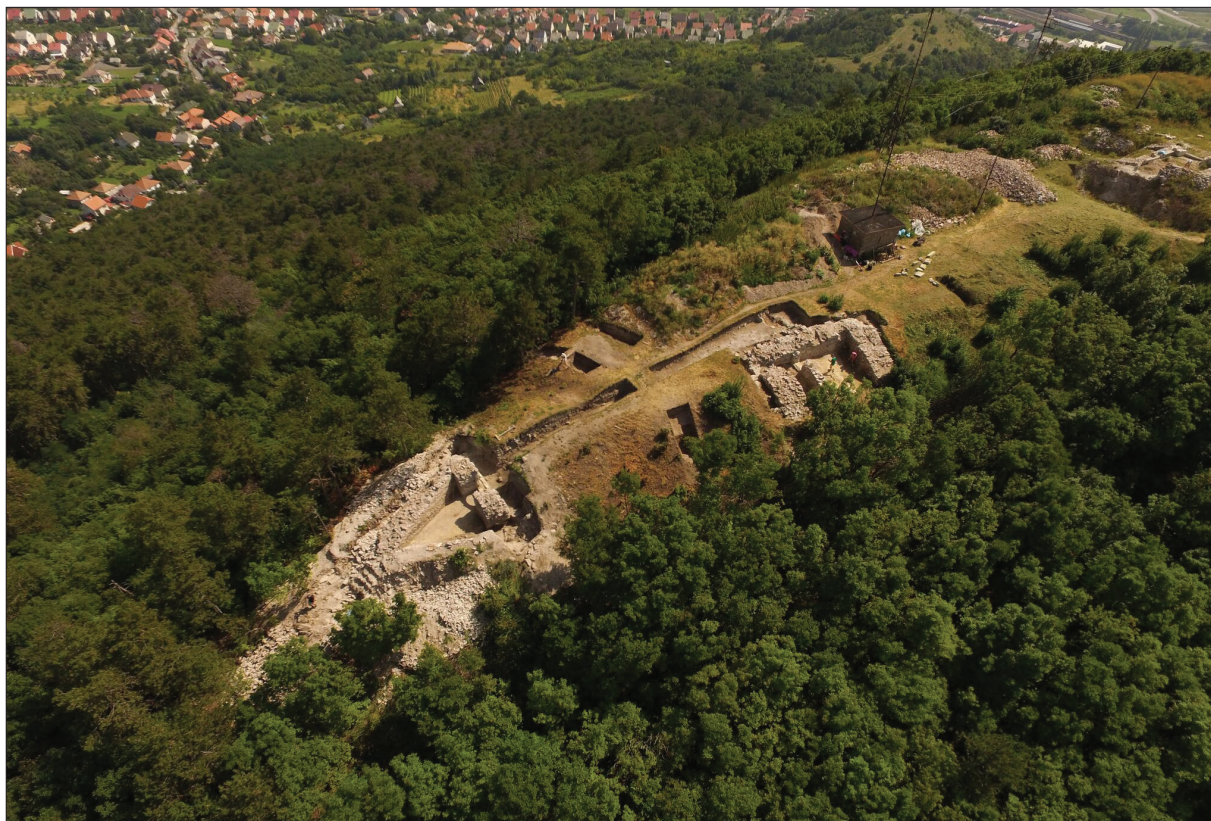
*Fig. 2.* Aerial photography of the castle at the beginning of the excavation in 2017.

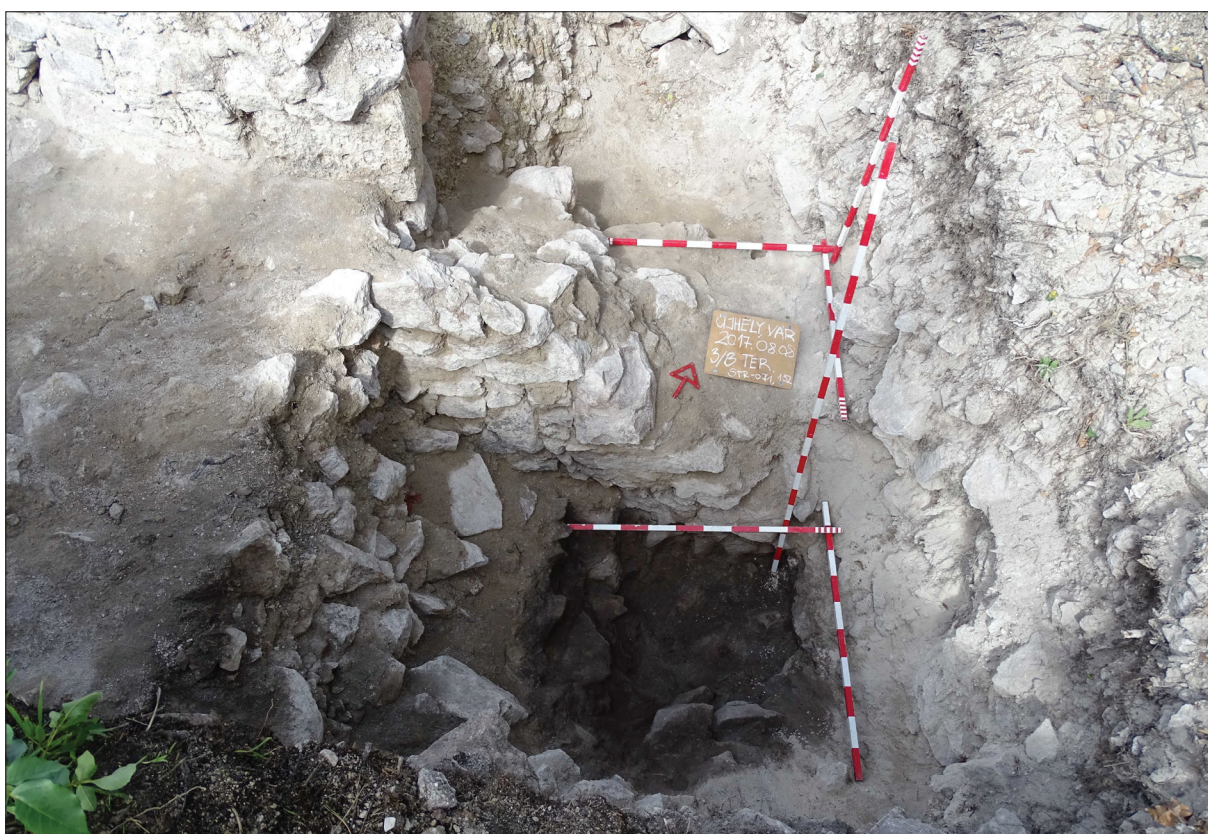
*Fig. 3.* The buttress used to support the merging of the tower's southeast corner and the connecting eastern castle wall.

The southeastern corner of the tower is the only one that remains. Here, we successfully discovered two ashlar, which were supposed to buttress up the corner of the building. At this site, it seemed that there is a heavily demolished east-western wall which was identified as a buttress used to support the merging of the tower's southeast corner and the connecting eastern castle wall. Only one row of stone has remained from the inner side of the castle wall, above the rock surface. Its outer face isn't there anymore, and only the core of the wall itself is visible with the mentioned buttress, which are approximately 1 meter lower than the inside face of the castle wall and the ground level of the castle's courtyard in front of the tower's entrance. In this part it can be observed that the rock surface of the mountain is not only northward sloping, but eastward and westward too (*Fig. 3*).

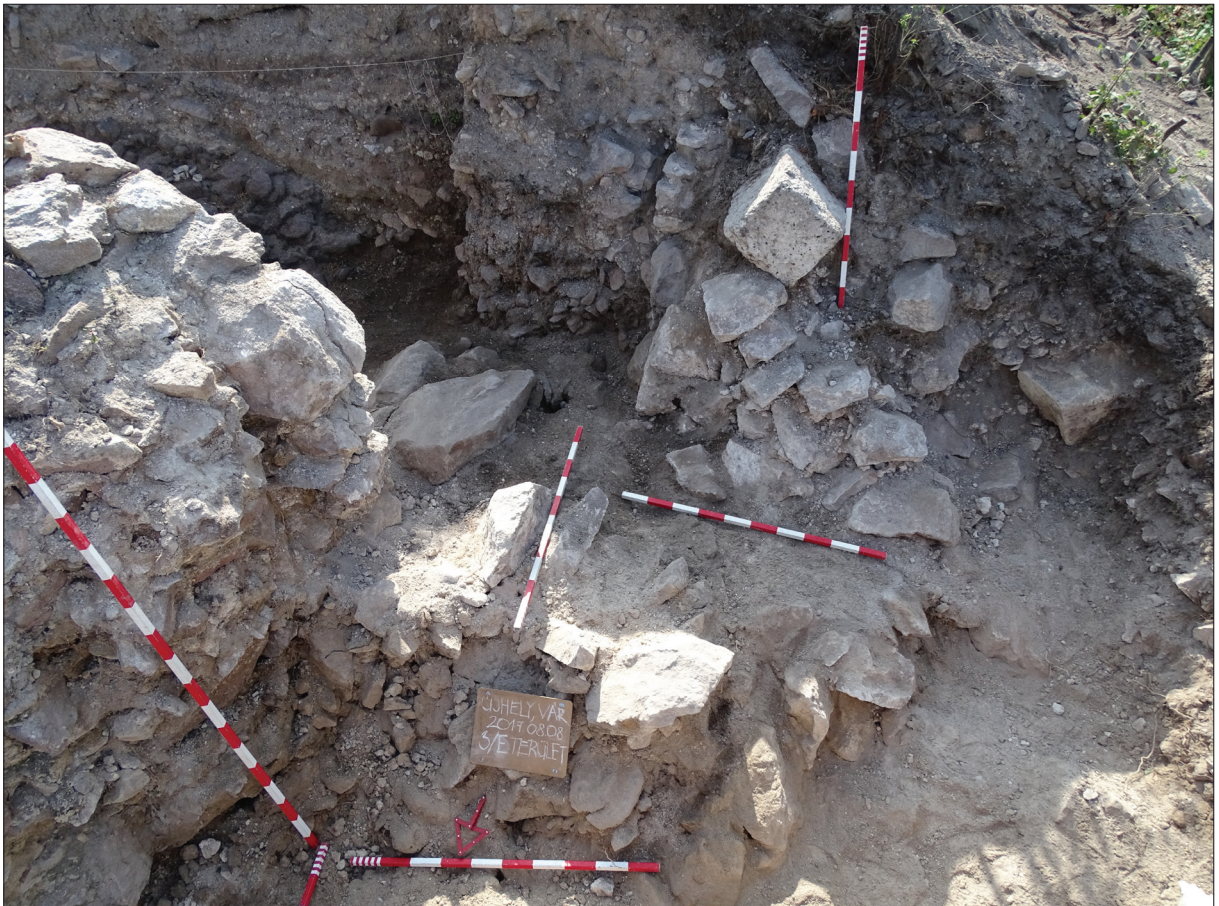
Fig. 4. The fallen ashlars from the former southwestern corner of the triangle-shaped tower.

current terrain's topsoil level at the former outer corner where we cut through thick layers consist of stones, rubble and mortar, and found a minimal amount of findings. This area unveiled a little taller than the inside of the tower's ground floor, a large, collapsed wall block, which was the former corner of the building. The southern, outer surface of the wall could be observed on it, since, basically, the entire corner fell out in westward direction. It is also the direction in which the ashlar fell, just like at the west castle wall, which used to connect to the southwest corner of the tower. The wall's fallen inner face could be observed within the southern profile of this field area wall. Between the western end of the southern wall of the tower and the collapsed tower corner the natural rock surface with the western slope, the foundation of the building, and the place of the western castle wall were all unearthened (*Fig. 4–7*).

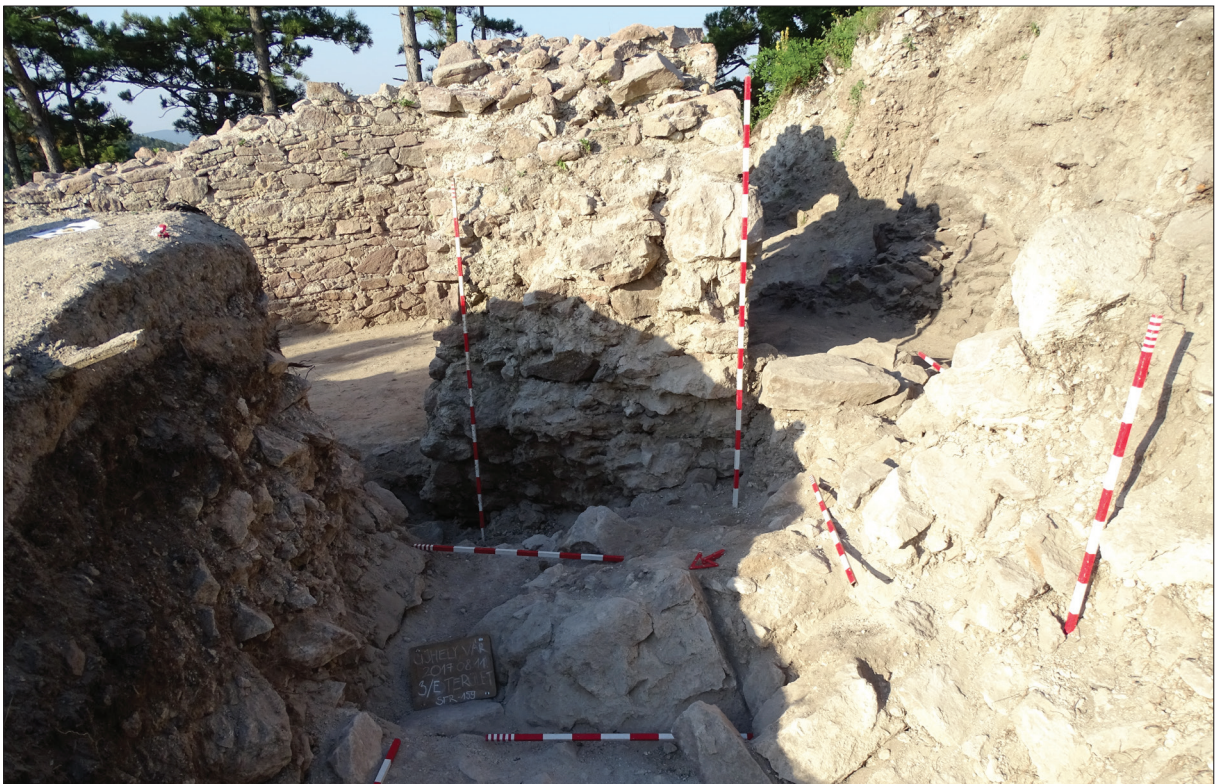
Fig. 5. The southwestern corner of the triangle-shaped tower during the excavation.

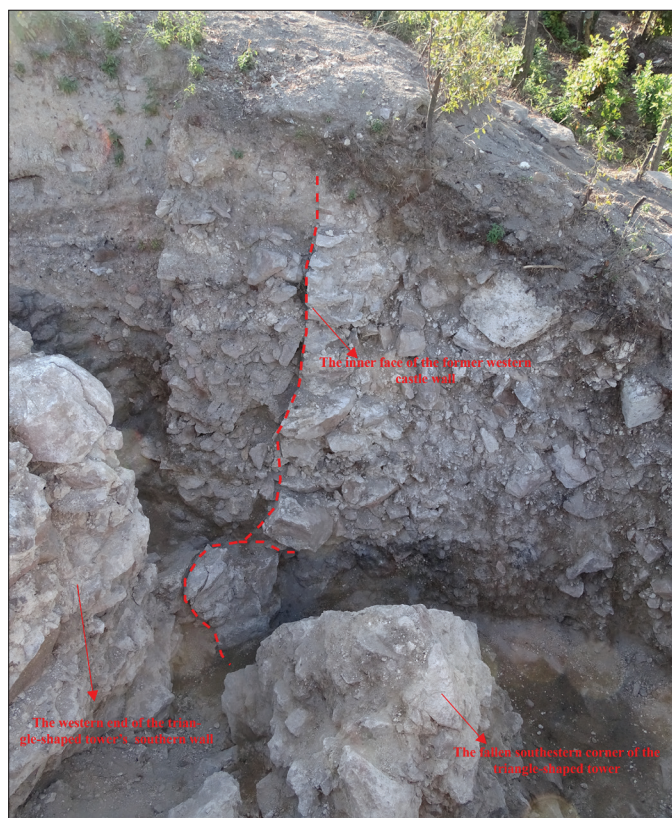
*Fig. 6.* The southwestern corner of the triangle-shaped tower with the inner face of the former western castle wall.

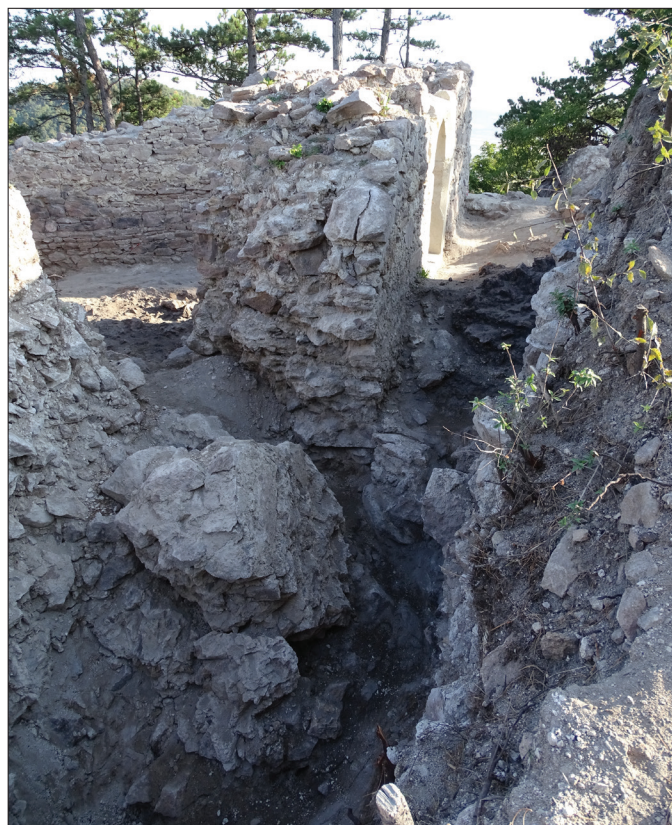
*Fig. 7.* The fallen southwestern corner of the triangle-shaped tower.

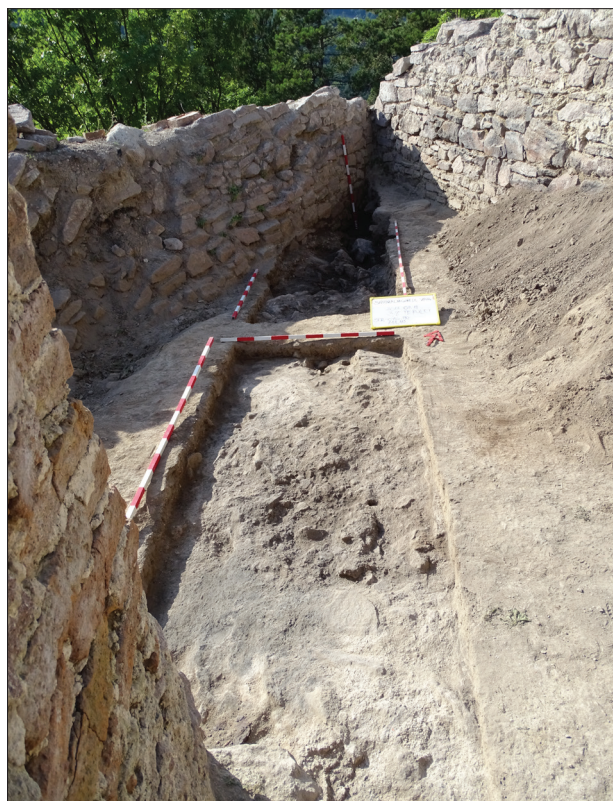
*Fig. 8.* The cross-section of the ground floor of the tower and the remains of the earlier ground floors.

In 2016, we cleared the whole surface of the clay floor inside the tower. In 2017, we first cross-sectioned it with two ditches. Then, after their documentation, we demolished the entire interior. There we found a large amount of pottery fragments, a half millstone, a carved bone, and a fragment of a pruned beaker in the clay layer, which was 2–4 centimeters high in the south parts, but 20–30 centimeters thick in the east. Among the pottery fragments, there are a number of burnt, reduced, stone diluted, uneven surfaced, slow pottered ones, and fragments of more bottom stamp pots. From these remains a whole pot can be almost completely assembled. Besides that, we found many fragments of better quality, thin-walled, finely-sliced, slow pottery wheeled, red-painted pots (*Fig. 8–9*).

Under the clay floor, near the door of the tower, we found remains of two earlier mortar floor levels directly over the rock surface. During the examination of the floor levels, it was an important question as to whether the current door of the tower was built together with the south wall, or later than that. The second statement had already seemed to be confirmed during the scanning of the masonry of the tower's wall, but the cross-section of the clay floor has certainly verified our assumptions. The relationship between the former levels was not determined by this ground floor entrance because of the unearthened and small revealed details of them.

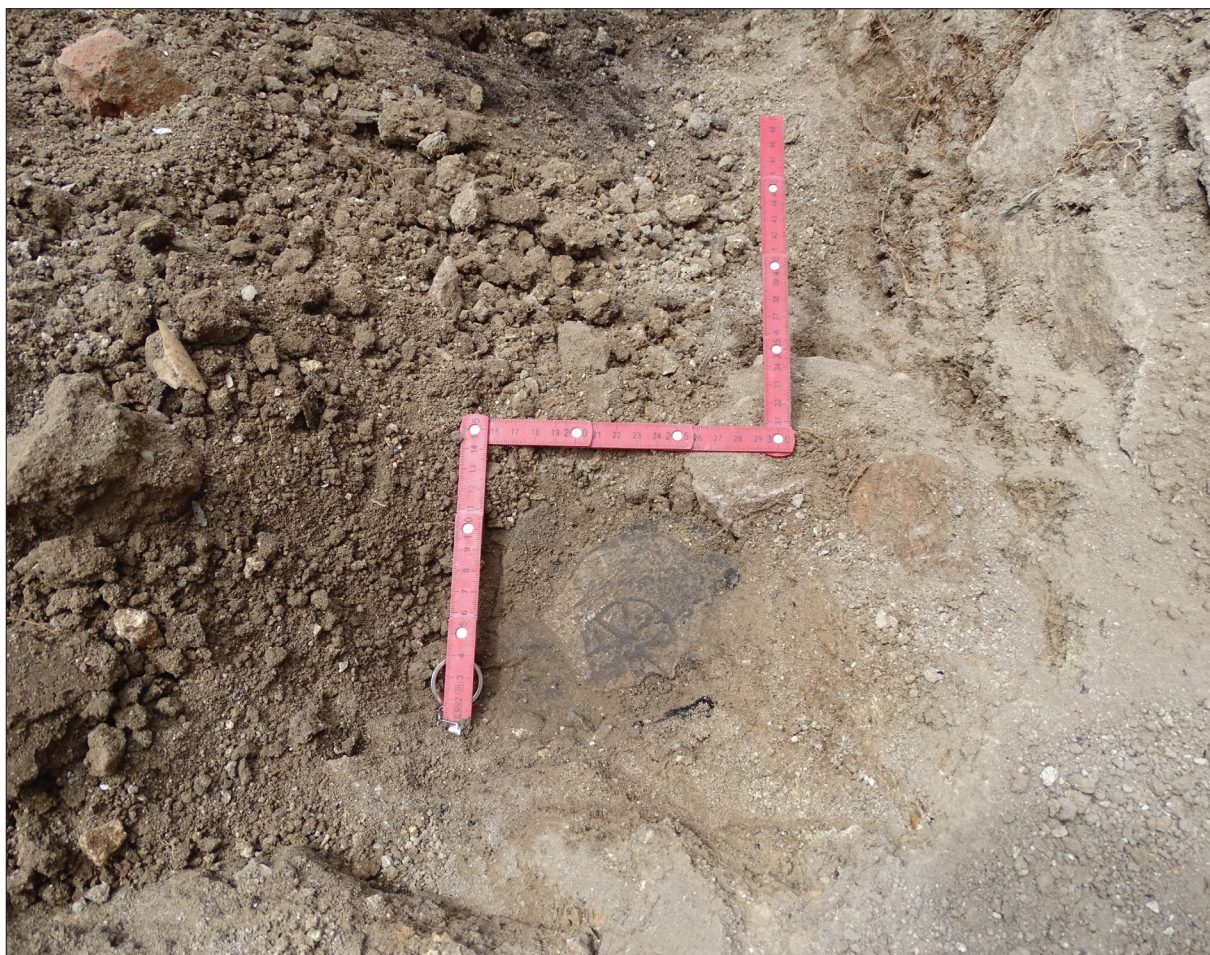
*Fig. 9.* A fragment of a pot with a bottom stamp from the clay floor of the tower.

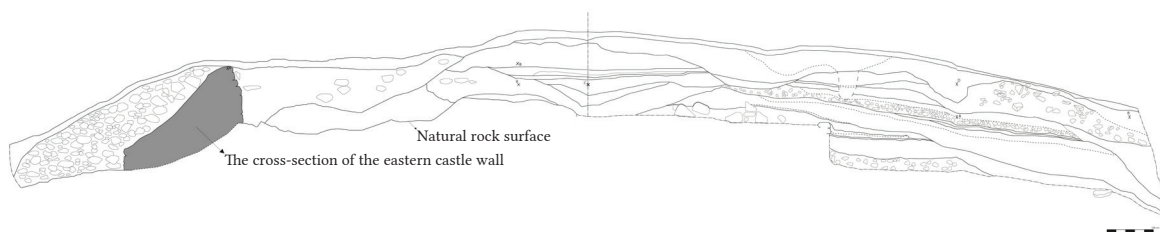
*Fig. 10.* The southern and western profiles of the 1<sup>st</sup> site with the thick layers of rubble and fill and the cross-section of the eastern castle wall.

After removing the humus level, we found more mixed red colour, mortared, crushed stone, successive destruction levels on the top of each other, sloping in northern and eastern directions according to the geography of the hilltop. The rocky layers were divided by solid clay and charcoal bands, which were rich in finds. These bands were hard to observe during the work, but they were well presented by the profiles. In the middle of the area, we reached approximately 170 centimeters depth (*Fig. 10*). Here a back-filled ditch, perpendicular to the plateau of the hilltop, cut through the area. The ditch was probably a trench from the Second World War according to the rifle bullets and shrapnels we found.

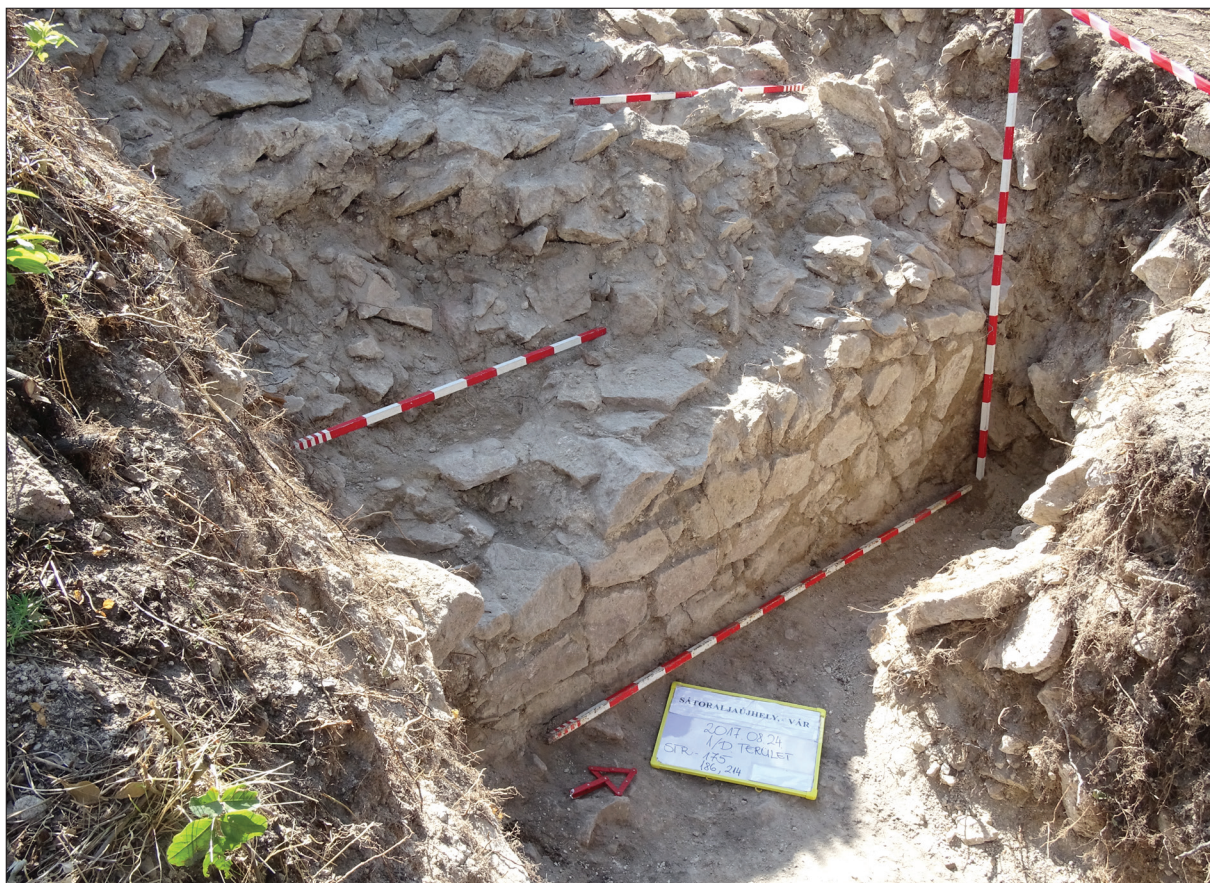
Fig. 11. The outer face of the eastern castle wall.

We have already found the inner face of the eastern castle wall under the current topsoil at the beginning of our work in this season. The inner face of the wall is 1 meter high, while the outer part is just 40–60 centimeters. The condition of the wall is becoming worth with reaching closer to the northern tower. (*Fig. 11*) The wall connecting to the south-eastern corner of the tower is just one stone line tall as we mentioned before. The northern part of the wall and the face of it are missing, because this section of the wall was torn out in east, in the direction of the slope of the hill. It could happen because the wall was built directly on the heavily sloping rock surface. In this northern part, over the remaining fragments of the inner part of the wall, a heavy, rocky, mortared layer stretched. From this layer, a green glazed, rosette applique ceramic pipe from white clay has been found. The size of the torn out wall is unknown because the outer side have not been excavated yet. (*Fig. 12*)

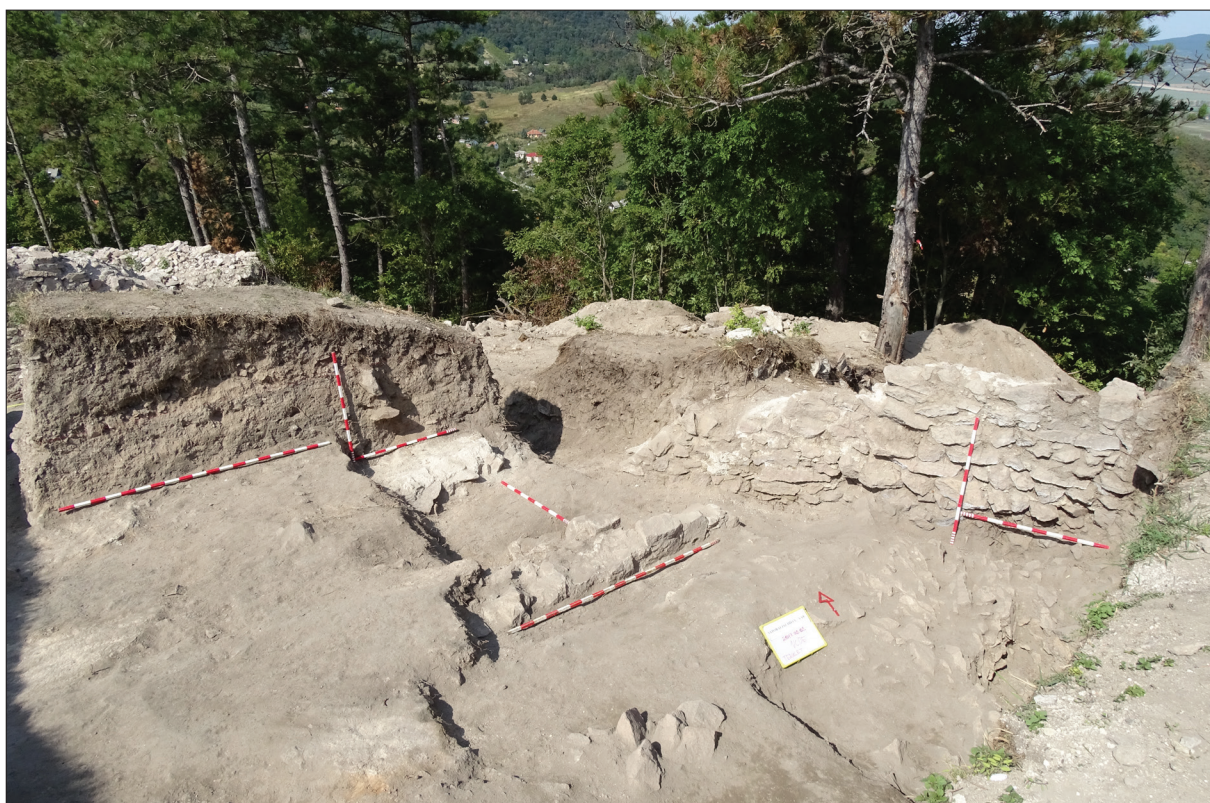
Fig. 12. The 1<sup>st</sup> site at the end of the excavation.

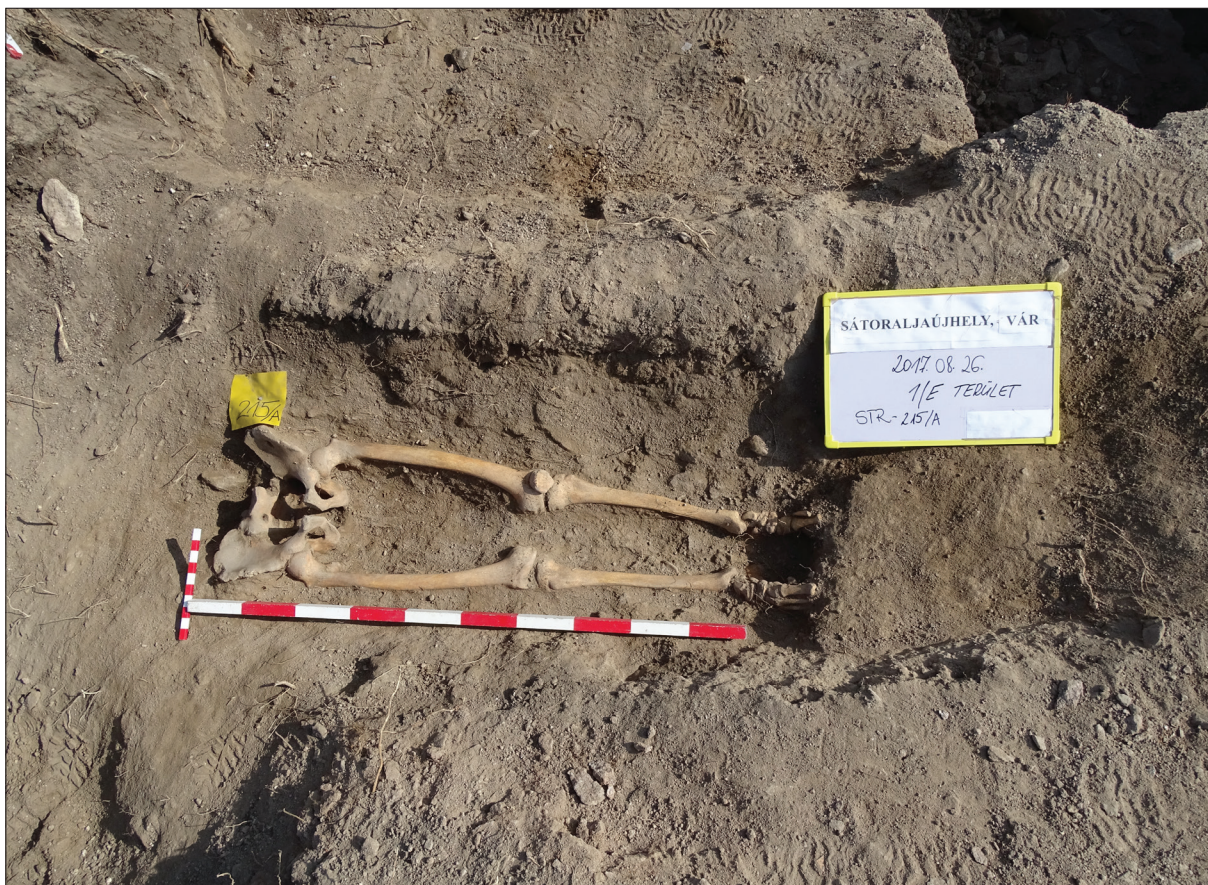
Fig. 13. One of the graves on the courtyard of the castle in the 1<sup>st</sup> site.

During the excavation, we found the remains of six human bodies, and high numbers of human bones spared out in the whole area at the border of the humus and the destruction layers. The positions of the remains were identical with the position of the skeleton found in 2016 nearby. Each of them was north-south orientated. From the six skeletons only three were articulated in anatomic order, while the three others had disturbed contexts, and none of the bodies were full. The dating of the remains is questionable; however, their stratigraphy excludes their medieval origins. The missing parts of the remains of four human bodies were placed directly in the World War trench. As a result, it can be supposed that the bodies were disturbed when the trench had been dug out during the War. It can explain the origins of the remains that The First Military Survey shows a scaffold on the top of the Castle Hill. Nevertheless, this theory needs further researches. Moreover, dating the remains is even more difficult due to the lack of grave goods, jewellery or personal items around the skeletons.

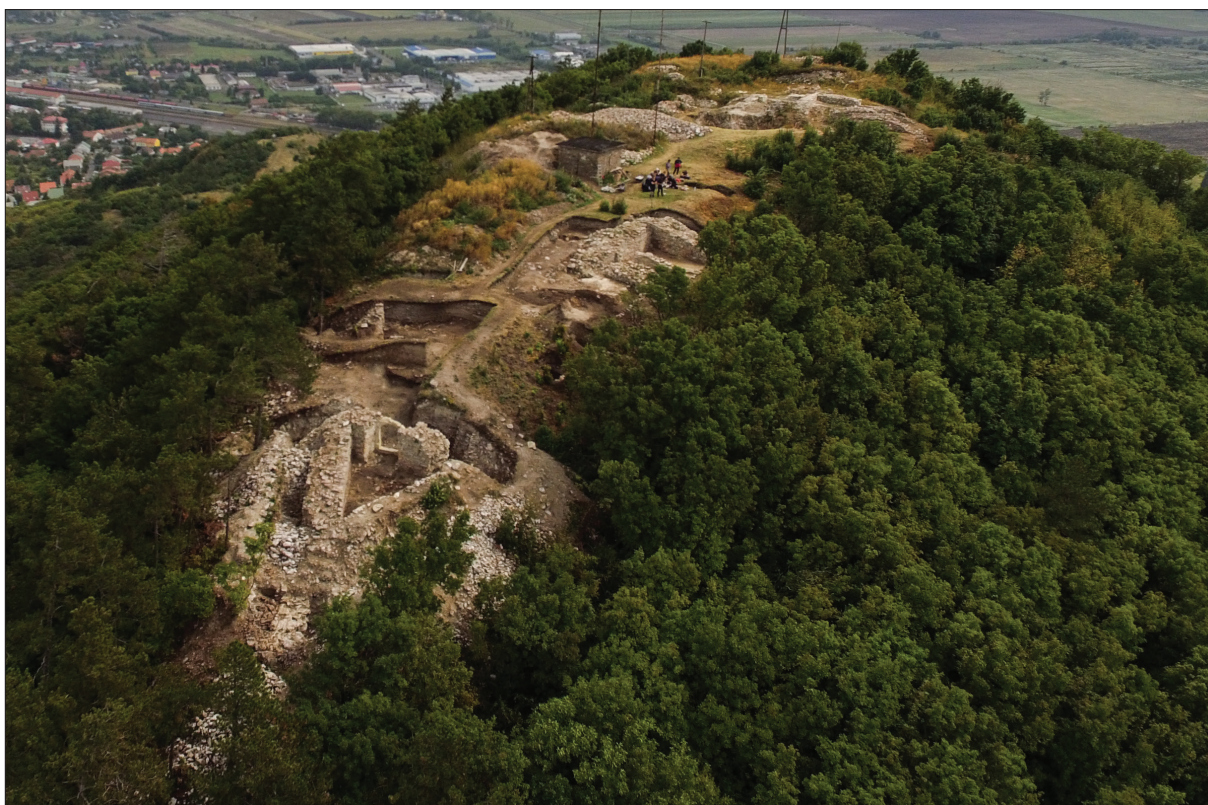
Fig. 14. Aerial photography of the castle at the end of the excavation in 2017.
