Trial excavations in mediaeval churches of Kishartyán, Kisterenyé, Mátranovák and Szuhá in Nógrád County 2021

Rita RAKONCZAY

Abstract: In 2021 the Department of the Migration Period and Medieval Archaeology of Eötvös Loránd University participated in excavations at nine mediaeval (or seemingly mediaeval) churches in Nógrád county in collaboration with the Dornayay Béla Museum, Salgótarján commissioned by the Diocese of Vác. This short report presents four excavations of the churches of Kishartyán, Kisterenyé, Mátranovák and Szuhá where the research was led by the author.

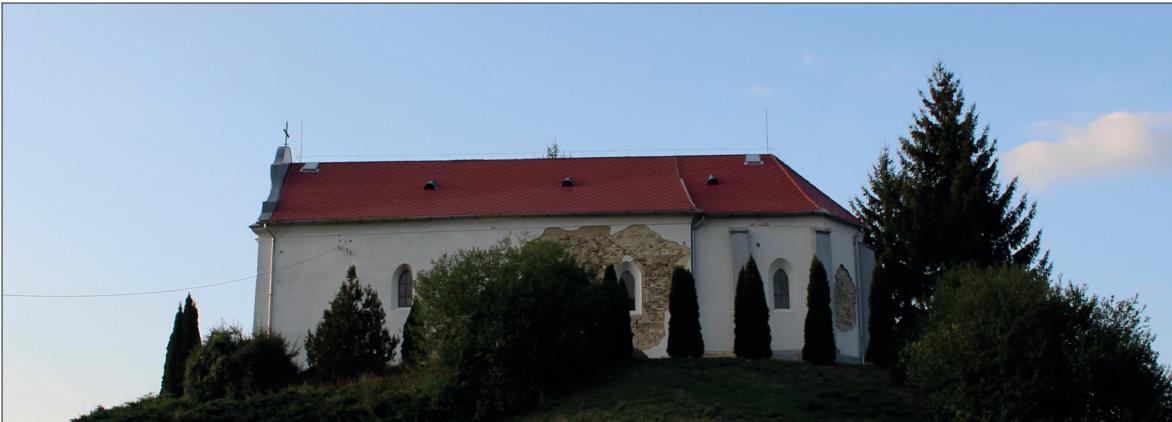
Fig. 1. The church of Kishartyán (photo: R. Rakonczay).

The village of Kishartyán is located in Nógrád county, west of Salgótarján. The first written mention of the village is uncertain because Kishartyán and the nearby Sóshartyán were uniformly referred to as *Harkyan* in the Middle Ages.¹ The church (*Fig. 1*) is mentioned – indirectly – in the papal tithe list from 1332 where the priest of Hartyán was named.² The church was mentioned next in the written sources only in the 18th century, in 1712, when the vault of the sanctuary was demolished, the nave was enlarged to the west and got a flat ceiling.³ However, the village was recorded as completely destroyed as early as 1548,⁴ so it can be assumed that in the 16–17th century the church was not used, and was already beginning to be destroyed. In the first half of the 18th century, the village was relocated, and only five households were recorded in the 1715–1720 tax censuses.⁵ The church was renovated sometime in the first half of the 18th century when it gained its present form. The church was renovated in 1936 and 1975 based on the years presented above its western entrance.

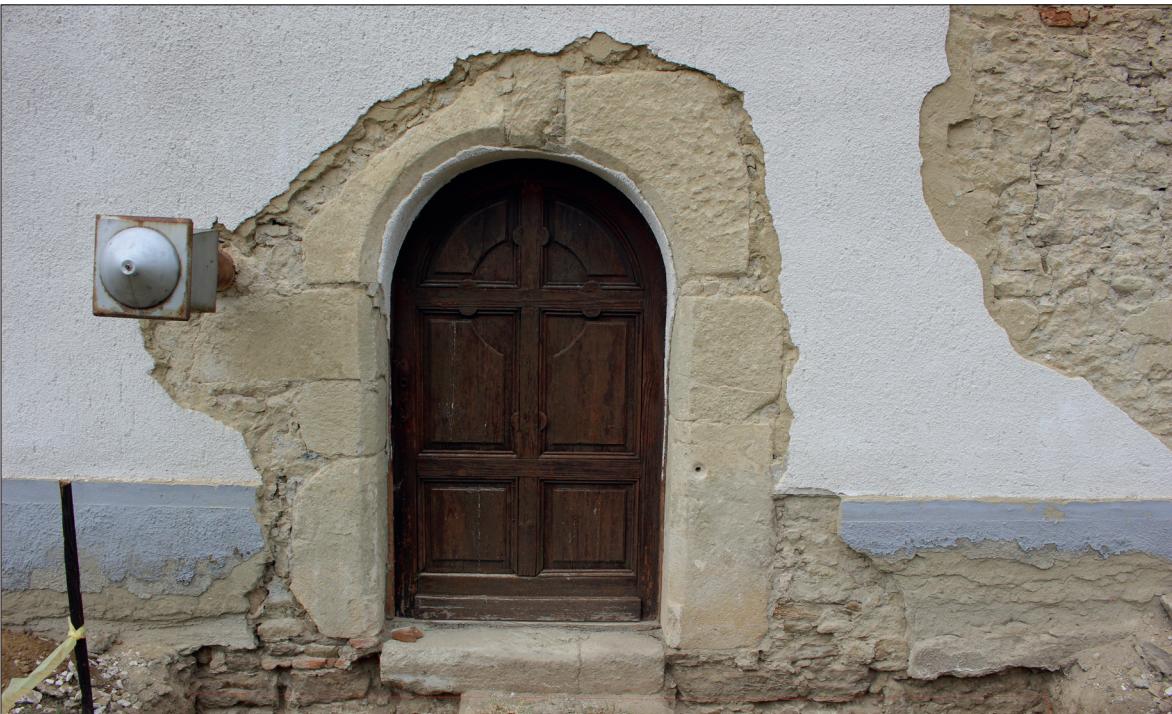
next to the southern Gothic entrance of the church (*Fig. 2*). Trenches 3 and 4 were opened next to the southern and northern sides of the sanctuary, and trench 5 was designated at the outer junction of the sanctuary and the sacristy wall. Trench 6 was drawn on the northern side of the church in the line between the nave and the west foyer, while trench 7 was opened north of the building, on the edge of the church hill, in order to find the curtain-wall of the church (*Fig. 3*).

Fig. 2. The Gothic entrance on the southern façade (photo: R. Rakonczay).

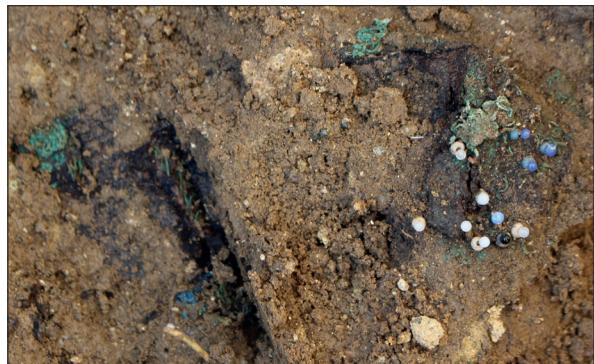
Fig. 4. Pieces of a corolla decorated with beads (photo: R. Rakonczay).

South of the church are the remains of the mediaeval and the early modern cemetery. Although no complete grave was found, the yellowish-brown, slightly clayey layer found here at a depth of approx. 50 cm, contained a large amount of scattered human bones and attire elements were also found in a secondary position, such as pieces of a corolla decorated with beads (*Fig. 4*), a hairpin, and a fragment of a French clasp (*Fig. 5*).

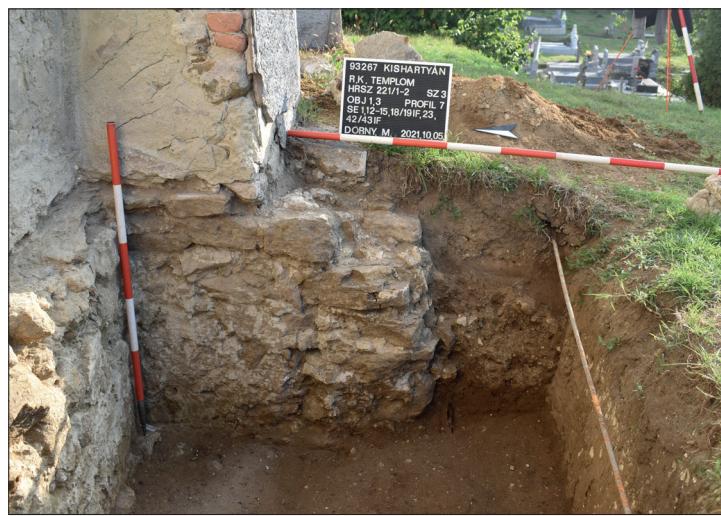
Fig. 7. Strongly demolished buttress in the trench 3 (photo: R. Rakonczay).

The most spectacular results of the excavation include observations related to the construction history of the church. The foundations of the buttresses were found in trenches 3–5, which were connected to the sanctuary. In the trenches next to the sanctuary, it could be observed that the foundation wall of the church did not protrude from the level of the ascensional walls, and the buttresses were contemporary to them and not a later addition. This suggests that the polygonal sanctuary was completed at the same time as the vault and the buttresses. However, the original, mediaeval buttresses, which were wider, were lat-

er strongly demolished, and only served an aesthetic function (Fig. 7). This may have happened when the vault of the sanctuary was demolished around 1712 and fitted with a flat ceiling. In trench 5 it was also observed that in the first period the pillar was demolished, and a little later, when the sacristy was built next to the northern side of the church, the previously demolished pillar was included into the newly erected wall.

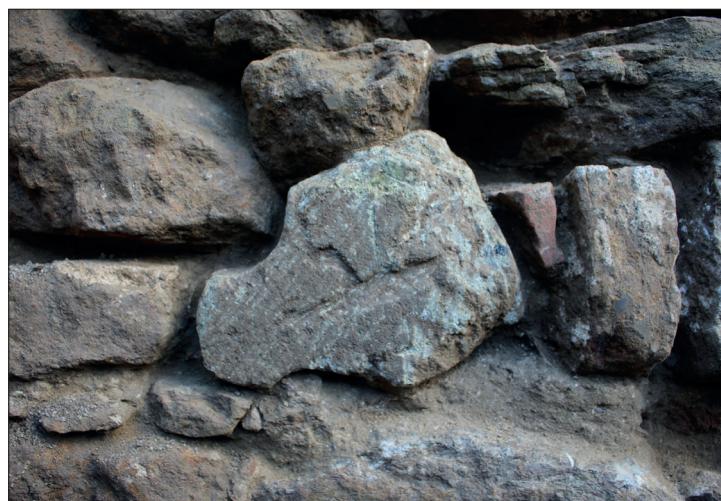
Fig. 8. A mediaeval vault rib in secondary position (photo: R. Rakonczay).

Both on the northern and southern sides of the church a large number of carved stone elements can be found, which are secondarily used elements of the mediaeval church (Fig. 8). The foundation of the walls is different on the two sides. On the southern part, where the church also has a Gothic entrance, the face of the foundation does not stand out of the line of the ascending parts. This is identical to the foundation of the mediaeval sanctuary. No mediaeval carved stones of secondary use were found amongst the stones of the foundation in this part. On the north side, however, the foundation does stand out at approx. 20 cm, is at least 2 m deep, and contains fragments of the mediaeval vault. The foundation of the western foyer of the church is also prominent, but at the same time, it was much shallower, with a depth of only 1 m. The foyer may have been completed after the Baroque reconstructions when the western wall from the Baroque era was demolished and the church was extended to the west.

mediaeval vaulted ribs found in the wall of the church. The western part of the southern wall of the nave with the Gothic entrance may also be mediaeval, but the ascending walls are probably Baroque complements based on the secondarily used mediaeval carved stones. However, the northern wall of the nave may be entirely from the Baroque era, considering that the foundation of the wall is different here, with mediaeval carved stones in secondary position. It is possible that in parallel with the construction of the nave, the mediaeval vault could have been demolished and the pillars of the sanctuary restored. In a later period, the northern sacristy was attached to the building, and the church was expanded to the west.

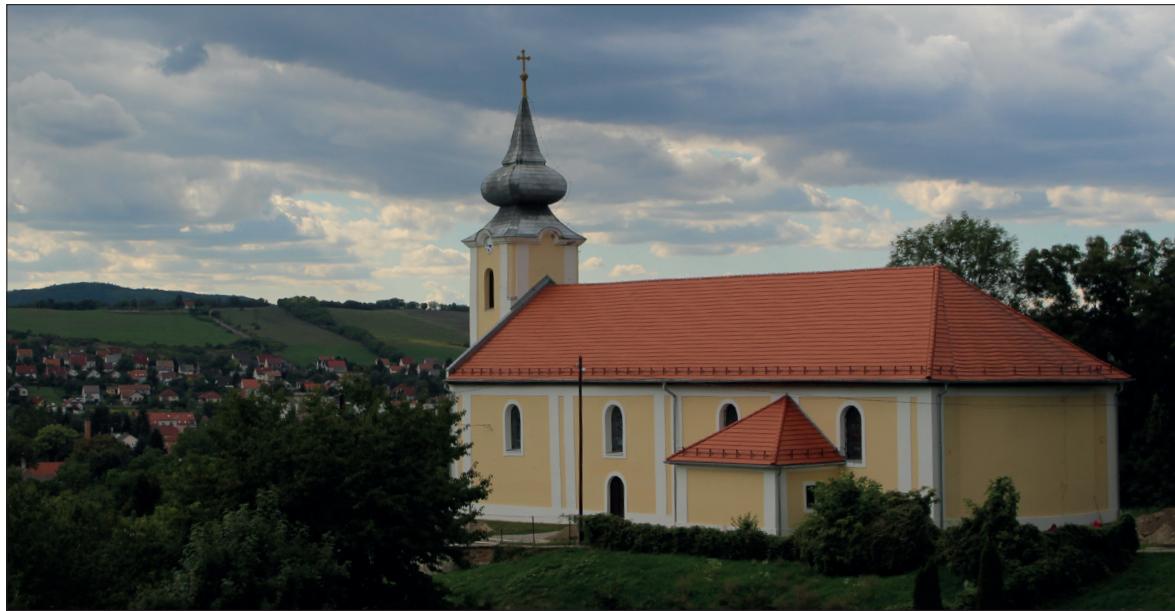
Fig. 9. The church of Kisterenye from south-east (photo: R. Rakonczay).

The church (Fig. 9) has a single-nave, segmented arched apse to the east and with a tower on the west side. The purpose of the trial excavation¹⁷ at the Baroque church at first glance, was to clarify the antecedents and chronology of the church. During the excavation six trenches were opened (Fig. 10). Trenches 1 and 2 are located perpendicular to the sanctuary of the church, with the first facing east, and the second north. The sanctuary and the nave are the same width, but a partition can be observed on the facade, where we opened the third trench. Trenches 4 and 5 were drawn on the southern side of the church, parallel to the wall, and the longitudinal axis of the church. Trench 6 was drawn only later, between trenches 2 and 3, in order to find a continuation of the walls found in trench 3.

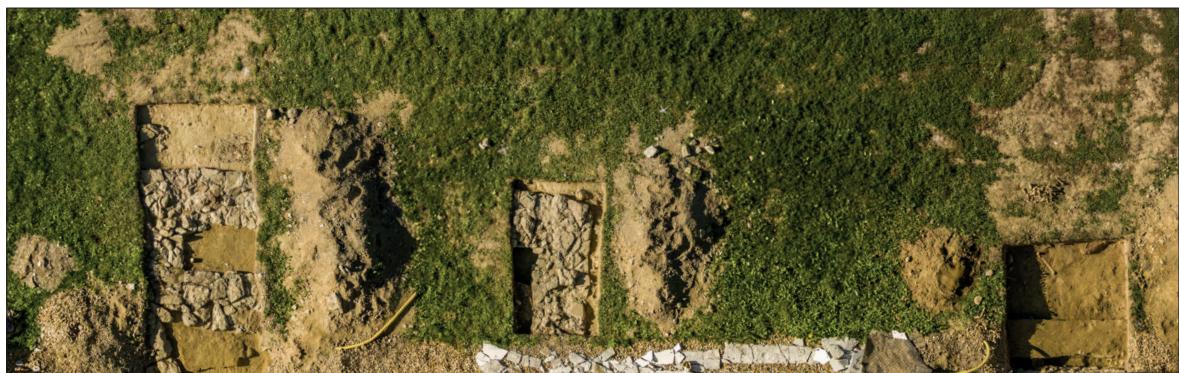
Fig. 11. The orthophoto of the excavated building (photo: K. Tóth).

On the northern side, however, the graves have already emerged at a depth of 15–20 cm and were nearly dug into the subsoil. The yellow, clayey, completely sterile subsoil was found at a depth of 30 cm. Trenches 3 and 6 reveal the remains of a hitherto unknown building. The thick, 90 cm wide walls were made of angular stones. The rectangular building runs under the present northern wall of the church but was heavily demolished, presumably during the construction works of the baroque walls. The fourth, south wall of the rectangular “room” is separated from the U-shaped wall and is much shallower. The excavated building here thus had at least two construction periods and can be interpreted as the northern sacristy of the church, which has been mentioned in written sources since 1674 (Figs 11–12).¹⁸

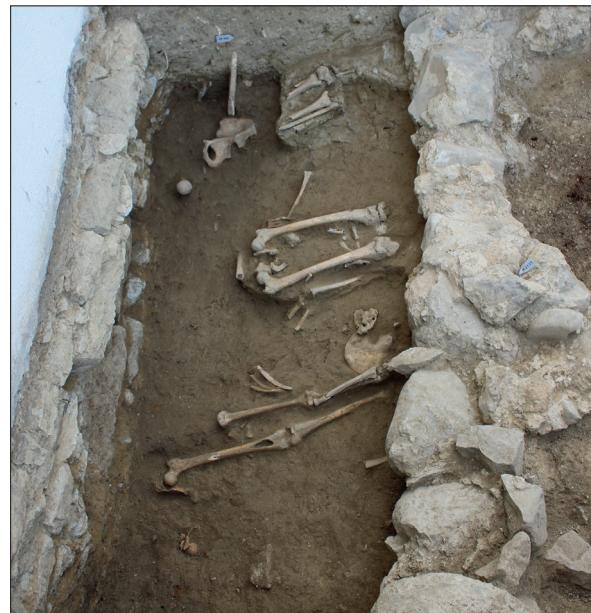
Fig. 14. Strongly demolished graves east of the sanctuary (photo: R. Rakonczay).

In trenches 1 and 2, the degree of landscaping was already lower. In trench 2, the yellow subsoil was found at a depth of 50 cm, above which a yellowish-brown, slightly clayey grave fill was observed. The continuation of this layer was found in trench 1, along the wall of today's sanctuary, in which four heavily disturbed burials were excavated (Fig. 14) other by a 60 cm wide wall oriented north-south. A 14th-century denarius of Queen Mary¹⁹ (Fig. 13) was found around the wall. On the eastern side of the wall, 17–18th century features were excavated: mostly pits, storage pits and post-holes. In one of these objects, the remnants of an *in situ* pole was also observed. On the top of one of the pits lies a full pot from the 18th century (Fig. 15). Although we did not dive to the level of the graves on the eastern side of the trench, it was clear that the features were dug directly into the soil of the former cemetery. Based on this observation, the north-south stretching wall can be interpreted as a curtain wall, which – for some unknown reason – narrowed down the area of the former cemetery. On the east side of the wall, the traces of a settlement dating back to the 17–18th century, could be observed.

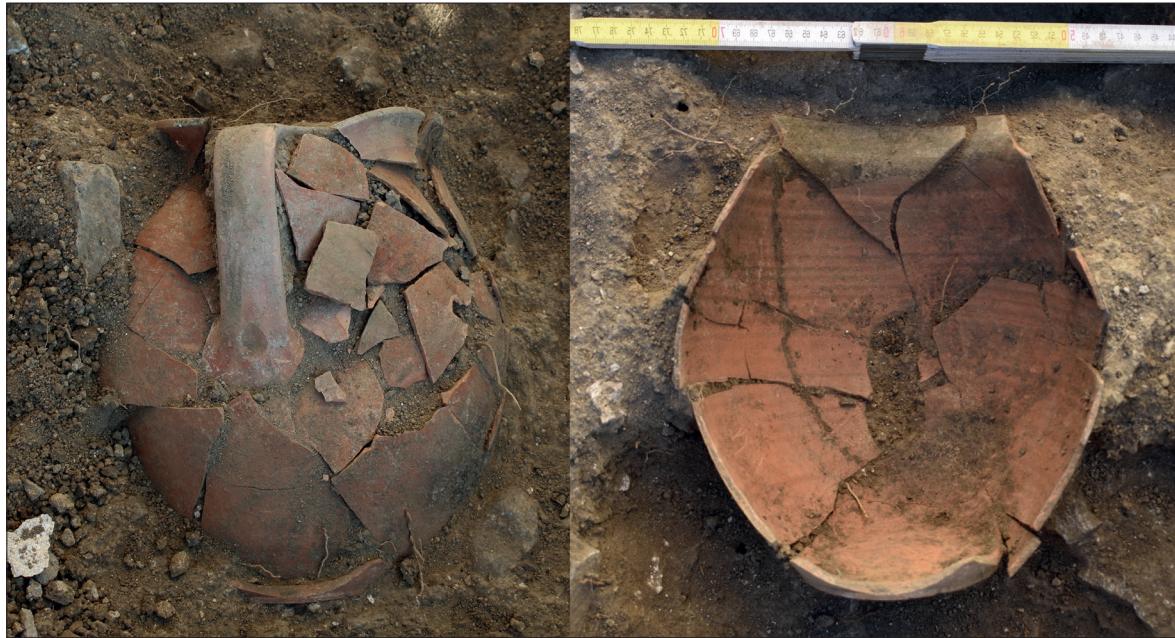
Fig. 15. A pottery from the 18th century on the top of a pit of the settlement (photo: R. Rakonczay).

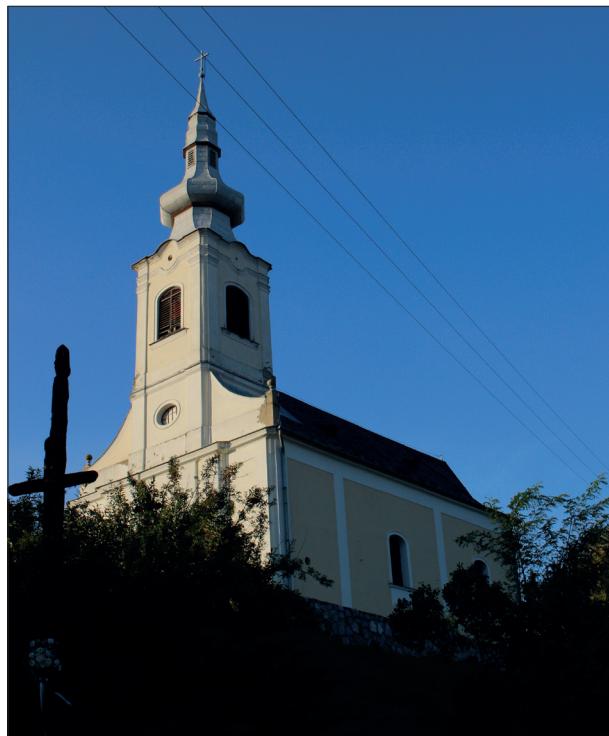
Fig. 16. The church of Mátranovák from south-east (photo: R. Rakonczay).

Mátranovák is located in Nógrád county, southeast of Salgótarján. The church (Fig. 16), which is dedicated to St. John of Nepomuk, is located in the northern part of the village's core, on the eastern side of the Bárna stream. The church building, which can still be seen today, dates back to the Baroque era, and was built in the 1800s according to the inscript visible on the southern main entrance. The first written mention of the village is known from 1384.²⁰ There is no written source known about the mediaeval church in the village. According to a census of 1674, the church was shared by the inhabitants of Mátranovák and the neighbouring Homokterenye, and presumably lay on the border of the two villages. The church built in honour of St. John was first mentioned

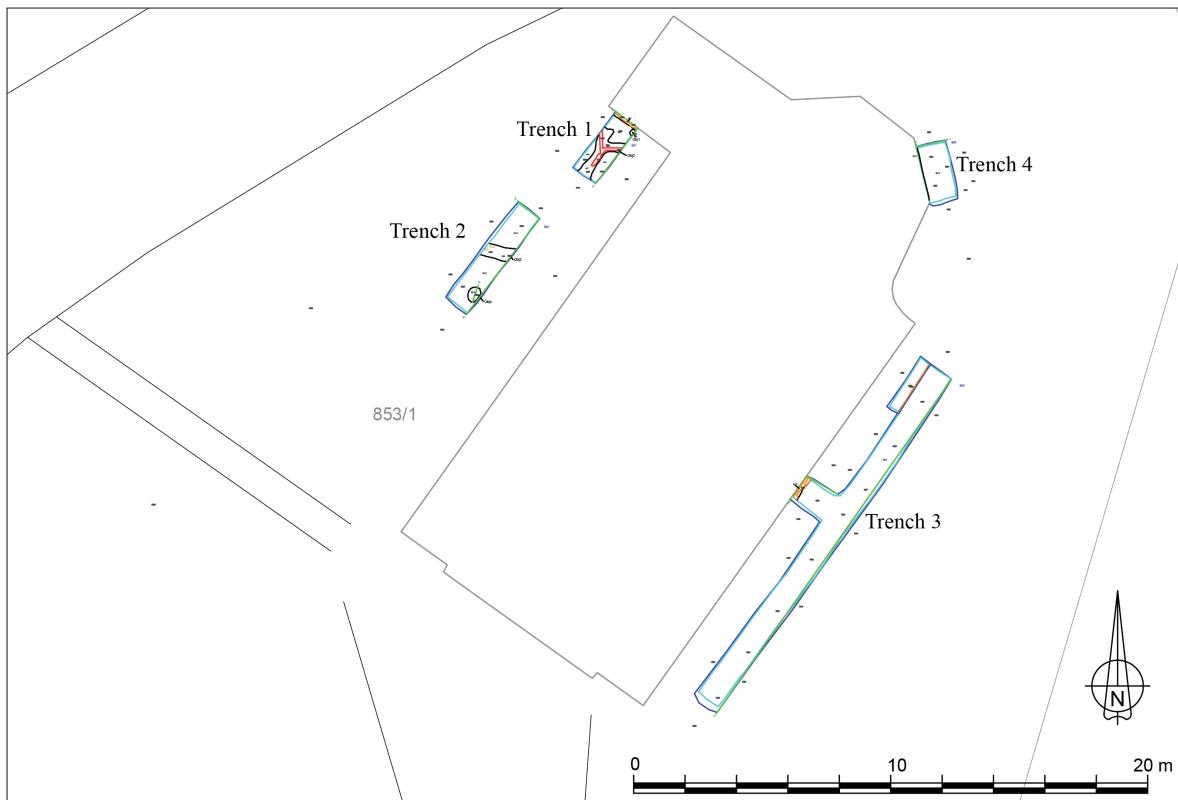
Fig. 17. The plan of the church and the excavation (graphic: Archaeojedi Company).

The primary purpose of archaeological research²⁴ was to examine the antecedents of the Baroque church, especially with regard to the question whether a Mediaeval church building could have stood on the site of today's building. During the excavation, we opened four trenches in the churchyard (Fig. 17). In trenches 1–2, and 4 early modern as well as prehistoric cultural layers and objects were discovered, which were disturbed by modern construction sites, while in trench 3 no archaeological feature was seen.

In trenches 1–2 at a depth of 20–40 cm, a dark brown, sometimes black, slightly clayey layer was found, from which white pottery fragments dating back to the 16–17th century derived. In trench 2, at a depth of 50 cm, a clayey, black layer comprising reddish clay clumps was observed, which contained prehistoric pottery. In the middle of the trench, a grave (Fig. 18) was seen, which was dug into the two clay layers. A relatively large number of late mediaeval and early modern pottery fragments were unearthed in the burial. The rite and the findings clearly refer to a Christian burial. Presumably there may have been a former church nearby, the remains of which were not discovered during the excavation. This was the only grave in the opened trenches, so most probably only the edge of the former cemetery was found. On the second military survey map, a larger stone building is marked on the site of today's church, the orientation and dimensions of which are the same as today's buildings. To the north of this building a cemetery or graveyard was depicted (Fig. 19). It is conceivable, therefore, that the former church, or at least the cemetery, was located a little further north, and one of its outermost burials was excavated.

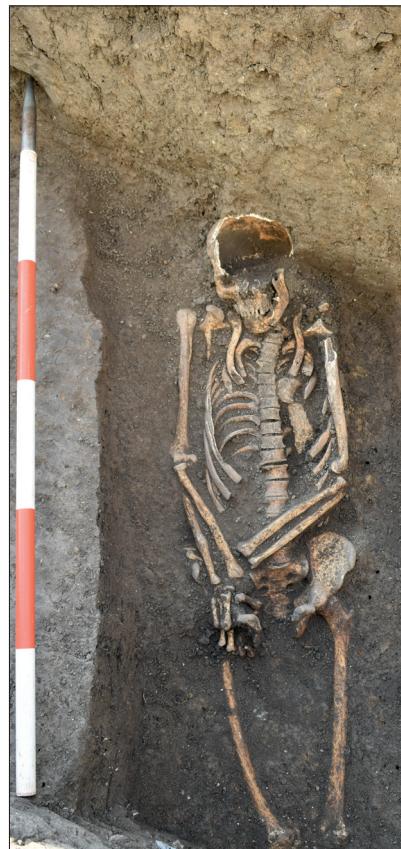
Fig. 18. The only grave at the site of Mátranovák (photo: R. Rakonczay).

Based on the results of the excavation, we can state that the former church is not to be found in the narrower environment of today's parish. No remains of stone walls or scattered human bones suggesting the existence of an earlier building were found at the site. There was also a prehistoric and an early modern settlement in the area, the strata of which were successfully excavated. The eastern side of the church hill was highly disturbed during the construction of the church, so no archaeological sequence could be observed here, only the building layers belonging to the structuring in 1800 were found above the subsoil. The only early modern burial at the site presumably belonged to the cemetery marked on the second military map, stretching northward, and can be identified as one of its southernmost graves.

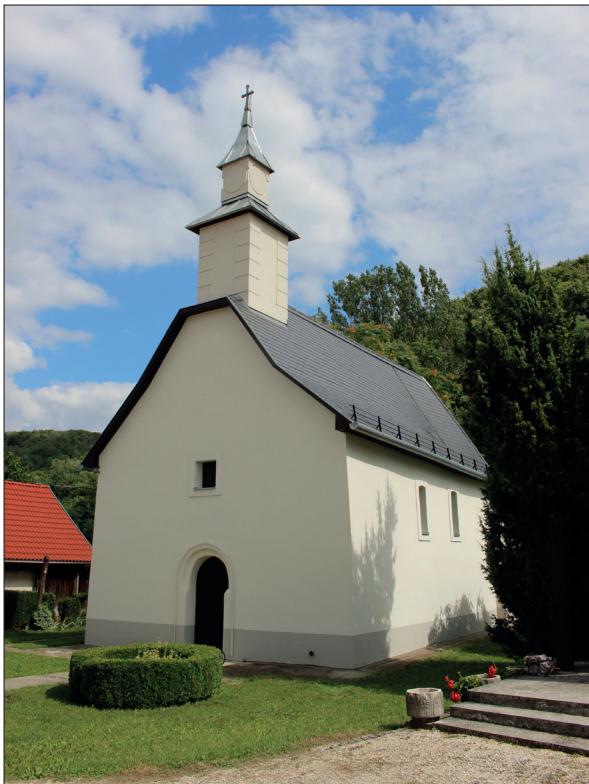
Fig. 20. The church of Szuha (photo: R. Rakonczay).

The village of Szuha is located in the south-eastern part of Nógrád county. Its Roman Catholic church (Fig. 20) dedicated to Nativity of Mary is in the centre of the village, west of the Galya stream. The church has a single nave with a polygonal sanctuary. The sacristy joins it on its north-east-eastern side. The church is not oriented to the east, but its sanctuary faces the south-southeast direction. To the external side of the polygonal sanctuary robust, irregularly distributed support pillars are joined (Fig. 21). The main entrance on the northwestern side is from the Gothic period, just as the door frame that separates the sacristy and the sanctuary.

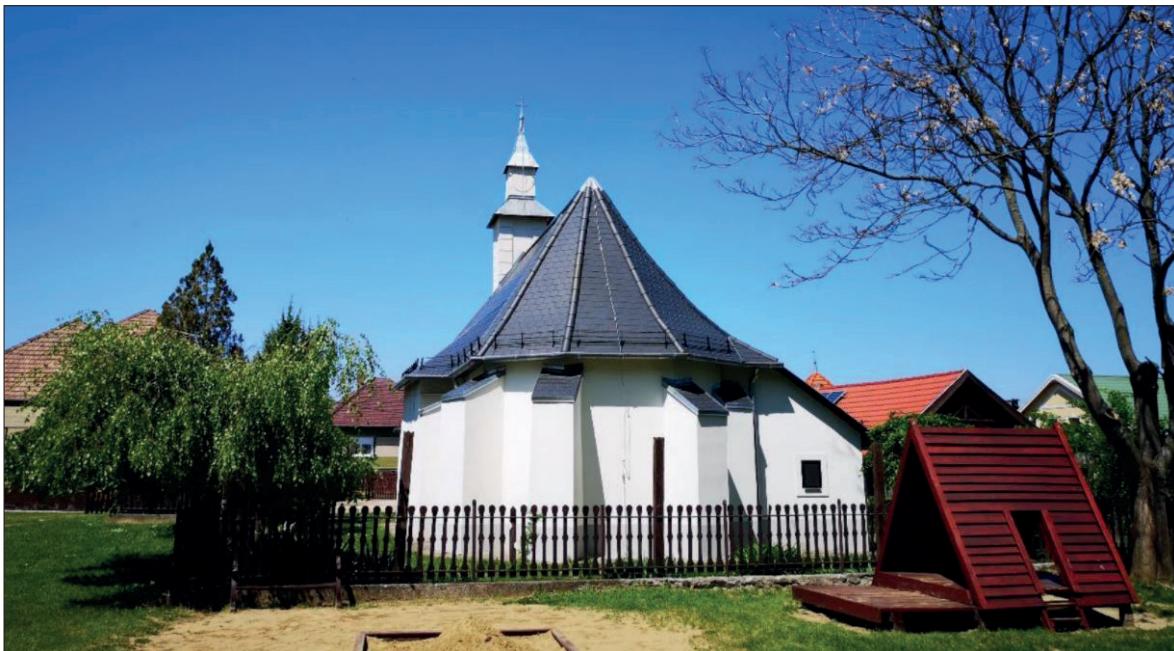
Fig. 21. The polygonal sanctuary robust, irregularly distributed support pillars (photo: A. Szilasi).

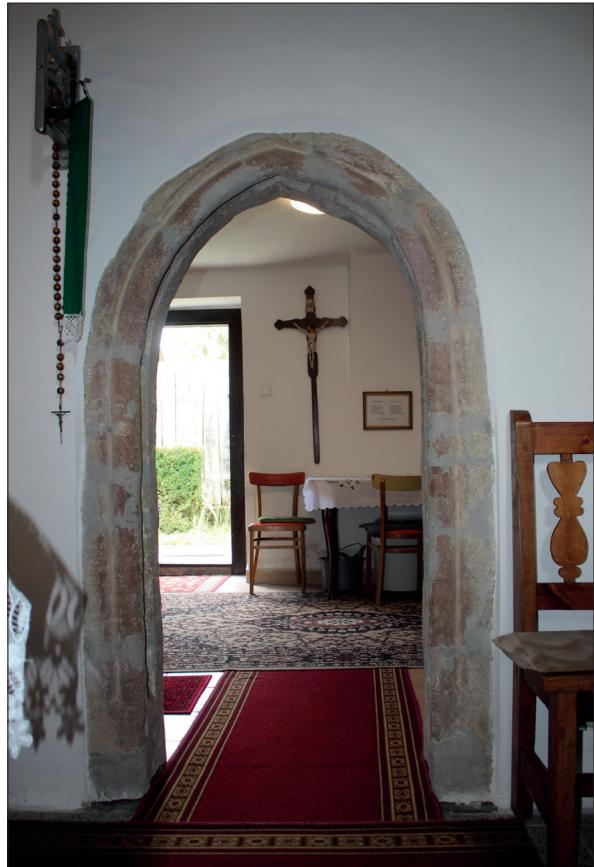
The test excavation²⁵ was justified by the mediaeval nature of the church. Its size, as well as its two Gothic door frames (Fig. 22), also suggested mediaeval origins. It was listed as a mediaeval church

Fig. 22. Gothic doorframe between the sanctuary and the sacristy (photo: R. Rakonczay).

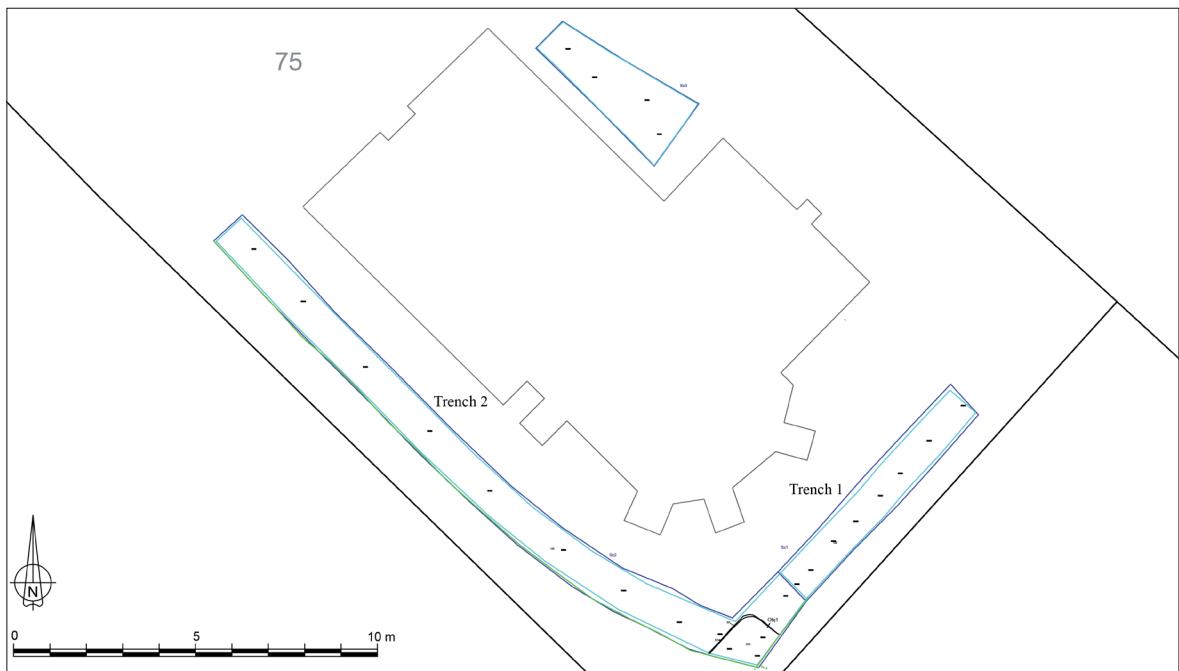
Fig. 23. The plan of the church and the excavation (graphic: Archaeojedi Company).

The primary purpose of the excavation was to date the present church and to identify the churches based on the written sources. During excavation, two long trenches were opened: trench 1 at the sanctuary of the church, in a southwest-northeast direction, and trench 2 on the longitudinal axis of the church, on the south side of the building, in a northwest-southeast direction (Fig. 23).

In both of the trenches, we reached the yellow subsoil in a depth of 30–50 cm, above which only humus and a thin culture layer were found. In these layers pottery fragments from the 17–18th century and a Fillér from 1927 were found. South of the sanctuary of the church, a large lime-pit was found, which can be dated to the second half of the 20th century, based on the floor tiles and pottery in it. No sporadic human bone, plaster fragments or other re-
