A Late Medieval House in Mosonmagyaróvár

Archaeological and Architectural Research of the Cselley House

Adrián MELYKÓ

Abstract: The late medieval origins of 19 Fő Street, or as it is often called, the Cselley House, have been investigated during the reconstruction of the Old Town of Mosonmagyaróvár in 1974; the works brought to light several *in situ* details. Ferenc Dávid excavated the building's walls on multiple occasions as the renovations progressed, while Rezső Pusztai and Péter Tomka led archaeological excavations to explore earlier building phases of the street wing of the building complex. My BA thesis discussed the building's history between the 13th and the mid-18th centuries. The late medieval reconstruction was a major one when the house got the basics of its current façade and layout. Also, this was perhaps the time when it had the highest prestige. The house was a two-storey building with a reverse L-shaped ground plan, a ground floor divided by a vaulted doorway, and an enormous cellar in the courtyard wing. Based on analogies and excavations, the related building phase can be dated to the second half of the 15th century (probably around AD 1470–1480) or the turn

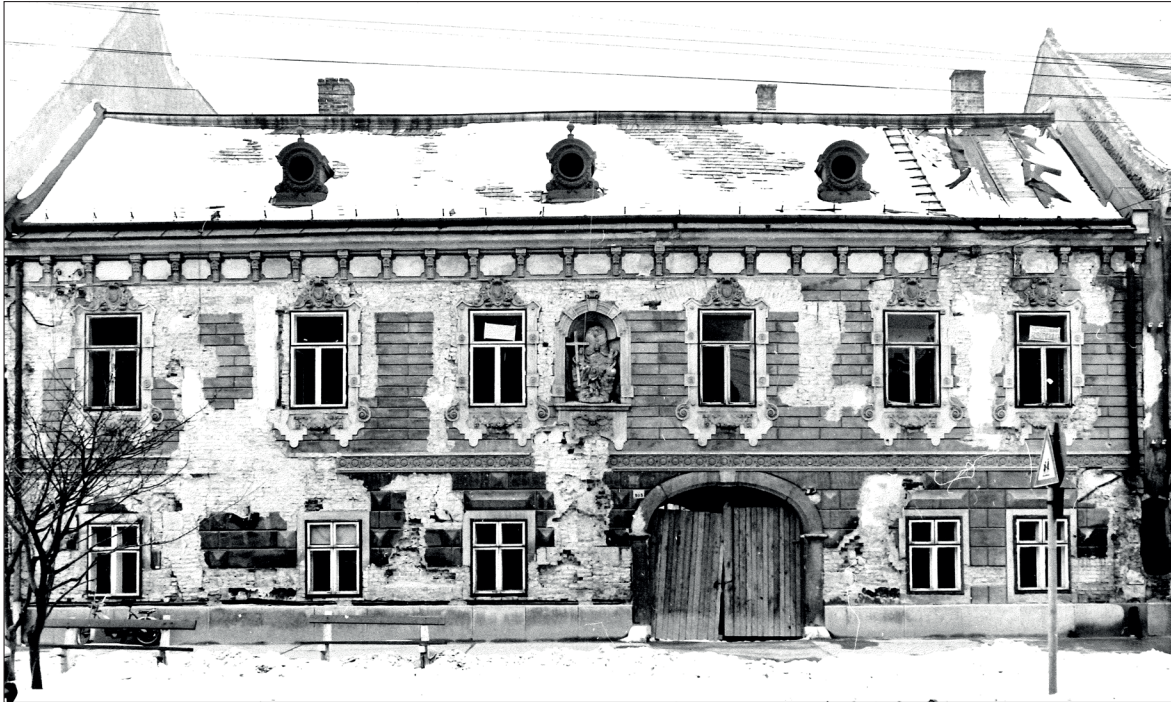
Fig. 1. Street façade of the building at the time of the wall research campaign (Hungarian Museum of Architecture, Data Archive on Jász Street, Inv. no. 22629).

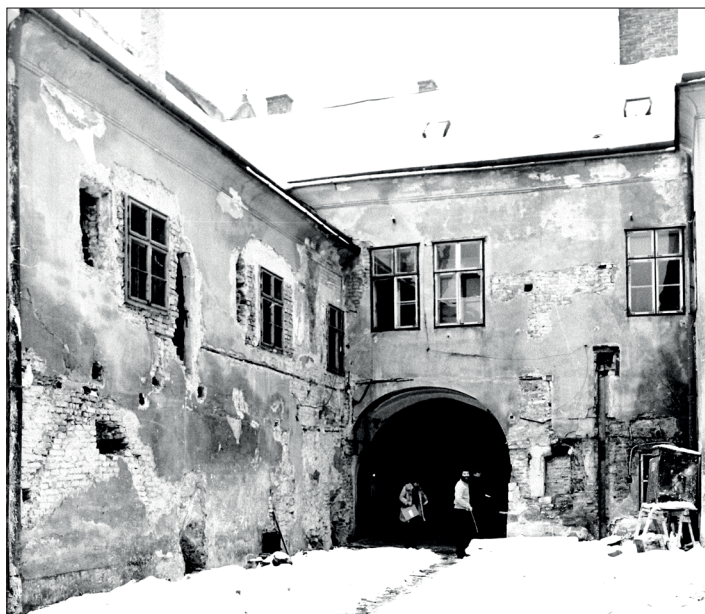
Fig. 2. Courtyard façade with the exposed medieval openings and other details (Hungarian Museum of Architecture, Data Archive on Jász Street, Inv. no. 22629).

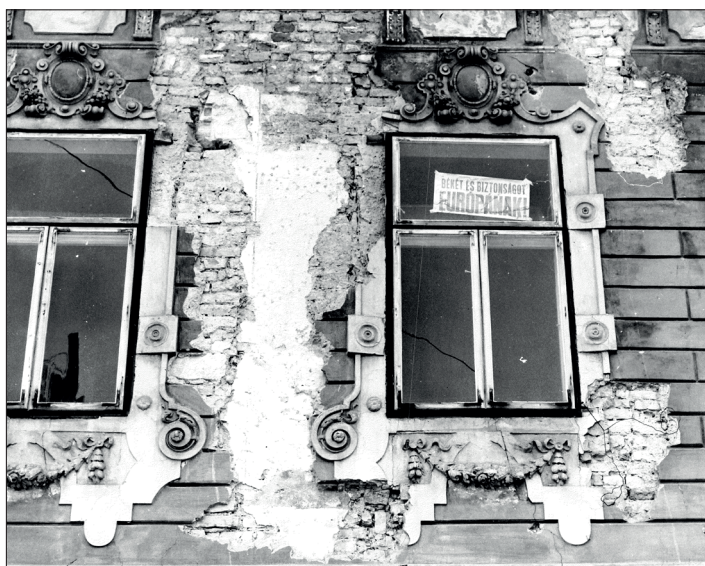
Fig. 3. Openings XXa and XXb with the painted plastered wall between them (Hungarian Museum of Architecture, Data Archive on Jász Street, Inv. no. 22629).

it contained a fragment of the painted framing of the windows, featuring delicate red lines on an off-white background. Another spot, north of window XXb, had a different pattern: a kind of corner rustication imitation, alternate quoining made of diagonally divided painted rectangles, with the lower-left half (triangle) painted red and the upper-right white (Fig. 3).²⁵ The gate (0a) probably stood where it is today; its original extent can be measured from the remains of its frame on the inner side. The distance between the two reveals is 3.15 m, indicating 1.75 m-wide door frames, which fit well with the wall niches. Based on the cross vault arch, the original doorframe's highest point (in the middle) could not be higher than 3.55 m; that is, it must have been lower and smaller than today. As the related parts of the arched stone head had been lost, no information persisted on the arch type and moulding of the gate; it was probably similar to other openings of the period. Some red-painted plastered wall parts persisted *in situ* in the gateway (Room 0), marking the western end of the building in phase VII (Fig. 16).²⁶ The gateway's barrel vault, perpendicular to the street, and the cross vault making up the ceiling of its eastern end were also constructed in this phase.

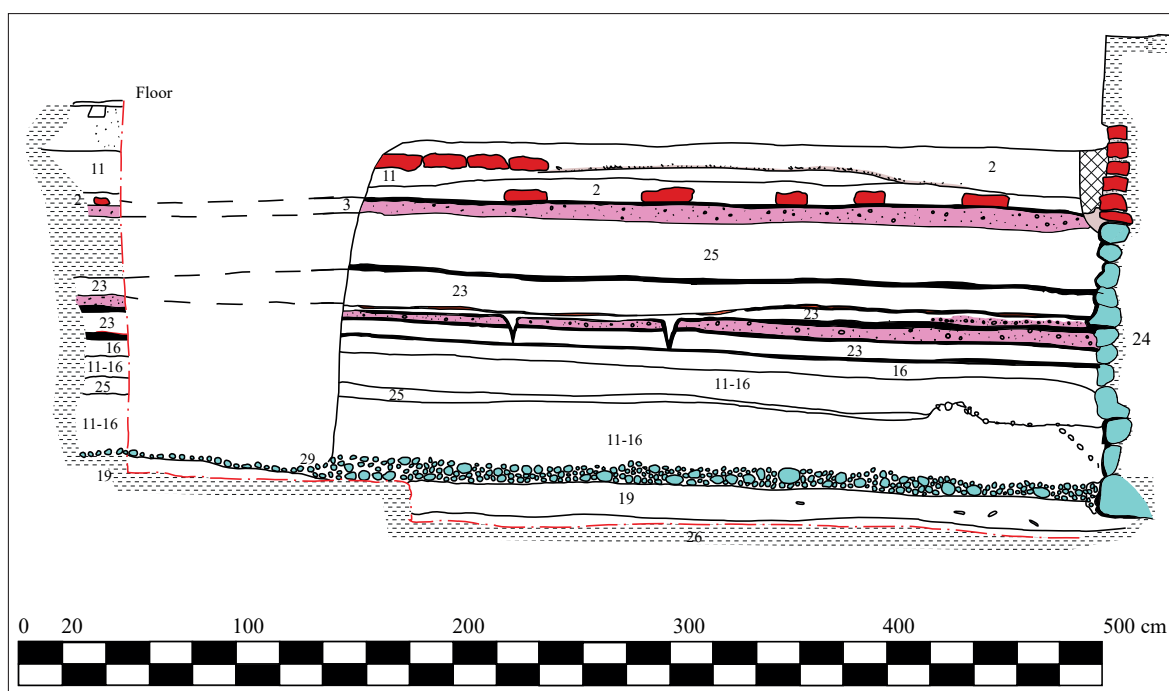
Fig. 10. Northern profile of trench D1 (after P. Tomka and R. Pusztai 1977, III. 26/ 1978. Hungarian National Museum, Data Archive on Magyar Street, Inv. no. 11382). The legend see: Fig. 24
